TEST REPORT

Sample Name : AMF-N/S
Material and Mark : Adhesive Film (Aluminum)
Other Information : Colour: White

Test Item: Anti-Slip Property

Test Method: DIN 51130:2014-02 Testing of floor coverings - Determination of the anti-slip property - Workrooms and fields of activities with slip danger, walking method - Ramp test

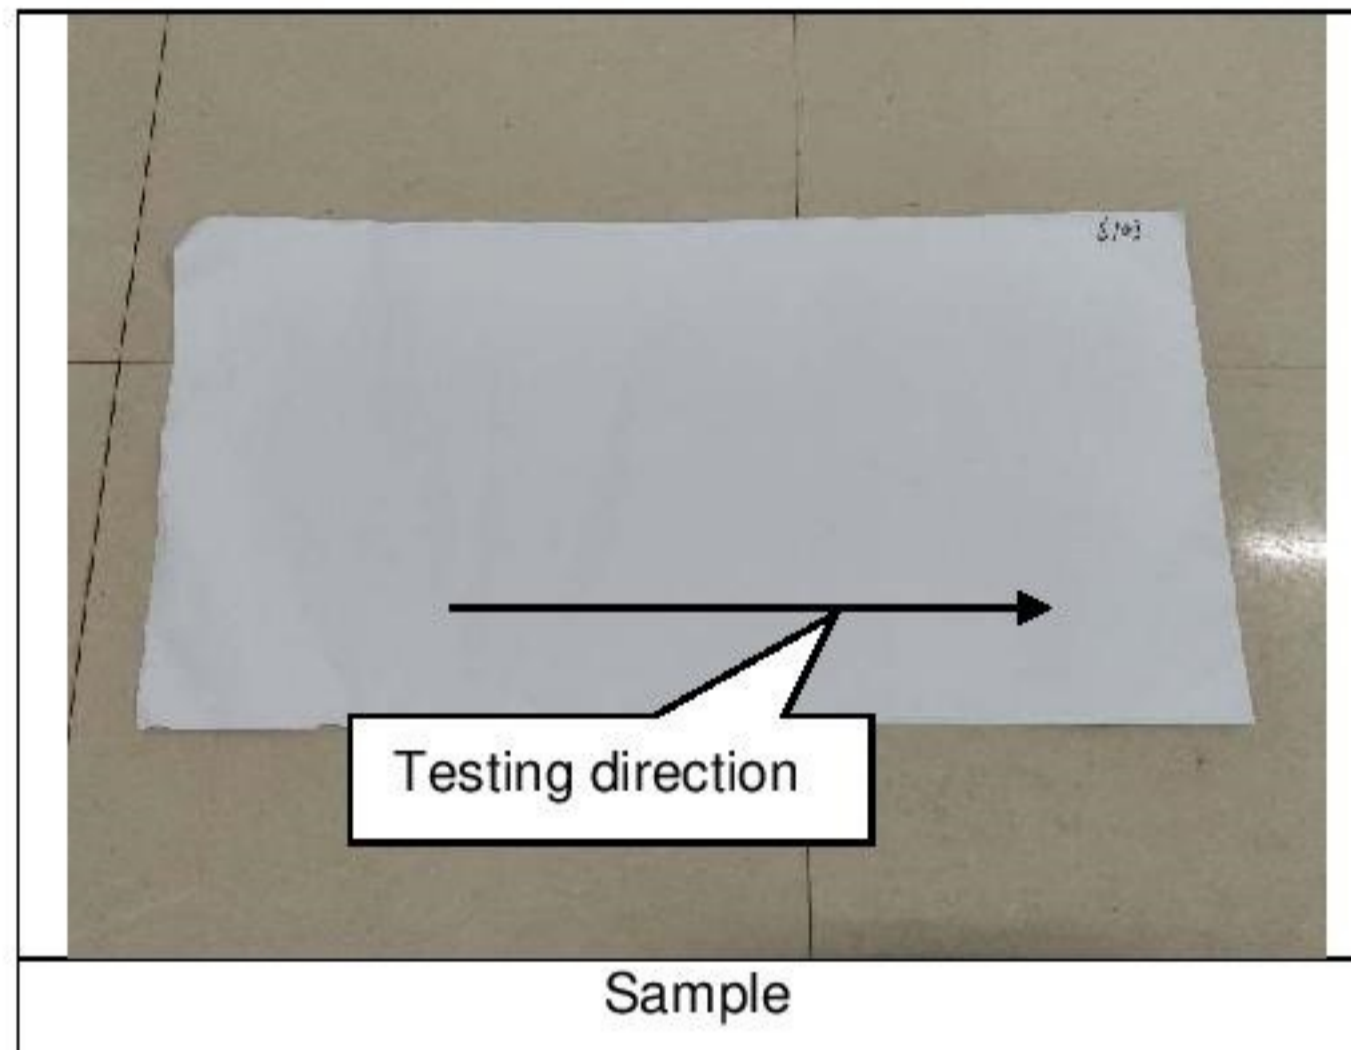
Original Sample Photo:

No.	Test Item	Test Method	Result
1	Anti-Slip Property	DIN 51130:2014-02	Critical angle of inclination: 28.7° Classification: R12

Sample Description: Flooring, See photo

Specimen: 1000mm×500mm, 1pc, see photo

Test item(s)	Test result(s)	Classification
Anti-Slip Property (oil-wet ramp test)	Critical angle of inclination: 28.7°	R12
