#### 2000+ Dodge 2500/3500 Installation Instructions

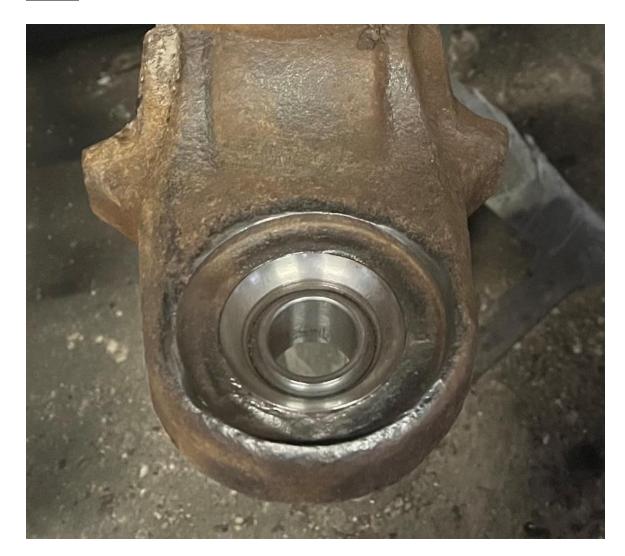
Figure 1: Lower assembly pressed in from bottom

- 1. Place upper and lower assemblies in freezer for at least an hour to lessen amount of force needed to press into knuckles.
- 2. Upper assemblies will be pressed in from the top and the lower assemblies will be pressed in from the bottom of the inner C (Figure 1).

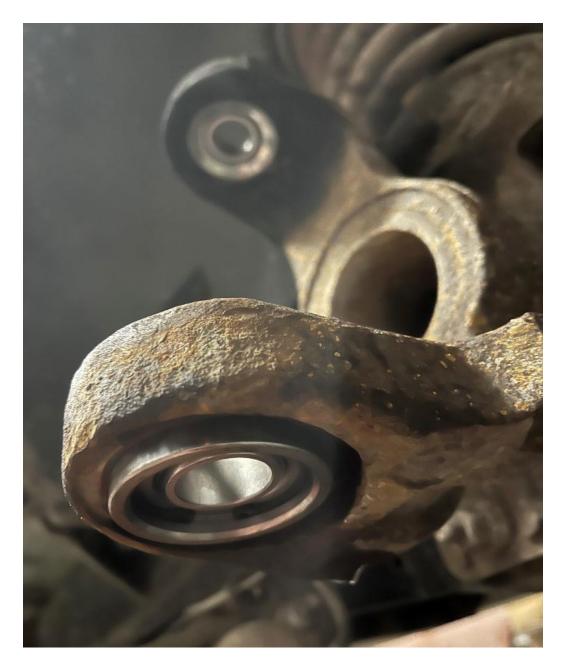
Figure 2: fully seated cups

- 4. Press in cups until shoulder stops progress (Figure 2).
- 5. Insert lower stud into the corresponding taper of outer knuckle and do the same with the upper stud. At this point you will have both studs seated into the outer knuckle using 40ft/lbs to seat the tapers. Use the hex pocket on top of each stud to hold in place.

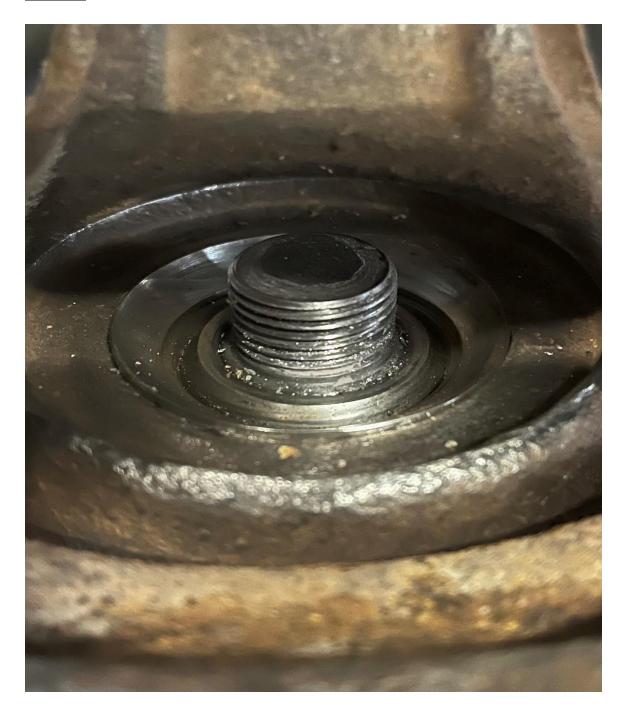
Figure 3a: Only the threads showing

- 6. Raise the outer knuckle to the inner C, lining up the studs with the bearing holes. You should see only the threads of the studs sticking from the top of the bearing (Figure 3).

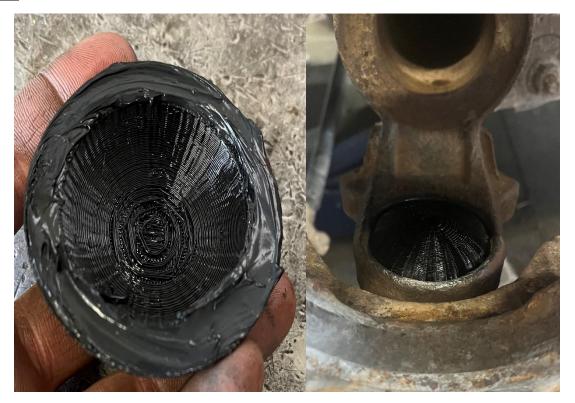
Figure 4: Dust cap installation

- 9. Apply RTV silicone to the underside of the dust cap (after test fitting the cap) as pictured below and after cleaning the surface of the knuckle of debris place cap over the lower assembly (Figure 4). (Note: 2000-2013 trucks will have a recessed area which is pictured below in Figure 1. 2014+ trucks will not have this and the cap will be smaller, actually inserting into the top of the machined cup as seen below in Pic 3b). Choosing not to run the cap will void the replacement warranty of the lower spherical bearings as they will load up with debris and prematurely wear.

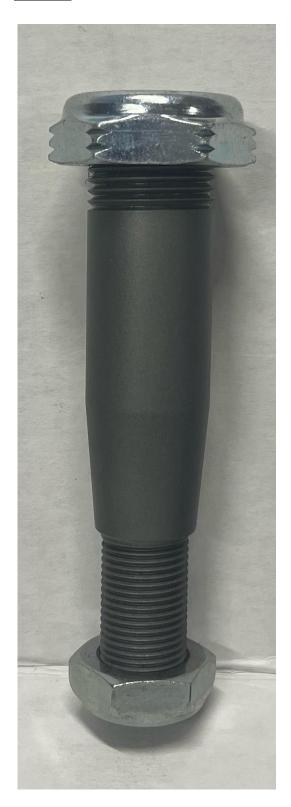
Figure 5: Upper stud with nylocks

- 8. Time to move on to the **top nylock of the upper assembly**. This nylock controls the steering firmness so follow the torque values!! Torque this upper 7/8" nylock to 30ft/lbs.
