Testing Performed by Lab One, Inc.
An Independent Fluids Analysis Laboratory

ULTIMATE CHEMICAL

Coolant

Current Interpretation

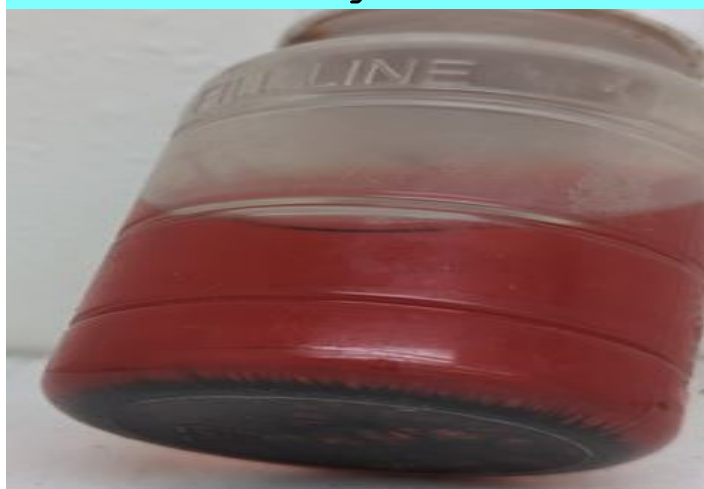
Image 1

CRITICAL SAMPLE IMMEDIATE ACTION REQUIRED. Metals extremely high. Coolant has MAJOR Sediment contamination. Total Dissolved Solids (TDS) elevated. Drain and flush system to remove contaminants/debris. Resample to monitor trend.
