URGENT – Medical Device Recall

Product: Philips M5071A (adult) and M5072A (infant/child) AED pads
Date: March 2, 2022
Subject: M5071A (adult) and M5072A (infant/child) pads for use with HS1/OnSite/Home AEDs may experience gel separation and reduction of gel surface area

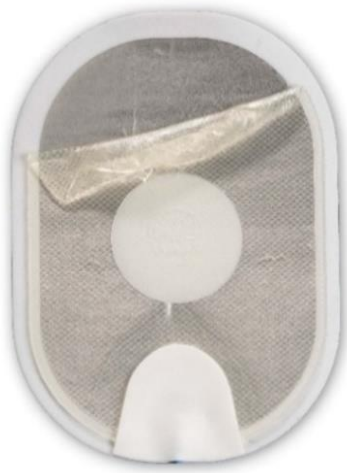
When a pad with separated, folded gel is placed on the patient's bare skin, the HS1/OnSite/Home AED could deliver less effective or ineffective therapy to the patient due to the reduced surface contact area with the skin. See example picture in **Figure 1**.

Figure 1: Separated gel that has folded onto itself when peeled.

Action:
Apply pads to the patient.
Do not hesitate.

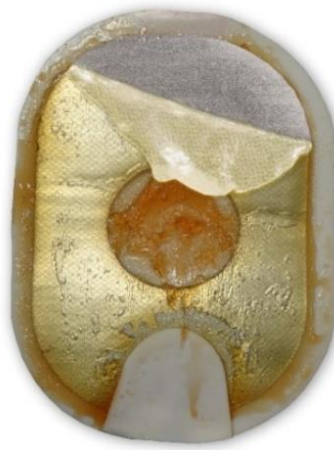
Separated, folded gel may also have a discolored and/or melted appearance. While the gel may also have a discolored and/or melted appearance, the appearance does not have any impact on the delivery of therapy; however, there may be a delay in therapy if the user hesitates to apply the pad due to its appearance, and the AED may deliver less effective or ineffective therapy to the patient due to the reduced contact area with the skin. See example picture in **Figure 2**.

Figure 2: Separated, folded gel may also have a discolored and/or melted appearance.

Action:
Apply pads to the patient.
Do not hesitate.

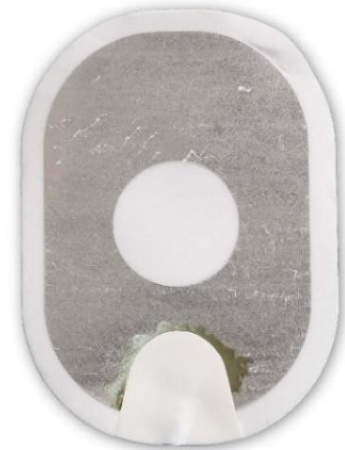
It is also possible that the gel could separate almost completely from the foam/tin backing when peeled, (see **Figure 3**.) Due to a small amount of gel surface contact area with the skin, electrical arcing could occur when a shock is delivered leading to burns to the patient's skin, or the AED could be unable to deliver any shock through the pads. A delay in therapy will result while the user installs a replacement pads cartridge (if available) or performs CPR while waiting for Emergency Medical Services Personnel to arrive. For comparison, **Figure 4** shows a normal pad. No matter the state of the pad, follow the voice prompts because the AED will step you through the necessary actions.

Figure 3: Gel almost completely separated from backing.

Action:
Replace pads cartridge if a spare is available. If no spare is available, perform CPR until help arrives.

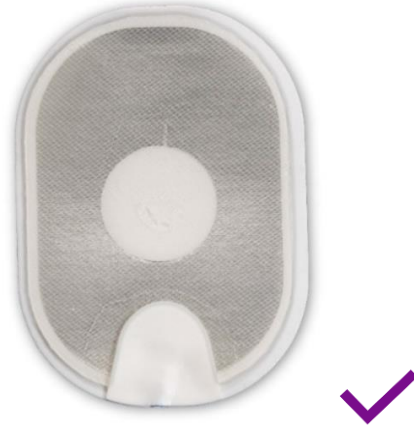
Figure 4: Normal pad.

Action:
Apply pads to the patient according to the Instructions for Use/Owner’s Manual.
