# LEAK TEST PROCEDURE

APPLICABLE TO DC3 INTELLI-GRIP LIFTERS – MODELS  
MRT4-DC3, MRTA8-DC3, MRTALP8-DC3 AND PC/P1-DC3 SERIES

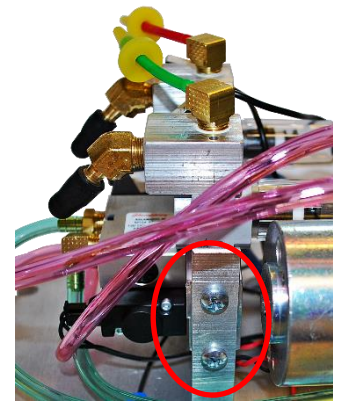
**FIGURE 16**

- 29) The manifold is secured by three Phillips head screws; one against the edge of the channel and two on the opposite side. See **FIGURES 16** and **17**. Remove these screws to access the filter screws on the bottom of the **PC/P1-DC3** manifold assembly.
- 30) Remove the screws securing the filter, shown in **FIGURE 14**. Do not lose the O-rings located between the filter and the manifolds.

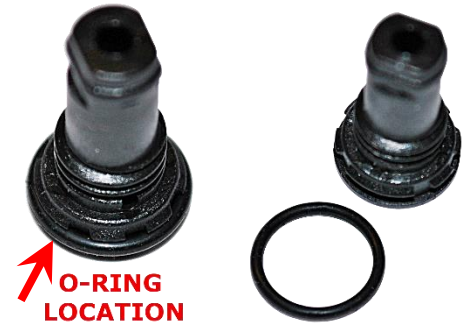
**FIGURE 20**

Once the cap is removed, fully unscrew the drain plug and push it into the filter bowl to remove it. The O-ring seal is located just beneath the plug head. See **FIGURE 20**. Remove the O-ring and clean the O-ring and plug body with a mild soap and water solution. Apply a thin film of rubber compatible grease to the O-ring and reinstall it on the drain plug.

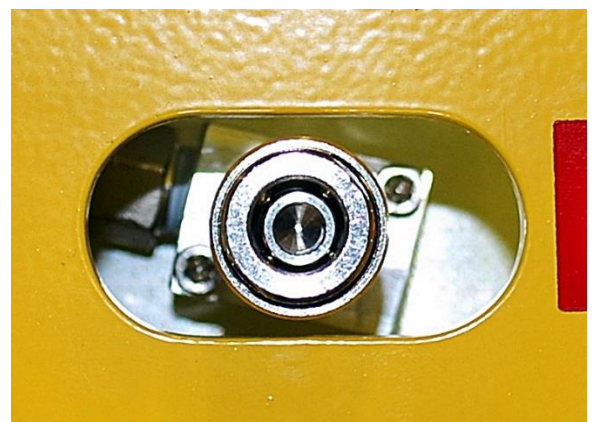
**FIGURE 24**

The quick connects of **MRTALP8-DC3** are attached to a manifold that is secured to the inside wall of the pad frame tubes by two socket head cap screws, located in opposite corners of the manifold. See **FIGURE 24**. A 7/64" hex wrench is required to remove these screws.

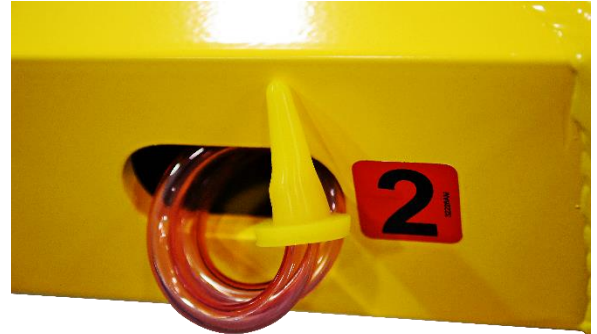
**FIGURE 26**

The vacuum line used on the **MRTALP8-DC3** is 1/4" O.D. hose and is capped-off using the small yellow, #53160, cap plug. See **FIGURE 26**.

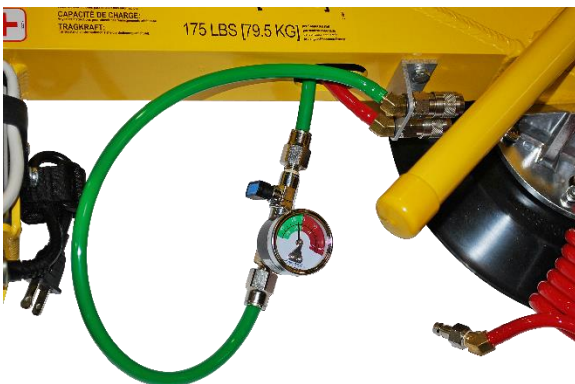
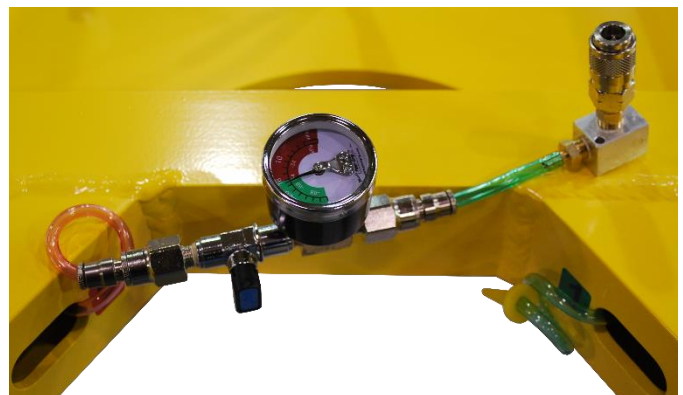
See **FIGURE 27** for the **MRTA8-DC3** and **FIGURE 28** for the **MRTALP8-DC3** which requires the 1/4" push-in hose adapters.

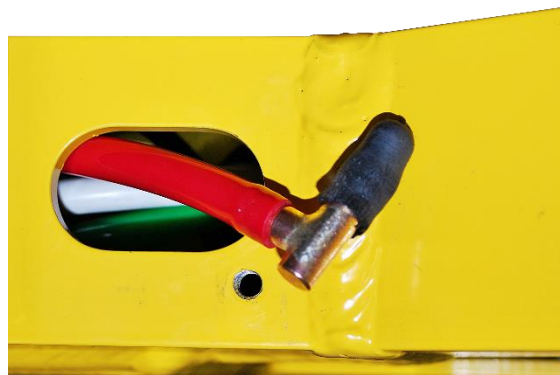
**FIGURE 31**

11) For **MRT4-DC3** lifters, the next test point will be the 90° barbed elbow, used to connect the coiled hose to the internal vacuum lines. See **FIGURE 31**.

- In respect to the **MRT4-DC3** lifter, if the system still leaks when the 90° barbed elbows are capped-off, this indicates that the leak is located between the 90° barbed elbows and the filter. If this is the case, remove the 90° barbed elbows from the vacuum lines of the circuit being tested and cap off the lines using the large orange cap plugs.

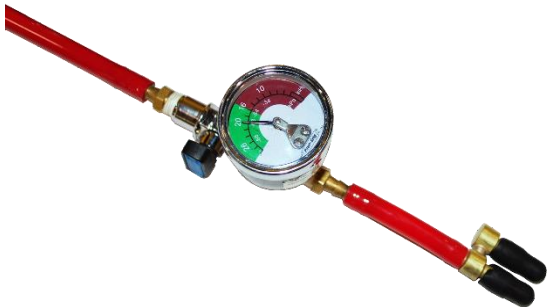
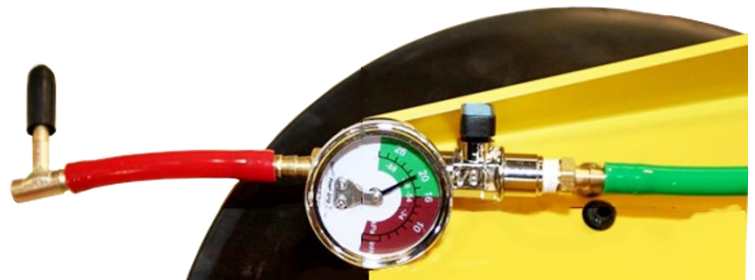
Other examples are shown in **FIGURES 32 and 33** where individual fittings are being tested using the ball valve and cap plugs. Whenever a part is being tested, any open ports that may exist must be plugged or capped-off to get a vacuum seal.
