# Troubleshooting Possible Display Issue on New or Recently Moved VT-34 TS Wine Coolers

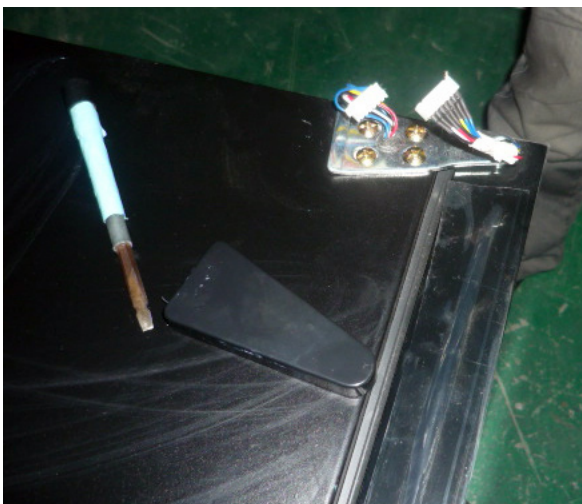
2. Check to see if wiring has come disconnected.
