GVW-321-945-351

LED Rear Side Marker Bulb Replacement
1980-1991 Vanagon

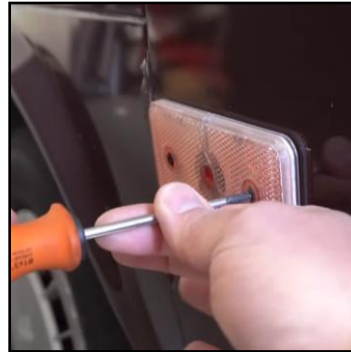
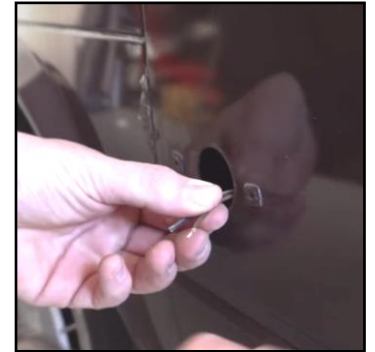
- 1)** Begin by removing the original side marker lens. Cut the wires close to the van body, while still allowing plenty of room to crimp the wires. Remove the entire side marker assembly.

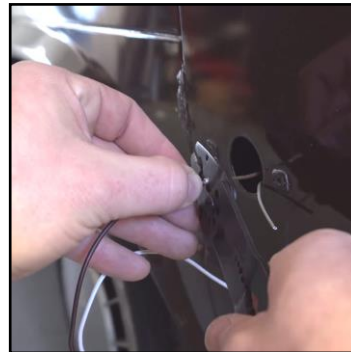
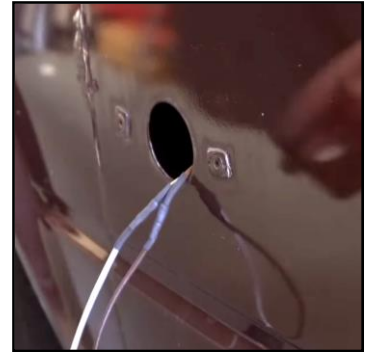
- 2)** Connect your new led bulb housing to the original wires using the butt splice connectors. Make sure to slide the heat shrink tubing onto the wire before crimping. Connect the red LED wire to your hot wire and the black wire to ground. You can test the light before crimping if you are unsure you have connected it properly. Once you have crimped the wires, slide the heat shrink into place and apply heat.

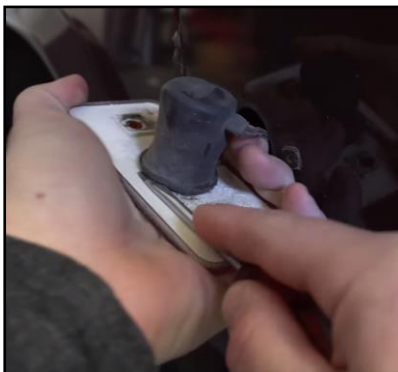
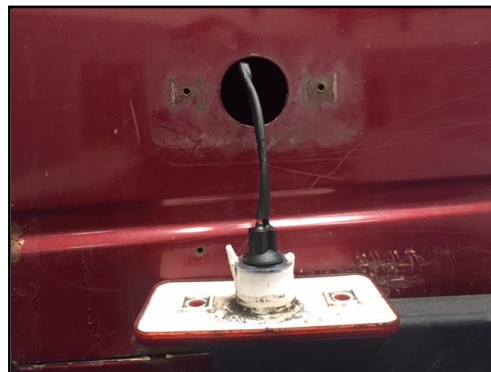
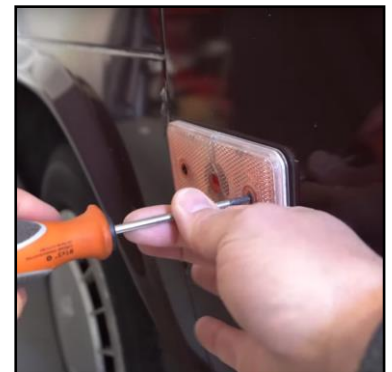
- 3)** Remove the rubber boot and original bulb holder from the OEM plastic housing. Snap the new bulb plate in place, and reinstall the lens into place.
