<b>Prüfbericht-Nr.:</b> <i>Test report no.:</i>	<b>CN210DVI 001</b>	<b>Auftrags-Nr.:</b> <i>Order no.:</i>	244381566	Seite 1 von 8 Page 1 of 8
<b>Kunden-Referenz-Nr.:</b> <i>Client reference no.:</i>	NA	<b>Auftragsdatum:</b> <i>Order date:</i>	2021-12-14	
<b>Auftraggeber:</b> <i>Client:</i>	Qingdaoaishinuodianzishangwuyouxiangongsi. ( QINGDAO iHOME E-COMMERCE CO., LTD ) M6 B10-3, Siliuzhong Road 46hao, zhenhua Community, Licang District, Qingdao, Shandong, China.			
<b>Prüfgegenstand:</b> <i>Test item:</i>	Mountain Bicycle			
<b>Bezeichnung / Typ-Nr.:</b> <i>Identification / Type no.:</i>	MTB-R2R			
<b>Auftrags-Inhalt:</b> <i>Order content:</i>	Test report service			
<b>Prüfgrundlage:</b> <i>Test specification:</i>	AS/NZS 1927:1998 Pedal bicycles—Safety requirements			
<b>Wareneingangsdatum:</b> <i>Date of sample receipt:</i>	2021-12-03

**Produktbeschreibung**  
Product description

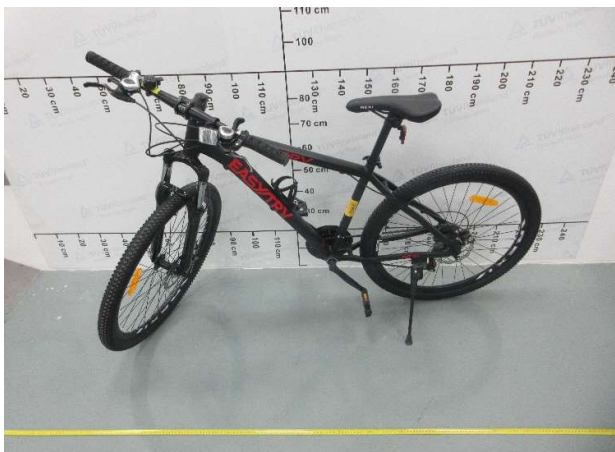
1

<b>1</b>	<b>Produktdetails</b> Product details	Suspension system on front fork.
<b>2</b>	<b>Maße / Gewicht</b> Dimensions / Weight	Net weight: 15.50kg; Maximum saddle height: 1020mm; Wheelbase: 1088mm.
<b>3</b>	<b>Bedienelemente</b> Operating elements	Solely human-powered.
<b>4</b>	<b>Ausstattung / Zubehör</b> Equipment / Accessories	./.
<b>5</b>	<b>Verwendete Materialien</b> Used materials	Frame: Aluminium Alloy.
<b>6</b>	<b>Sonstiges</b> Other	Test sample(s), as well sample information, description, product details and intended usage was provided by customer.
<b>7</b>	<b>Prüfmusterbereitstellung:</b> Test sample obtaining:	<input checked="" type="checkbox"/> Sending by customer <input type="checkbox"/> Sampling by TÜV Rheinland Group <input type="checkbox"/> others:
