# Determining Generation 1 or Generation 2 Retractable Screen

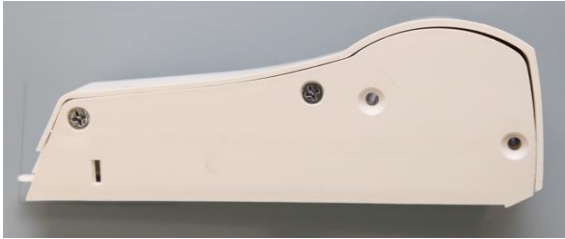
Housing end cap has 4 screw holes

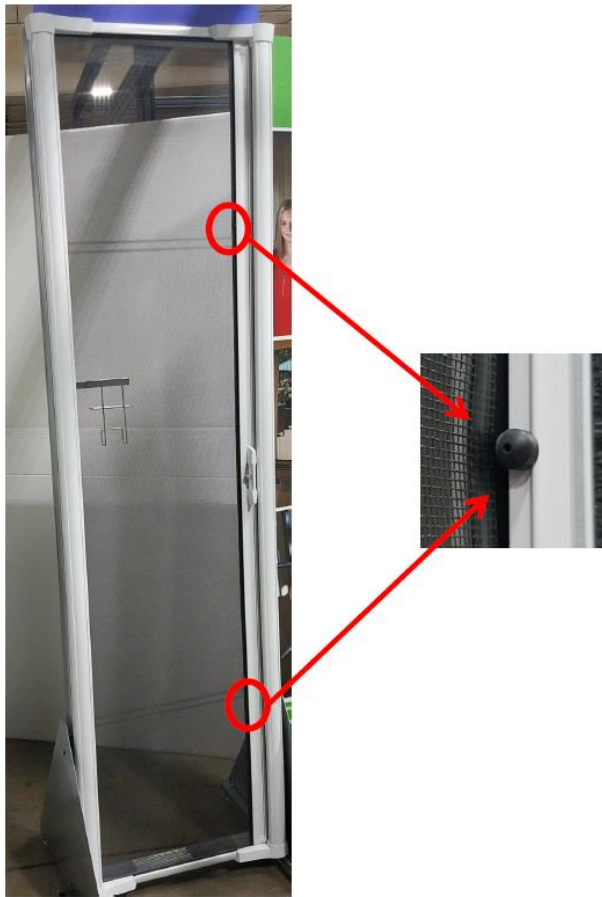
Slider bar end cap does not have a rubber bumper

Rubber bumper location on the slider bar

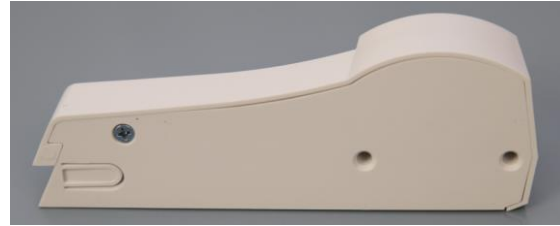
Housing end cap has 3 screw holes

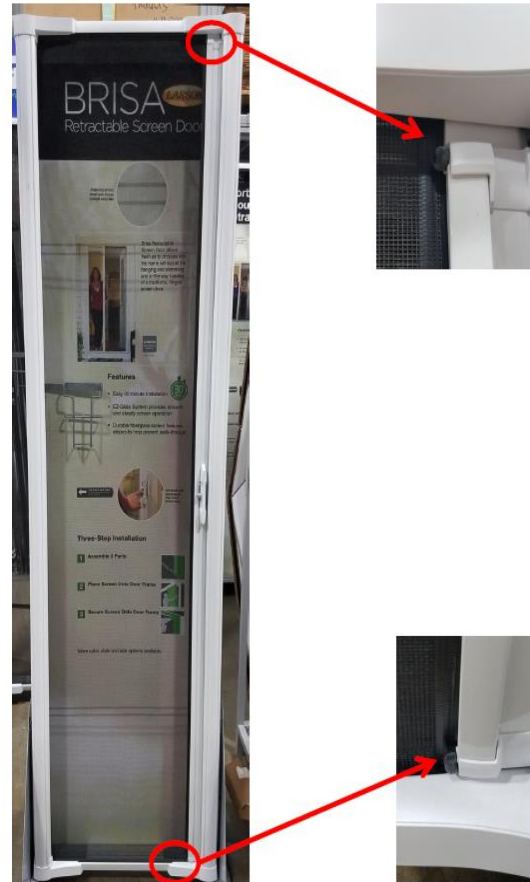
Slider bar end cap has rubber bumper

Rubber bumper location on the slider bar end cap
