Reliable Path-to-Ground

Solving the Wristband Snap Release Problem

by E. E. Bliley, [Lucent Technologies](#)

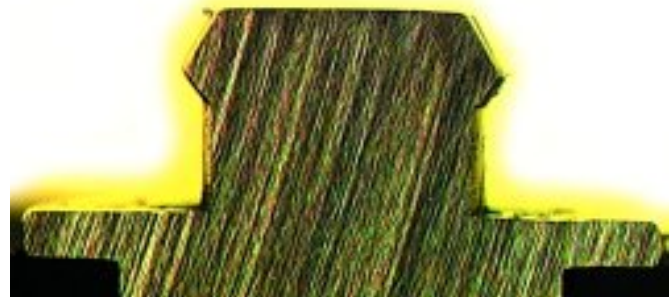
Figure 4 (right) is the cross section of a machined snap. Because of the solid construction and precise machining, it appears completely different than the formed snap and explains the corresponding difference in the breakaway force distributions.

Formed snaps are fabricated by a stamping operation of the two pieces that eventually will become the assembled snap. Machined snaps are exactly what the name implies. They are machined on automated equipment from stainless steel rod stock. A sample of each snap was mounted, cross-sectioned, and lapped for analysis.

Purchasing requirements were changed to specify wristbands with machined snaps and the new high-reliability ground cords.
