Air Cleaner Test Report

Report Number : REPAP19112001

Product : Air Cleaner

Model No. : MOLA300

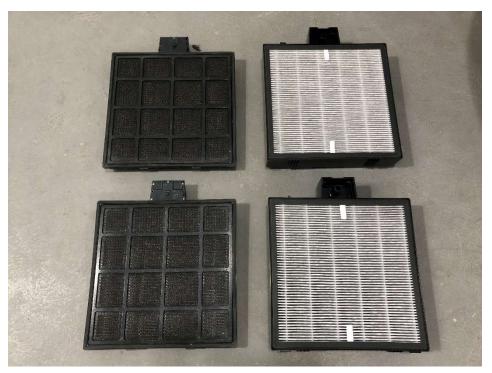
NCCO Reactor (NA213020300) and Activated Carbon HEPA

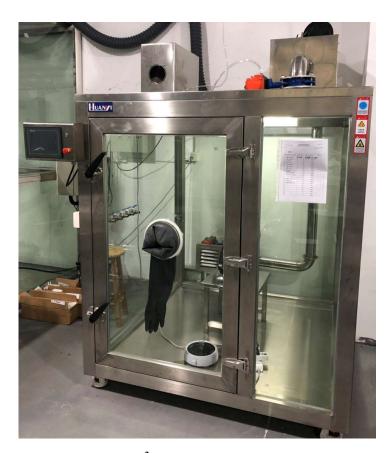
: 3m³ Testing Chamber **Testing Chamber**

Size $(W \times H \times D)$: $1.40m \times 1.40m \times 1.50m$

3m³ Testing Chamber

In a 3m^3 chamber, chemical was injected into the chamber by a syringe and evaporated by a hot plate. Internal circulation was turned on throughout the test to ensure the uniformity of chemical concentration inside the chamber. Initial concentration (C_0) of the chemical was recorded before switching on the air cleaner with a range of $100 \ (\pm 10) \ \text{mg/m}^3$. Then, the air cleaner is switched on for 60 minutes and the chemical concentration was recorded as C_{60} , the final concentration of chemical.
