Air Cleaner Test Report

Report Number : REPAP19111901

Product : Air Cleaner

Model No. : MOLA300

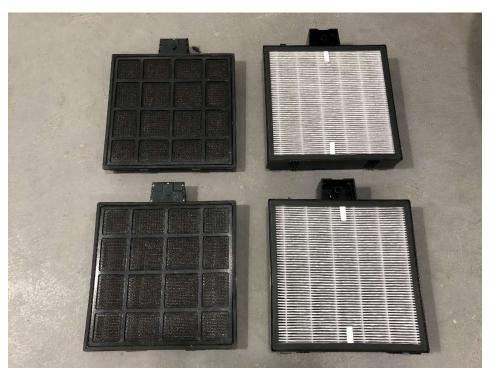
NCCO Reactor (NA213020300) and Activated Carbon HEPA

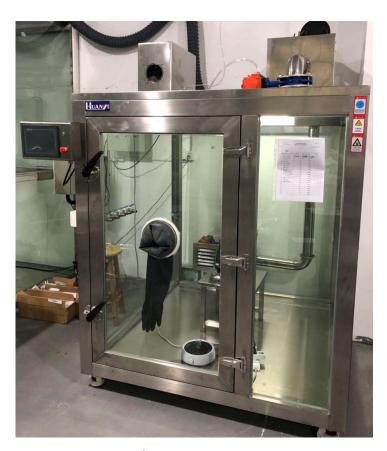
Testing Chamber : 3m³ Testing Chamber

Size $(W \times H \times D)$: $1.40m \times 1.40m \times 1.50m$

3m³ Testing Chamber

In a 3m^3 chamber, chemical was injected into the chamber by a syringe and evaporated by a hot plate. Internal circulation was turned on throughout the test to ensure the uniformity of chemical concentration inside the chamber. Initial concentration (C_0) of the chemical was recorded before switching on the air cleaner with a range of $100 \ (\pm 10) \ \text{mg/m}^3$. Then, the air cleaner is switched on for 60 minutes and the chemical concentration was recorded as C_{60} , the final concentration of chemical.

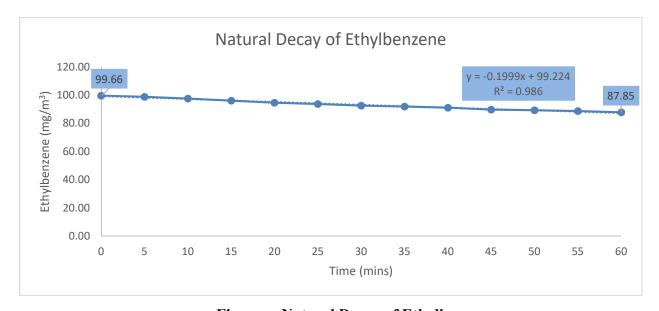
Figure a. Natural Decay of Ethylbenzene

The test was repeated without the air cleaner to determine the natural decay of the chemical at the test chamber. Chemical was injected into the chamber by a syringe and evaporated by a hot plate with an initial concentration (C_{N0}). The final concentration (C_{N60}) was determined 60 minutes later

Initial Concentration	Natural Decay, kn	Total Decay, ke	Removal Efficiency	
mg/m^3	(min ⁻¹)	(min ⁻¹)	(%)	
97.21	0.002	0.057	>99

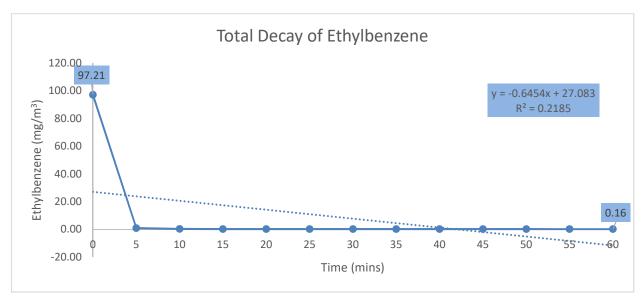
Figure b. Total Decay of Ethylbenzene
