Air Cleaner Test Report

Report Number : REPAP23060601

Product : Air Cleaner

Model No. : BP100

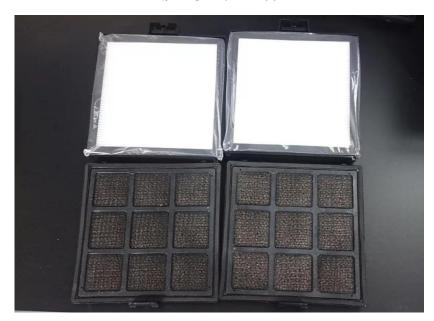
NCCO Reactor (NA213020300) and Normal HEPA

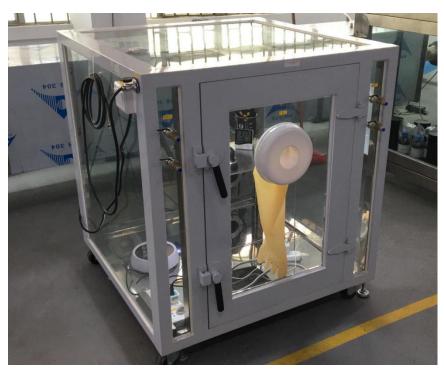
Testing Chamber : 1m³ Testing Chamber

Size $(W \times H \times D)$ mm : $1000 \times 100 \times 1000$

1m³ Testing Chamber

In a 1m3 chamber, chemical was injected into the chamber by a syringe and evaporated by a

hot plate. Internal circulation was turned on throughout the test to ensure the uniformity of

chemical concentration inside the chamber. Initial concentration (C₀) of the chemical was

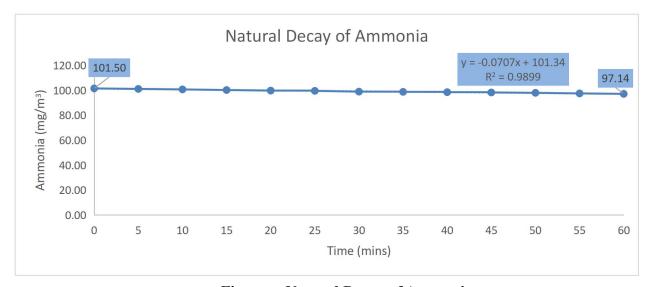
Figure a. Natural Decay of Ammonia

The test was repeated without the air cleaner to determine the natural decay of the chemical

at the test chamber. Chemical was injected into the chamber by a syringe and evaporated by a

hot plate with an initial concentration (C_{N0}). The final concentration (C_{N60}) was determined 60

minutes later

Initial Concentration	Natural Decay, kn	Total Decay, ke	Removal Efficiency	
(mg/m^3)	(min ⁻¹)	(min ⁻¹)	(%)	
109.8	0.001	0.128	>99.9

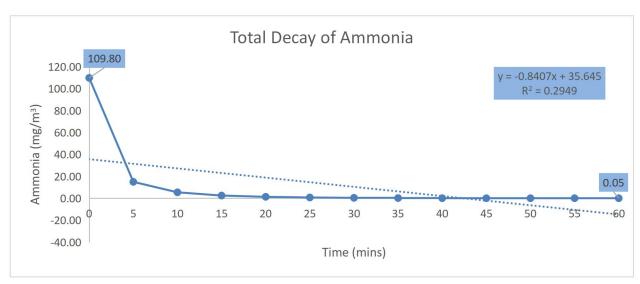
Figure b. Total Decay of Ammonia

Calculation:

$$A_{1} = \cfrac{C_{0} - C_{60}}{C_{0}}$$

$$A_{2} = \cfrac{C_{N0} - C_{N60}}{C_{N0}}$$

$$C_{0}(1 - A_{2}) - C_{60}$$
 Removal Efficiency =
$$\cfrac{C_{0}(1 - A_{2})}{C_{0}(1 - A_{2})}$$
