Air Cleaner Test Report

Report Number : REPAP22090401

Product	: Air Cleaner
Brand Name	: b-MOLA
Model No.	: BM20
No. of Sample Received	: 1
Test Date	: 25 May 2022 – 25 May 2022
Test Item(s)	: Pollutants Removal Efficiency
Test Requested	: Ethylbenzene
Test Reference(s)	: In-house method SOP200 (for VOC removal rate)
Test Equipment	: Honeywell instrument ppbRAE 3000
Equipment no.	: E002 – 003
Test Result	: See the attached sheets
Remark	: N/A

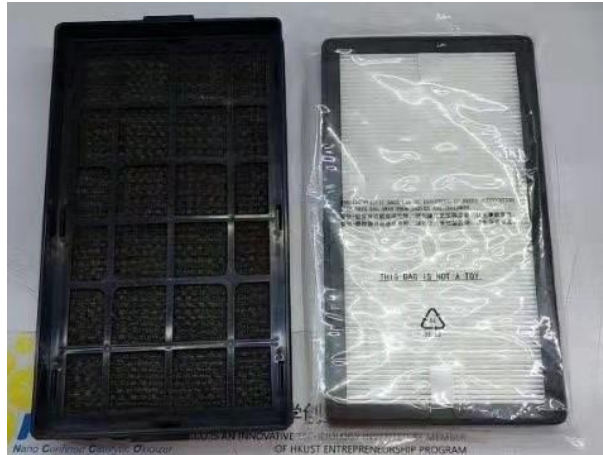
NCCO Filter and HEPA

New filters and HEPA have been used for each chemical test.

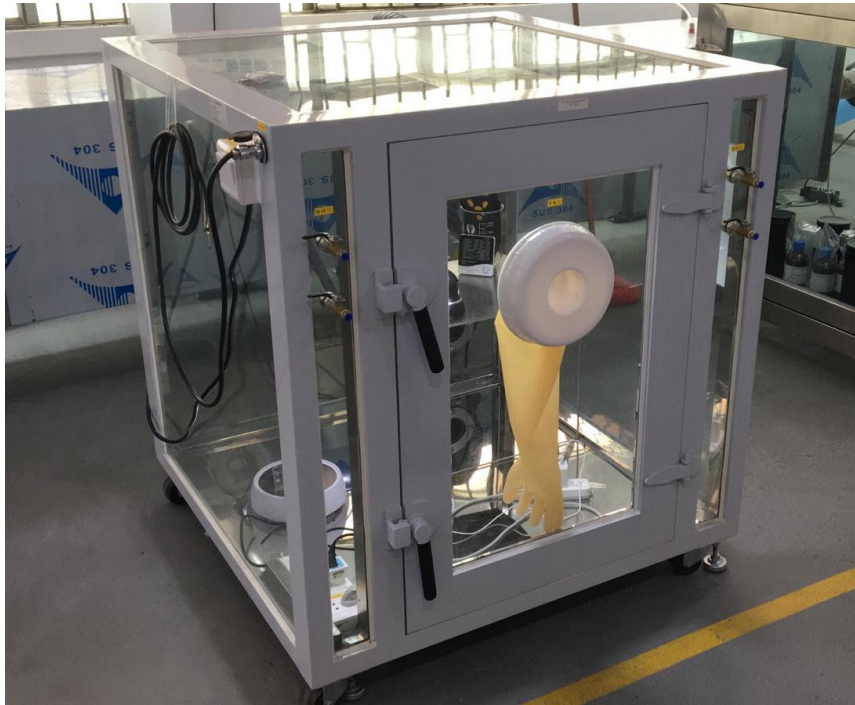
Temperature	: 25.3°C
Relative Humidity	: 50%
Testing Chamber	: 1m ³ Testing Chamber
Size (W × H × D) mm	: 1000 × 1000 × 1000

1m³ Testing Chamber

In a 1m³ chamber, chemical was injected into the chamber by a syringe and evaporated by a hot plate. Internal circulation was turned on throughout the test to ensure the uniformity of chemical concentration inside the chamber. Initial concentration (C_0) of the chemical was recorded before switching on the air cleaner with a range of 100 (± 10) mg/m³. Then, the air cleaner is switched on for 60 minutes and the chemical concentration was recorded as C_{60} , the final concentration of chemical.
