SHENZHEN POWEROAK NEWENER CO., LTD

TEST REPORT

230510047GZU-001

Applicant	:	SHENZHEN POWEROAK NEWENER CO., LTD
Address	:	F19, BLD No.1, Kaidaer Tonhsha Rd No.168, Xili Street, Nanshan Shenzhen, China.
Sample Description		
Name of Sample	:	Portable Power Station
Model Number	:	AC60
Brand Name	:	
Sample Development Level	:	prototype
Quantity of Sample(s)	:	2
Date of Receival	:	10 May., 2023
Date of test Conducted	:	10 May., 2023 to 16 May., 2023
Report Issue Date	:	25 May., 2023
Test		
Test Requested	:	IP65
Test Method	:	Refer to IEC 60529: 1989 + A1:1999 + A2: 2013, Clause 12, 13 and Clause 14
Test Observation:	:	Test probe can not touch hazardous live part.
		There is no talcum powder inside after test. There is no water inside after test.
Test Conclusion:	:	Pass
Other information	:	N/A
Remark	:	This test report is only for evaluation of the specified standard clauses listed in <u>Test Requested</u> .
		Determination of the test conclusion is based on IEC Guide 115 in consideration of measurement uncertainty.

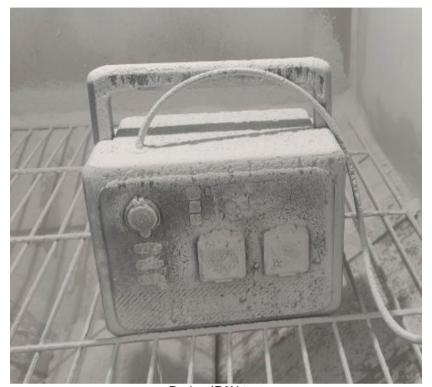
During IP6X test

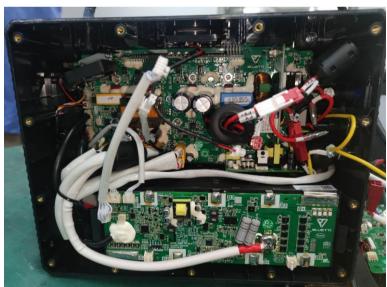
Internal view after IP6X test (there is no dust inside)

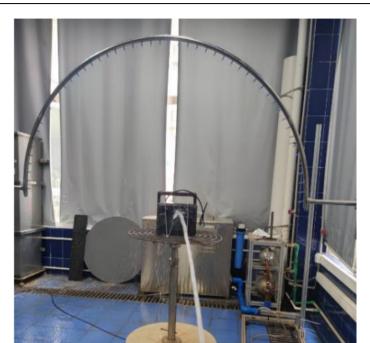
During IPX5 test

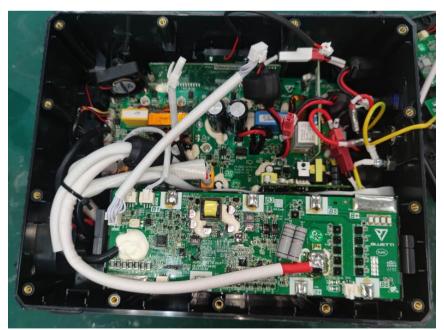
Internal view after IPX5 test (there is no water inside)

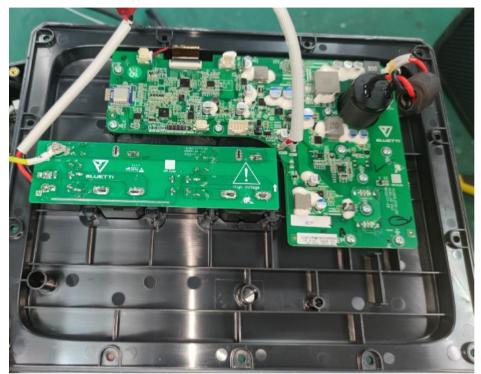
Internal view after IPX5 test (there is no water inside)

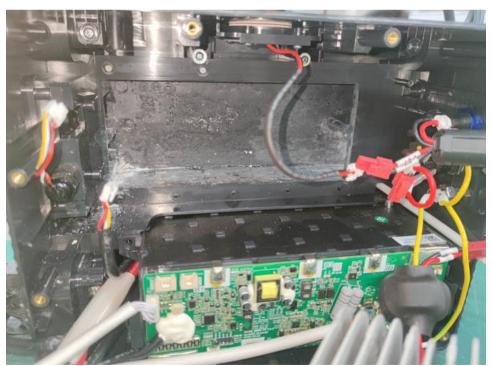
Internal view after IPX5 test (there is no water inside)
