Turbo Actuator Guide

TURBO ACTUATOR INSTRUCTIONS

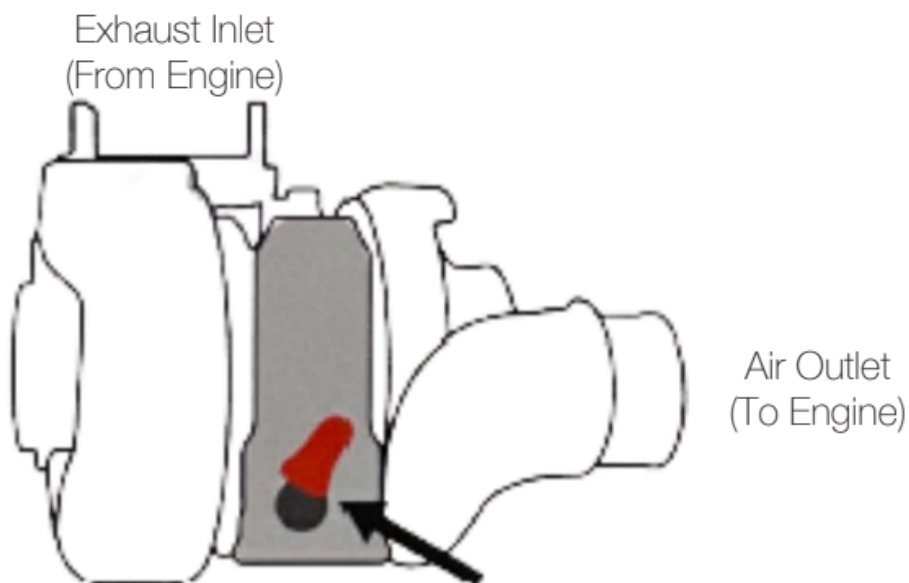
PUSH SECTOR GEAR IN THE DIRECTION INDICATED UNTIL IT STOPS

1. Begin with the engine off and the Key in the Off position
2. Drain the coolant from the engine cooling system
3. Disconnect the actuator from the vehicle by unplugging the cable
4. Remove the 4 bolts that hold the actuator in place and remove the actuator
5. Rotate the sector gear clockwise until it stops (see image below)
6. Ensure that the gaskets are properly seated on the new actuator and the mounting surface on the turbo is clean
7. With the actuator mounted and calibrated, refill the coolant system with new coolant
