### **NEW GENERATION HEIGHT CONTROL VALVE** PRESSURE DUMP CONFIGURATION INSTALLATION INSTRUCTIONS

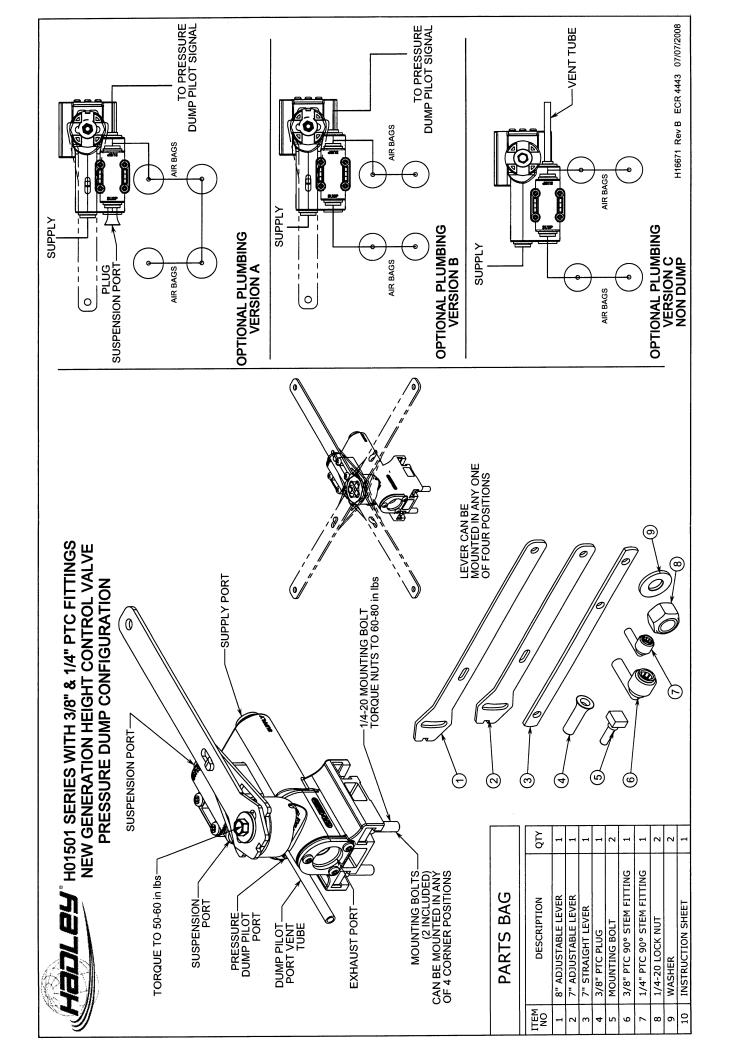
- Hold NGHCV next to height control valve to be replaced and determine mounting orientation of the NGHCV for best hose routings.
- NOTE: The supply port must be horizontal or pointing up.
- Determine location of the 2 mounting studs and proper lever length

- Each side of the NGHCV has arrows pointing toward the fill and exhaust directions.
- of the lever. Rotating the cap 180° will result in the opposite fill and exhaust lever movement. Align the U-shaped cap detail with the fill/exhaust arrows that correspond with the fill and exhaust movements

- Install the correct lever onto the valve. The lever can be mounted in one of four directions
- Ö Tighten screw to 50 - 60 in lbs.
- Install mounting studs into the T-slots. Use a hammer to tap square head into the T-slot if needed

- Remove old height control valve and note the hoses and ports.
- Attach NGHCV to mounting bracket and tighten nuts to 60 80 in lbs.
- Examine the end of each tube prior to insertion and trim the end as necessary to get a clean, 90° cut
- 90° stem fitting included in this kit if necessary. Make sure tubing does not interfere with lever rotation Attach hoses into the proper ports by pushing the tubes into the push-to-connect (PTC) fittings. Use the plug and
