Anti Cash-Trapping cleats for SelfServ 6626

SelfServ 6626

NCR PID: TBC

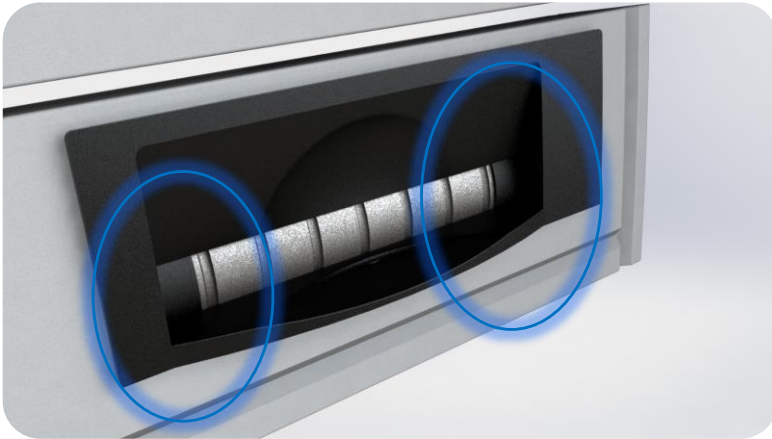
Area where trapper is fitted

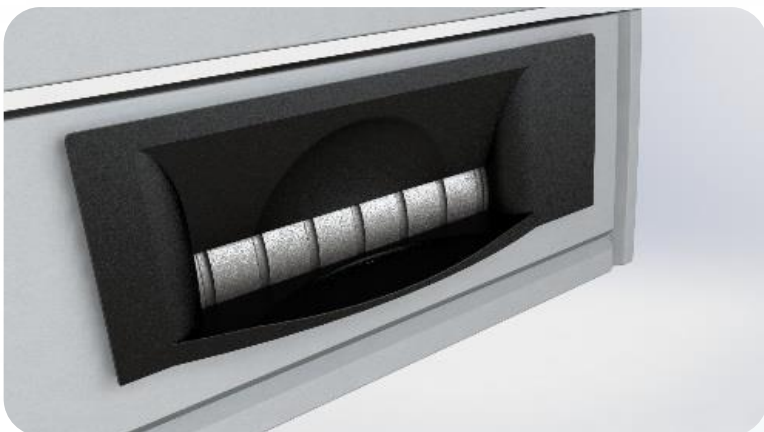
Cash slot with cleats fitted

There has been a recent cash trapping attack on the SelfServ 6626 ATMs. A metal cover is fitted in front of the shutter. A solution to prevent this attack is the Anti Cash trapping cleat that simply fits either side of the shutter and prevents the trapper being fitted.

- Fits in seconds
- No tools required
- Optional screw on system
- Looks like part of the ATM
- Uses VHB double sided tape to bond to cash shutter bezel

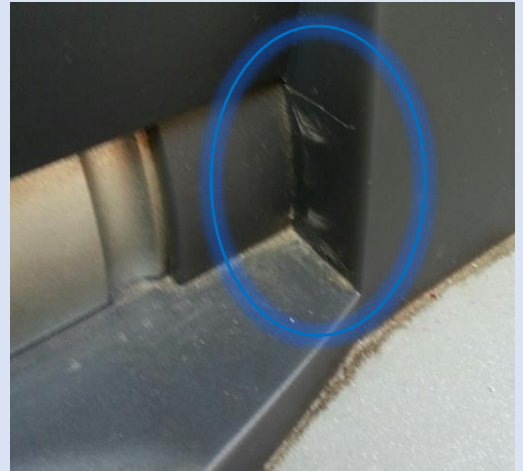
Scuff marks showing where device was fitted

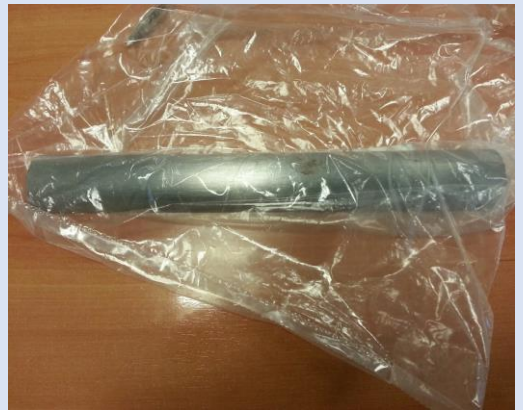
Recovered device

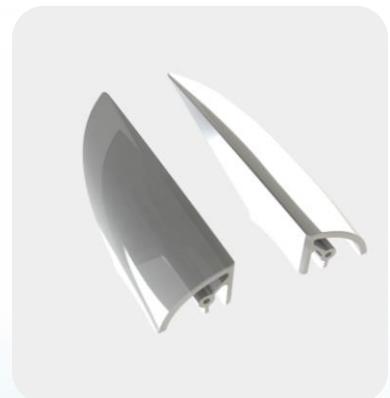
Anti Cash-Trapping cleats
