SVD35 / SVW34

Spotting Board Valve

Adjusting Packing Nut

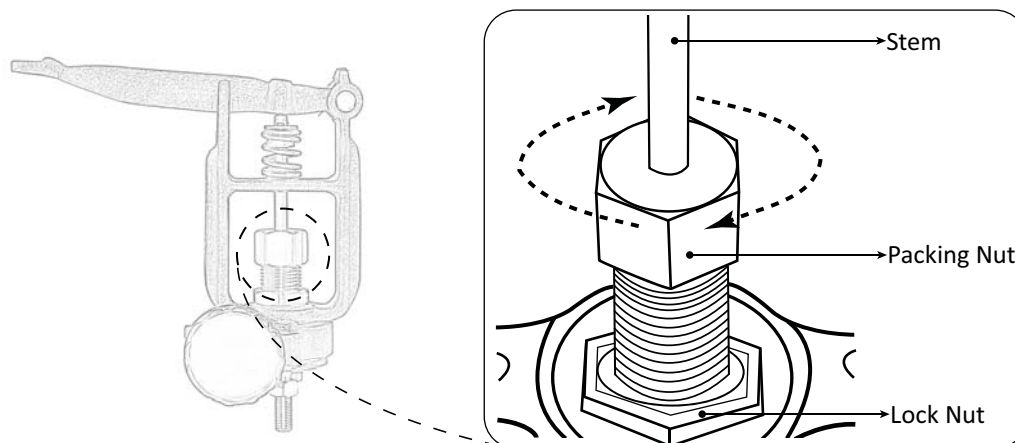
Leak from Stem & Packing Nut ?

If you notice a leak on the Stem & Packing Nut after installation.
Proceed to tighten the Packing Nut clockwise until the leak stops.

DO NOT OVERTIGHTEN as you may damage the Gaskets inside the valve.

This 'Adjusting Packing Nut' Procedure can be done repeatedly in normal use of this valve.
