FL / 02/ 01 error code is showing up on my chiller / and it's not starting up

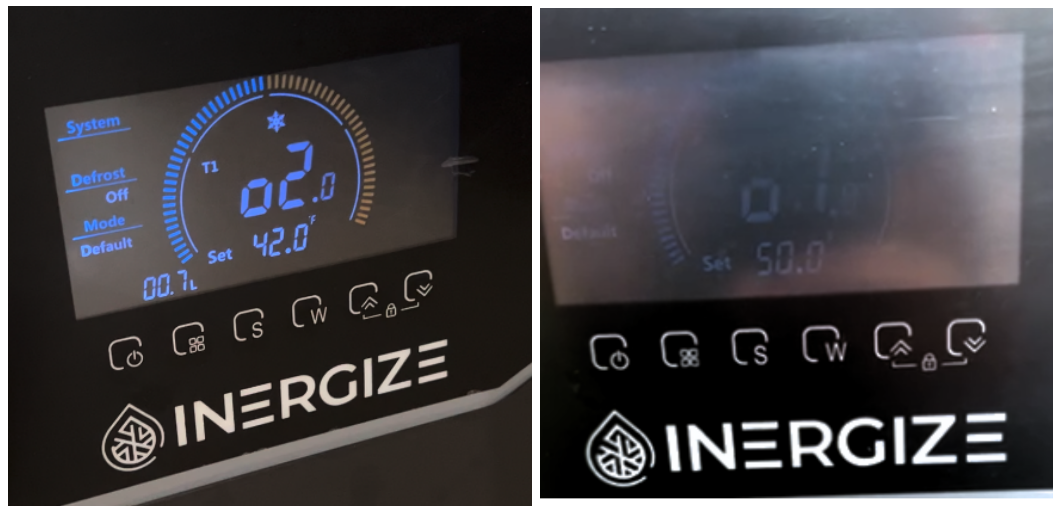
The code below displays when the Chiller is first started up and while the system is priming with water for circulation. This screen is generally normal to see and establishing water circulation can take up to 3 minutes, especially if the Chiller and/or Chiller Hoses were recently drained of water.

If after 3 minutes the machine has still not established water circulation, please check each of the following. The Chiller can be tested in between each step.

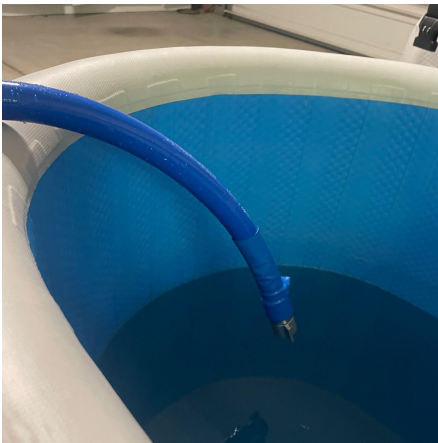
There is a Check Valve inside the outlet port on the Chiller. This can become stuck in the closed position and prevent water from flowing through the unit. If you notice that the Chiller is trying to prime but no bubbles are coming out from the Tub Water-In Fitting, this is a possible resolution. Reinstall the Chiller Hose, open the Tub Fitting Valves, and try Chiller again.

1. Turn off the chiller.
2. Close the ball valve in the perpendicular direction at the tub inlet.
3. Unscrew the chiller green outlet hose connection
4. Place hose inside the tub

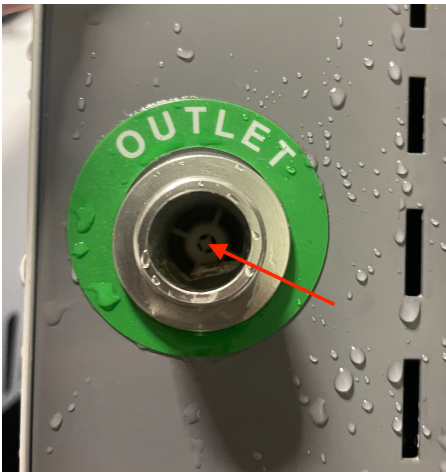
- 5.
6. Check to see if the little pin in the valve is stuck outward (toward you). If it is stuck outward, use a small screwdriver and press on it gently. If it was indeed stuck, you will feel and/or hear a little click that indicates the Check Valve has returned to position.

- 7.
8. Open the ball valve in the parallel direction at the tub inlet.
9. Turn the chiller back on.

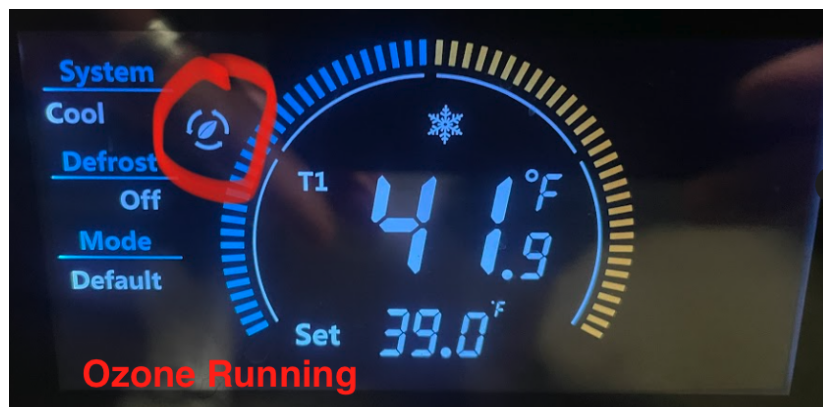
By following these instructions, you will successfully disable the ozone feature. This will enhance your cold plunge experience by **improving water flow** (FL code shouldn't appear as often as the filter gets dirty), **reducing noise levels**, and **promoting unit longevity**. It's a simple adjustment that will have a significant impact.

1. Click on the 'S' button
2. Press and hold the 'W' button until the display shows '03'.
3. Click the 'DOWN' button to set the value to '0'.
4. Press the 'S' button to save the changes.
