FACT SHEET

Peaking Seams

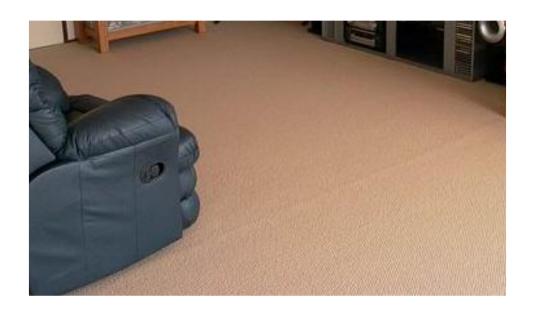
The action of stretching the carpet at right angles to the seam puts tension in the carpet that the backing can absorb. However, when the forces of tension reach the rigidity of the seaming tape, the tape is pulled upwards resulting in a lump or peaked seam.

Back-rolling the seam edges and pre-stretching the carpet along the seam area will help minimize peaking. Also stretching the carpet tighter in the direction parallel to the seam, and a little less in the direction perpendicular to, or across, the seam will relieve pressure on the seam and reduce peaking.

Locate the seam away from a window, glass door or other strong light source, where light may cast a shadow across the seam. Even the smallest peak will be accentuated and become more noticeable. It is our experience that peaking seams will diminish with time, i.e. with use and vacuuming.
