VINTAGE VIBE
ELECTRIC PIANO CO.

CUSTOMER SERVICE BULLETIN

#CSB0001

Stereo Vibe Units: Pre-Rev 5 PCBs

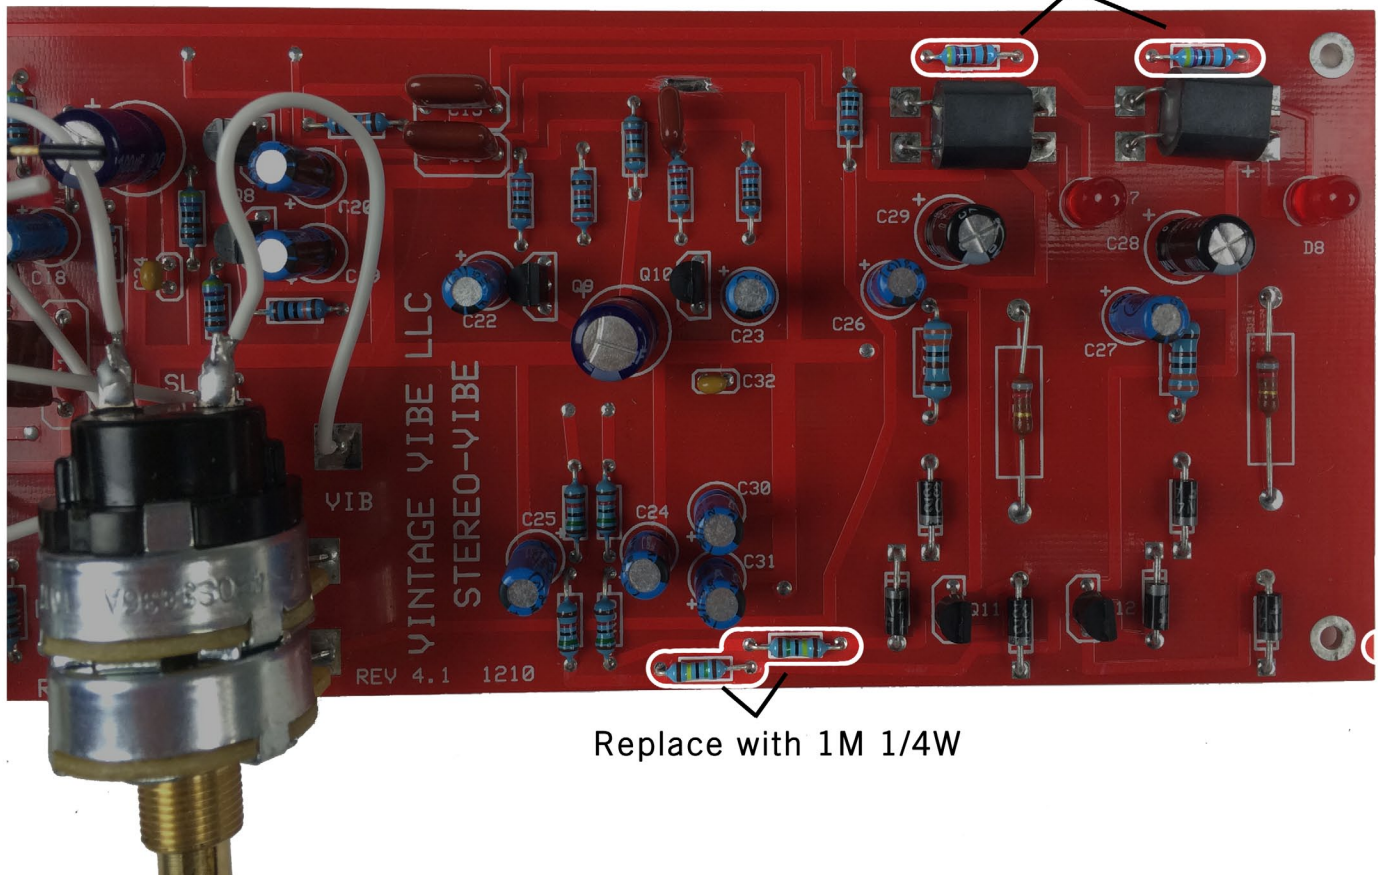
Replace with 20K 1/4W

Replace with 1M 1/4W

1. Replace both R52 & R53 with 1M 1/4W Metal Film resistors.
2. Replace both R31 & R32 with 20K 1/4W Metal Film resistors.
