**EN** Instructions for use / Assembly instructions

**Talis M54 210 2jet**  
72800XX3

**Talis M54 210 1jet**  
72802XX3

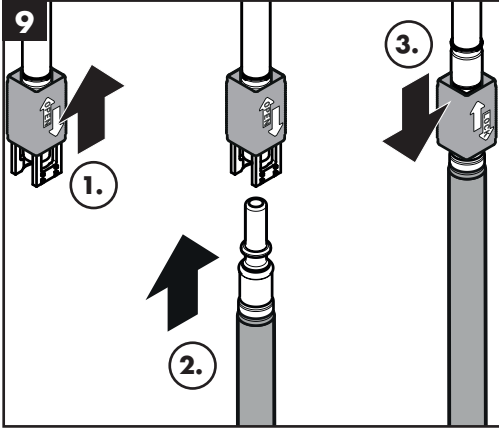
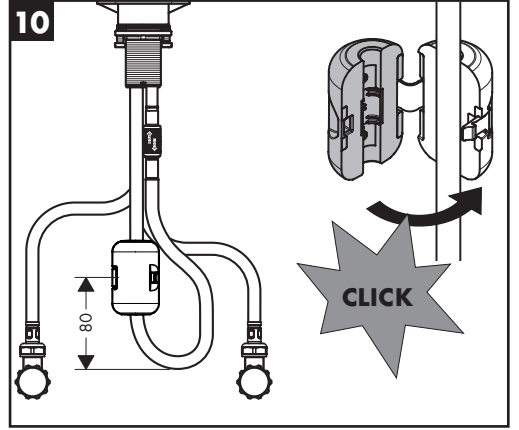
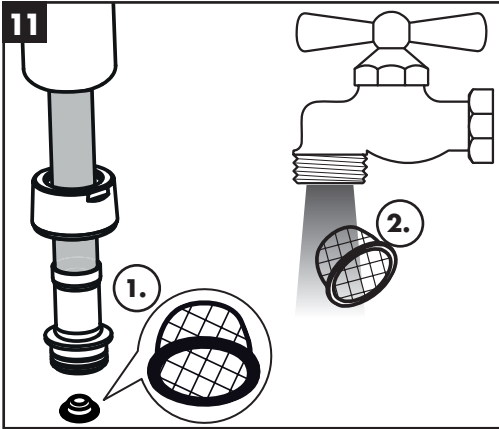
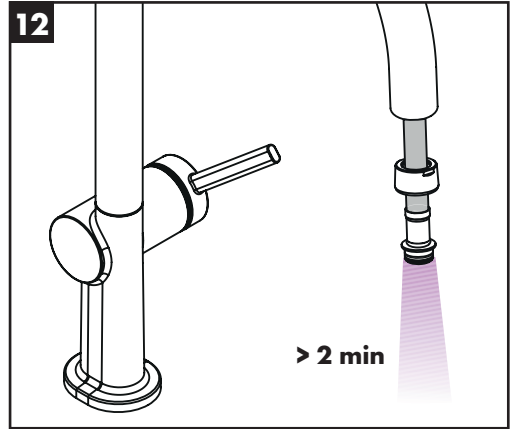
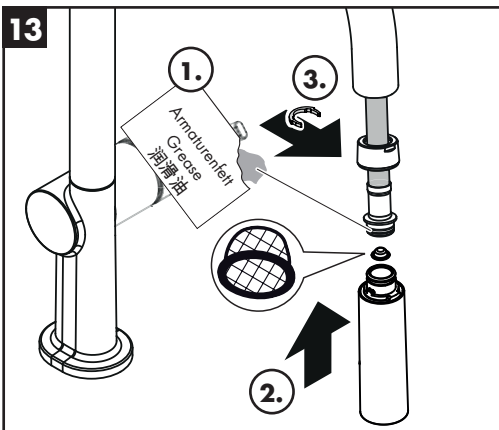
## Adjustment (see page 10)

To adjust the hot water limiter. Using a hot water limiter in combination with a continuous flow water heater is not recommended.

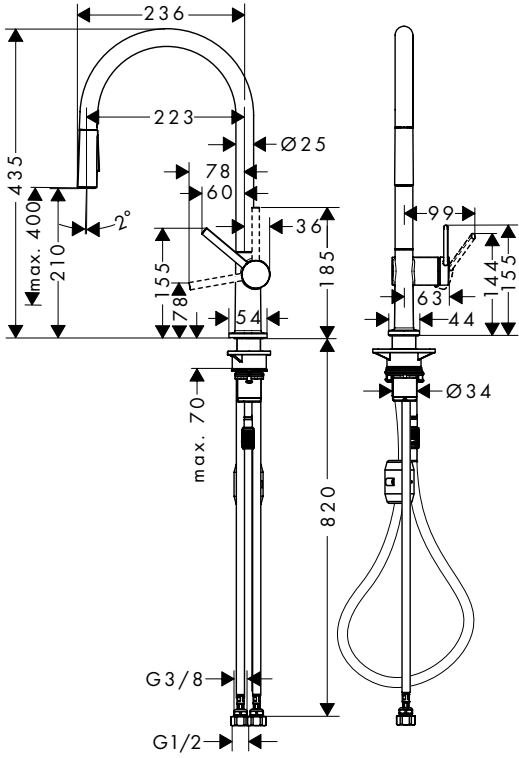
# Talis M54 210 2jet

## Dimensions (see page 12)

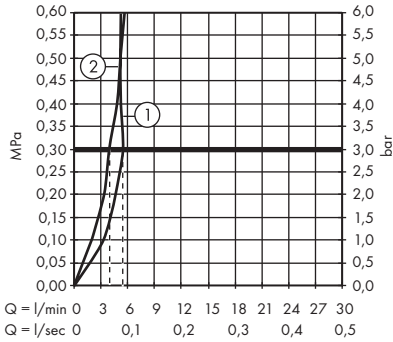
# Talis M54 210 2jet

## Flow diagram (see page 12)

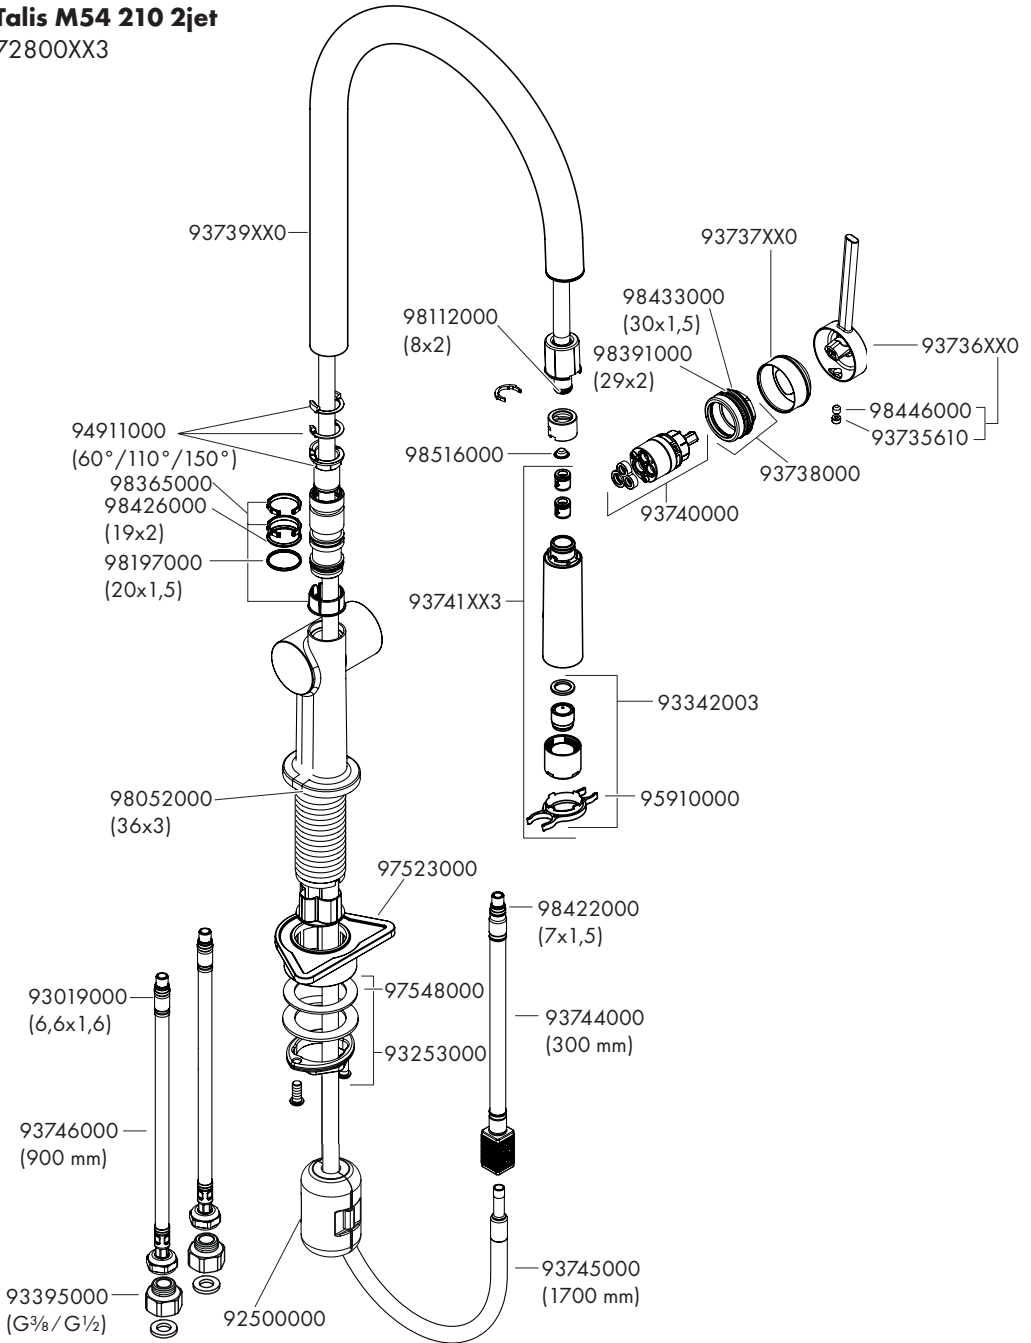
# Talis M54 210 2jet

## Spare parts (see page 14)
