GMRCK15S

Rear suspension package
Ensemble pour suspension arrière
Ensemble para suspensión de trasero

INSTALLATION INSTRUCTIONS

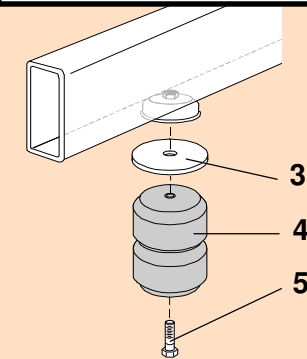
2007-On/Sur/En

Remove existing bump stop assembly using 10mm socket.

- Raise vehicle allowing the axle to hang freely.
- Remove existing bump stop assembly.
- Assemble Aeon rubber spring and bracket as shown in the adjacent diagram.
- Mount Timbren assembly using existing holes & Timbren supplied fasteners.
- Lower vehicle.
