POLYTRAP 500L INSTALLATION INSTRUCTIONS

Grease Trap Requirements as set out in Acceptable Solution G13/AS2

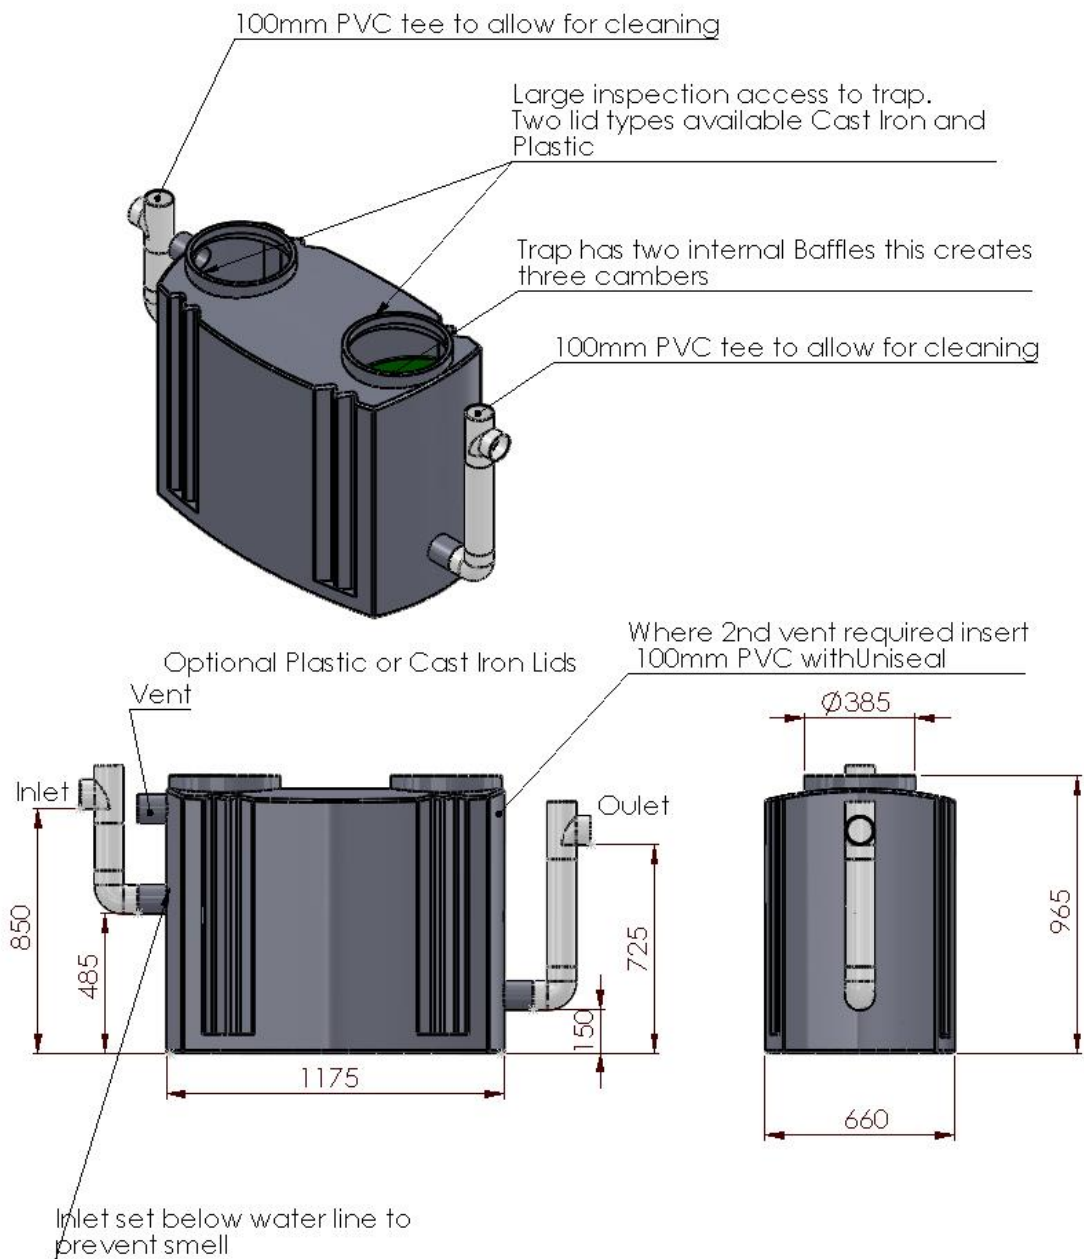
1. Grease Trap Sized at 500 Litre, both the inlet and outlet come standard and can be fixed to by using a 100mm PVC Rubber Connector.
2. The Inlet height is set at 850mm from bottom of tank All sanitary fixture waste outlets discharging into the grease trap must be now lower than 1000mm from bottom of tank

3. The inlet and outlet must be fitted as per drawing with inspection cleaning access caps, enabling future rodding access in the case of a blockage.
4. Excavate hole to accommodate the grease trap and associated pipe work.

6. Put the grease trap in place and half fill with water.
7. Install the remainder of pipe work.
8. It is important to note that the height of the outlet determines the water level within the grease trap, in the case of the Polytrap 500 the outlet height is fixed at 725mm from bottom of tank.

9. Check that the inlet height is higher than the outlet height so as water does not backflow.
10. Install a 100mm open to air vent to the local body requirements.
