# THE GREAT UK ANTIFOULING SHOWDOWN

20 paints tested in 13 UK locations: which works best where you keep your boat?

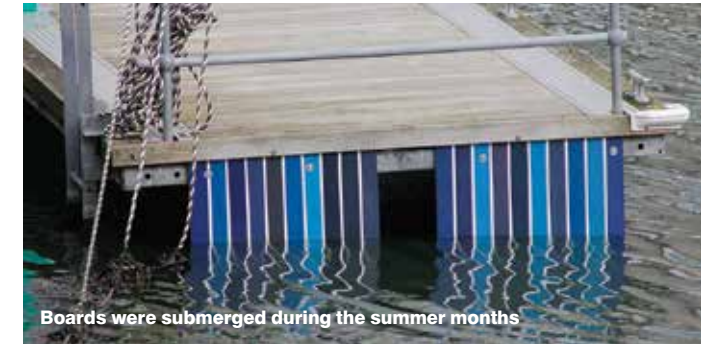
Boards were submerged during the summer months

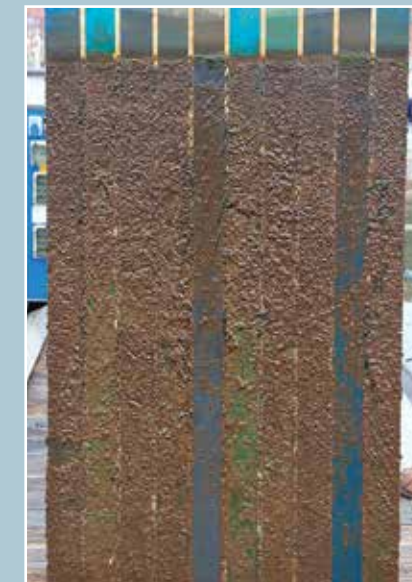
A board from Whitby as removed, showing how the slime ran off the two Seajet products, 038 and 033

These paints shed slime and other fouling so effectively in many places that when
