GLOBAL STONE

TROUBLESHOOTING GUIDE
www.globalstonepaving.co.uk

WELCOME TO THE GLOBAL STONE TROUBLESHOOTING GUIDE

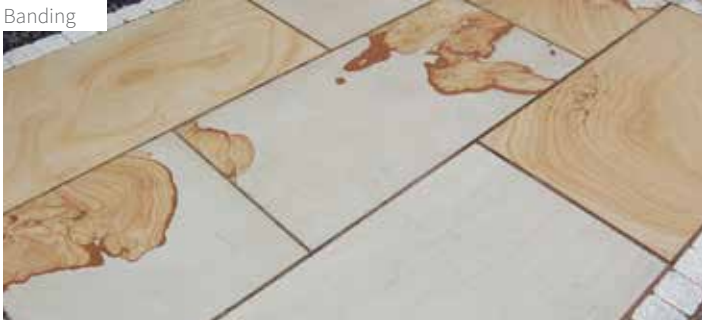
Banding

BANDING: Products that feature banding can vary in their patterns – while most banding is fairly subtle there can be occurrences where the banding is more dramatic – this example shows a very dramatic example of banding in our Sandstone

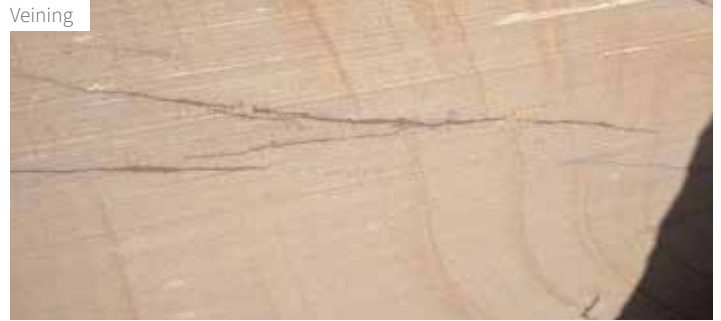
Veining

VEINING: While the surface may appear to display hairline fractures in the stone, these lines are actually natural veins that run through the stone. This example shows veins in a Premium Sandstone. (See p25 for more information and further examples of veining).

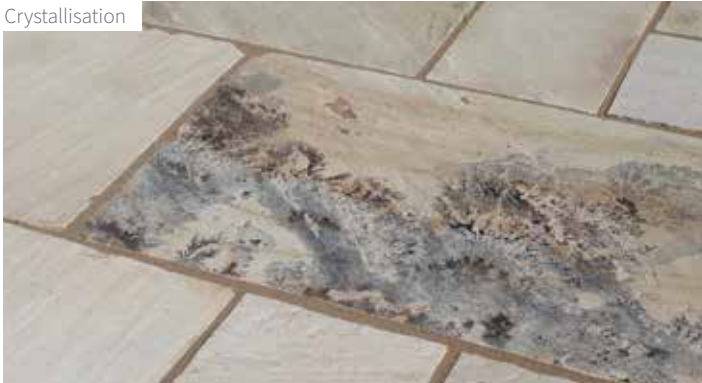
Crystallisation

CRYSTALLISATION: Some of our products may display areas of crystallisation, particularly in Premium Sandstone Mint. The above is an extreme example of the crystallisation that you might expect in natural stone.

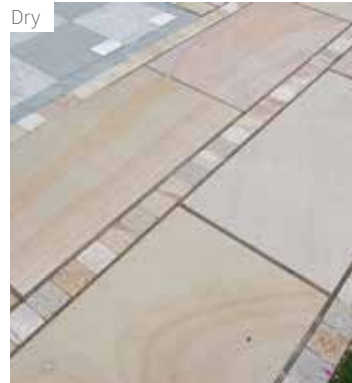
WET/DRY VARIATION: Dependant on the product, there can be strong variations between colour depending on whether the stone is wet or dry. We strongly recommend seeing the stone in real life to see this difference.

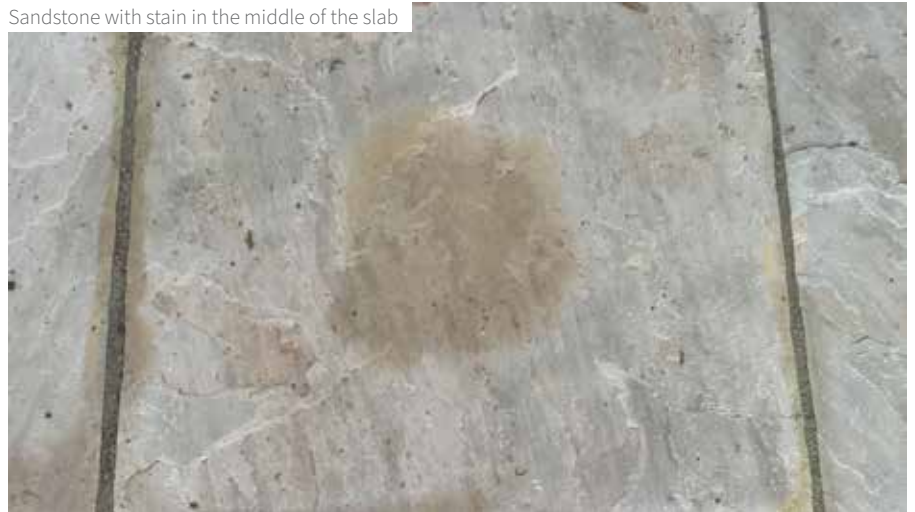
Sandstone with stain in the middle of the slab

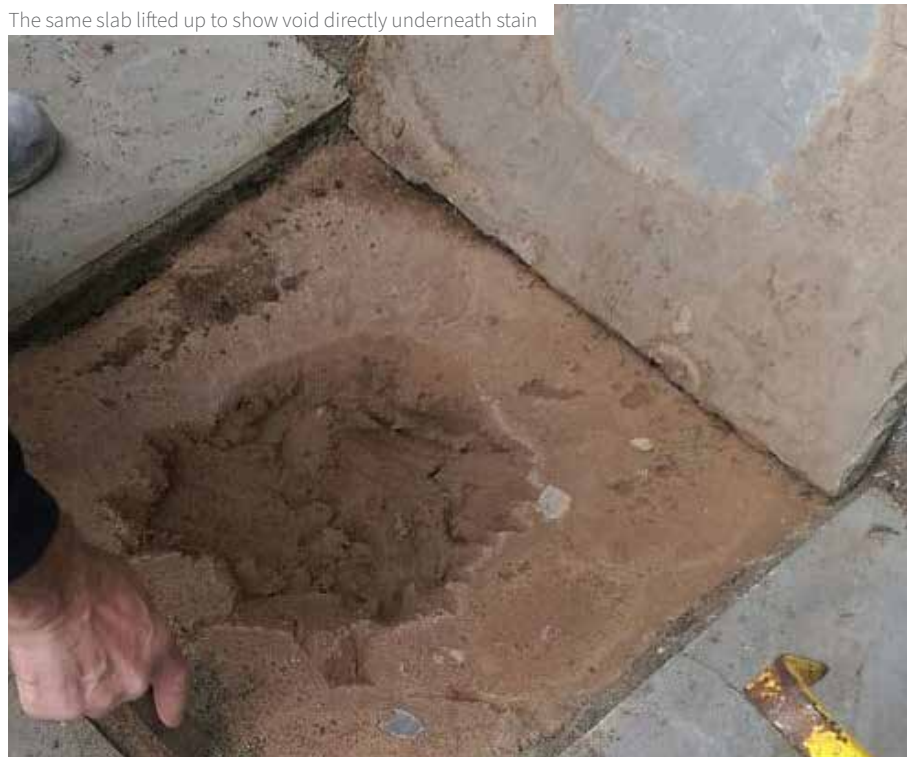
The same slab lifted up to show void directly underneath stain

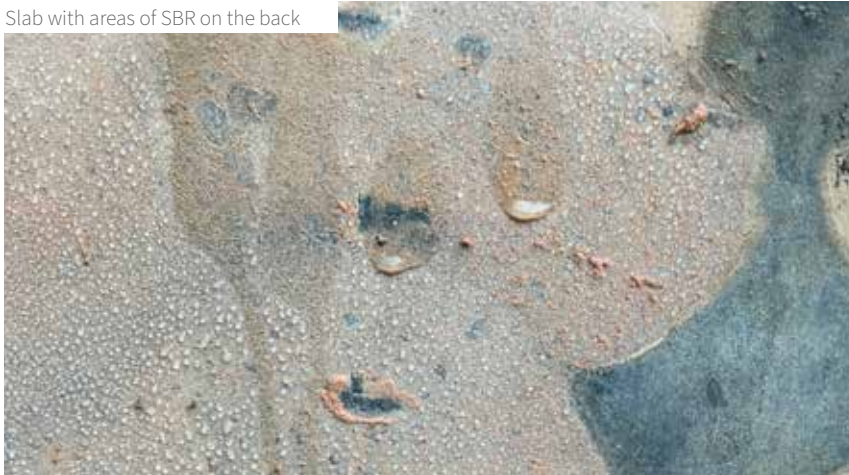
Slab with areas of SBR on the back

The back of this slab has some SBR applied to it – the areas where there is condensation is where the moisture cannot pass through the slab due to the barrier which the SBR has created. The dark space is where there is no SBR, where moisture will pass through the slab to the surface.

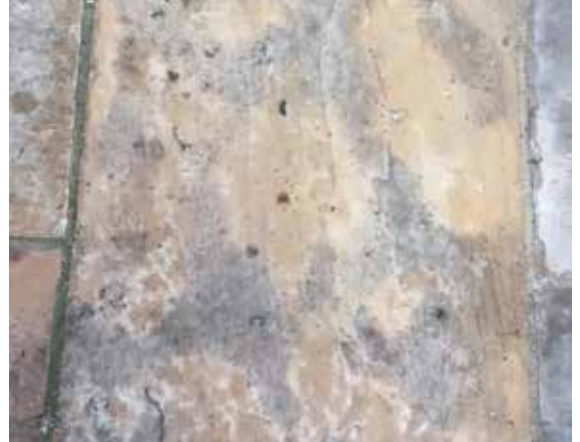
Dark patches showing areas where there are voids underneath

An example of what a slab affected by this issue can look like – patchy marks across the surface. The dark areas across the surface are areas where there are voids below the slabs.

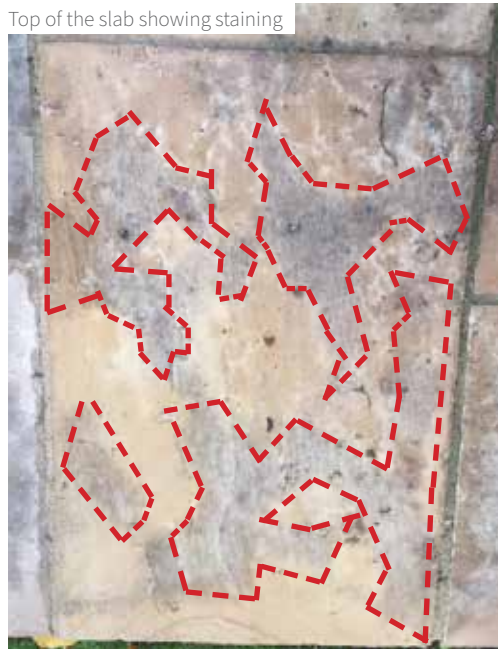
Top of the slab showing staining

When you view the staining on the surface of the slab next to the pattern of the mortar below, you can clearly see that the voids in the mortar match in shape the areas of dark staining on the surface of the slab.

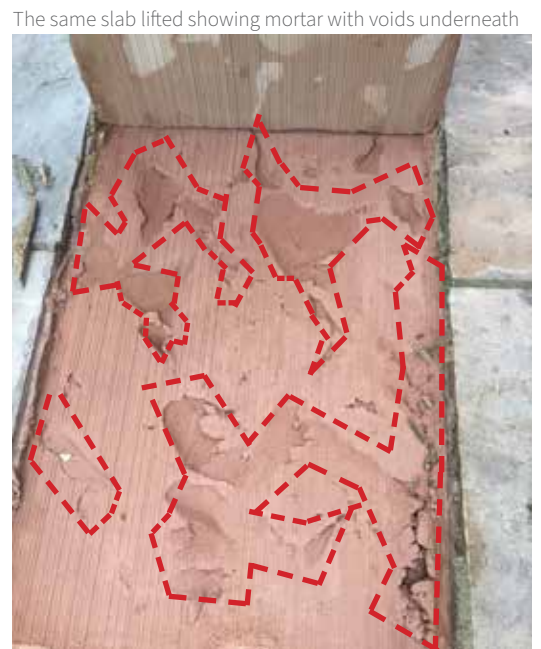
The same slab lifted showing mortar with voids underneath

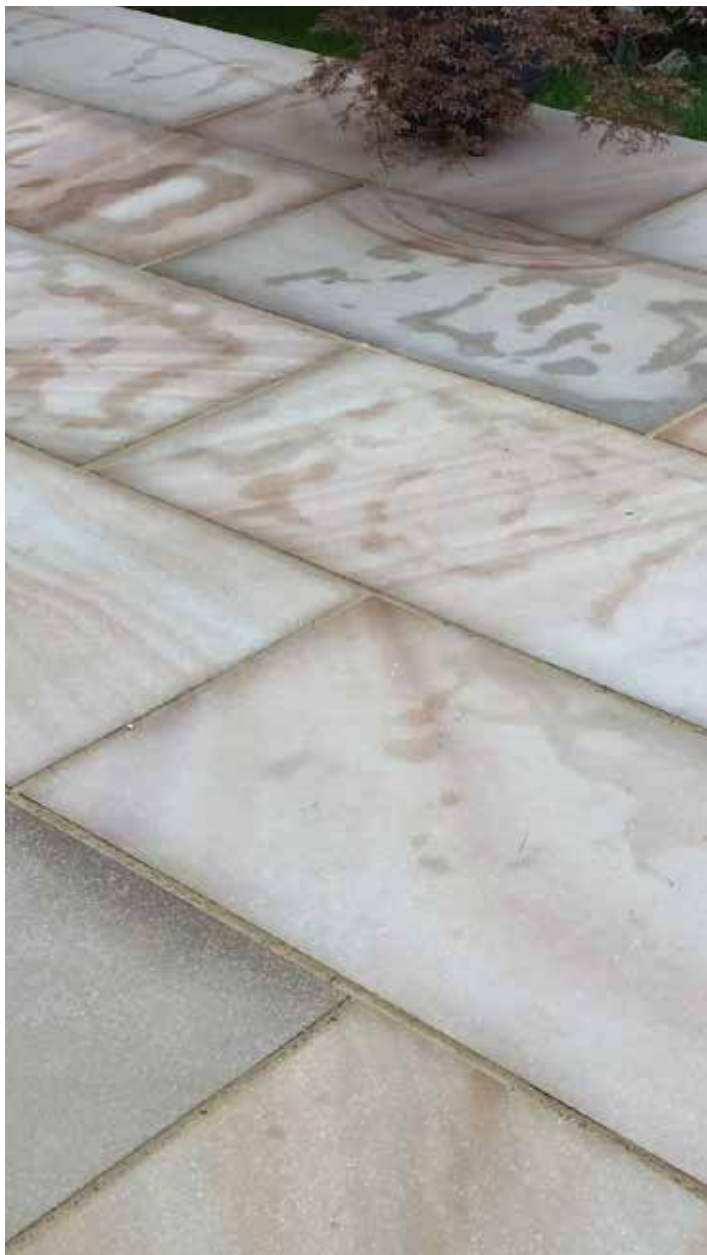
This image shows slabs that have been laid on spots – we can see the effects clearly as the damp patches on the slabs are a telltale sign of this issue.

The only solution to this issue is to pull up the flags, clean the slabs of cement as much as possible and re-lay them on a full bed of mortar with a proper compacted hard-core sub-base and adequate drainage. Once the product has been re-laid, it may take time for the staining to disappear. In some instances the staining may be too extensive, so unfortunately new stone may be the only option.

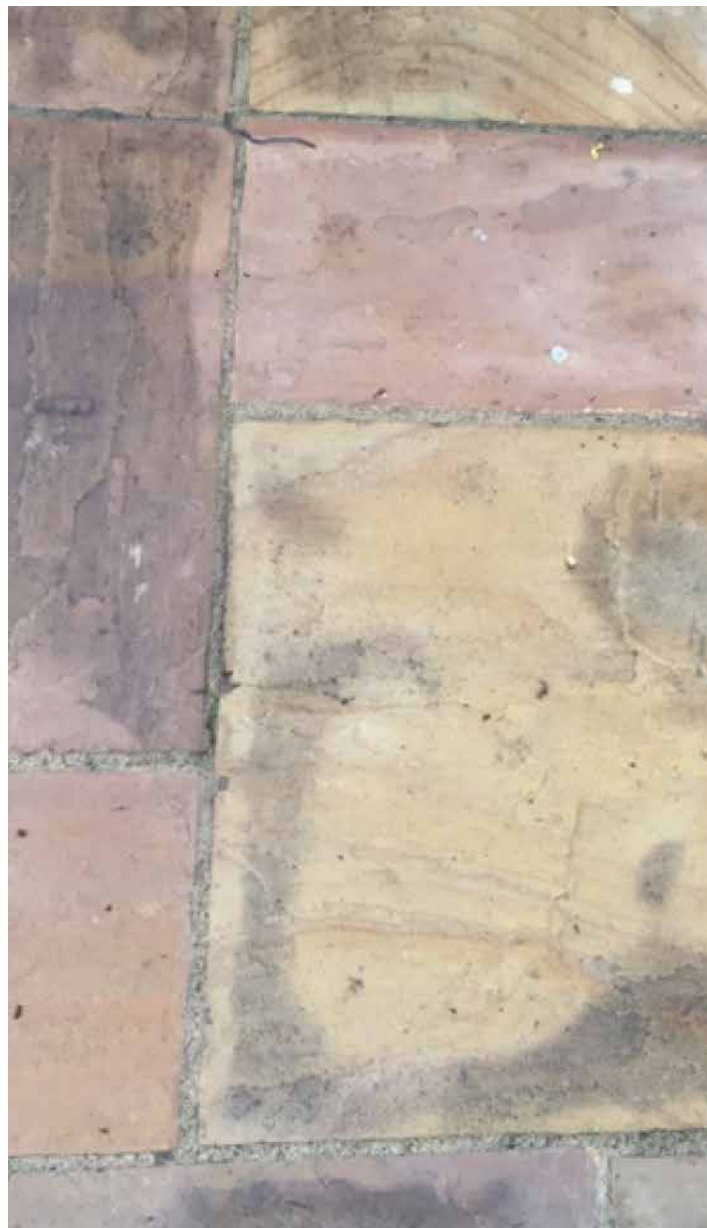
The dark patches across these slabs are another example of staining of this kind – you can see that impurities and damp have risen through the slab and left a mark on the surface.

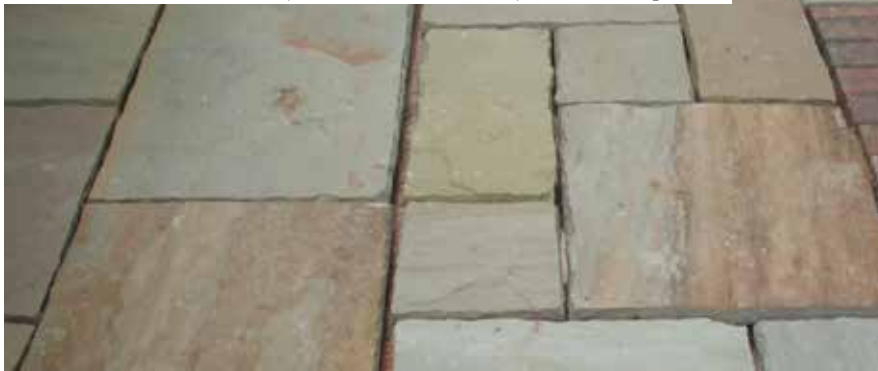
Sandstone which has been laid upside down (with widest tapered side facing down)

The edges of products (especially sandstones) should have the widest tapered side facing up. If flags are laid the wrong side up the only solution is to pull the patio up and try to clean off the cement to relay (but they may be stained from already being laid down). Unfortunately, new stone may be the only solution. Always refer to laying guidelines which are available in our literature and on our website. Laying guides for natural stone are also available to view on the product crate labels (attached to the side of the crates) which must be read prior to product installation. Specific laying guides for porcelain products are available on our website – we also have a number of case studies toward the end of this guide specific to porcelain.

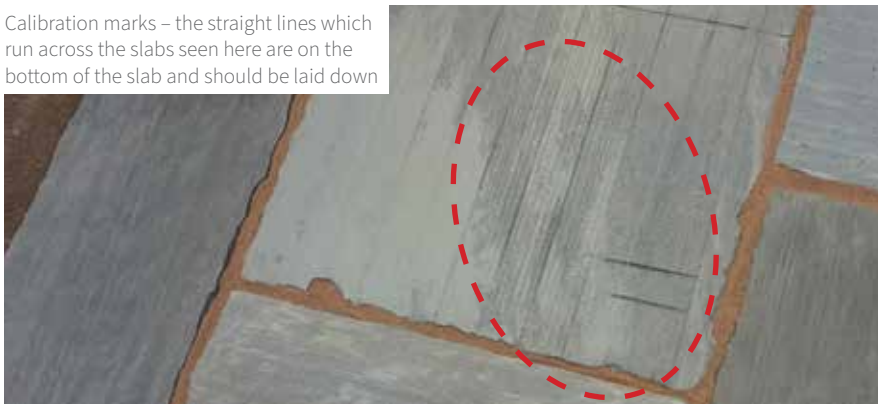
Calibration marks – the straight lines which run across the slabs seen here are on the bottom of the slab and should be laid down

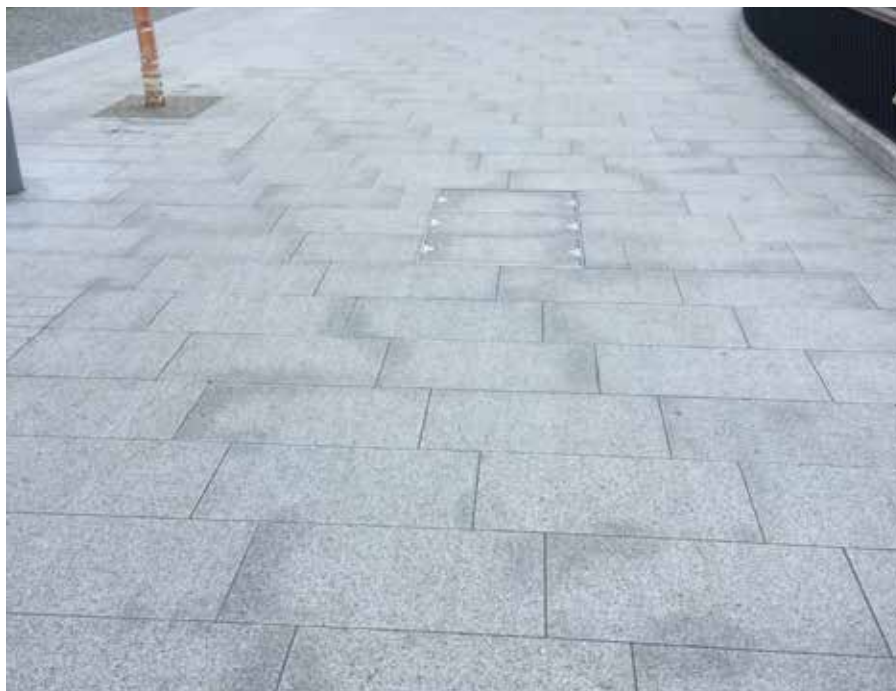
Damp patches around some of the joints are visible in this example

It is important to follow laying instructions as none of our products are designed to be butt jointed – we recommend a 10mm approx joint is used when laying.

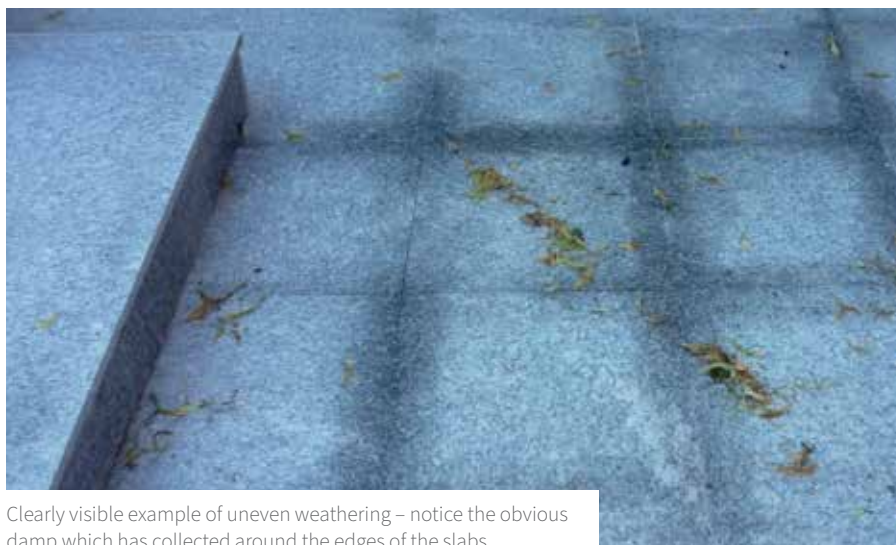
Clearly visible example of uneven weathering – notice the obvious damp which has collected around the edges of the slabs

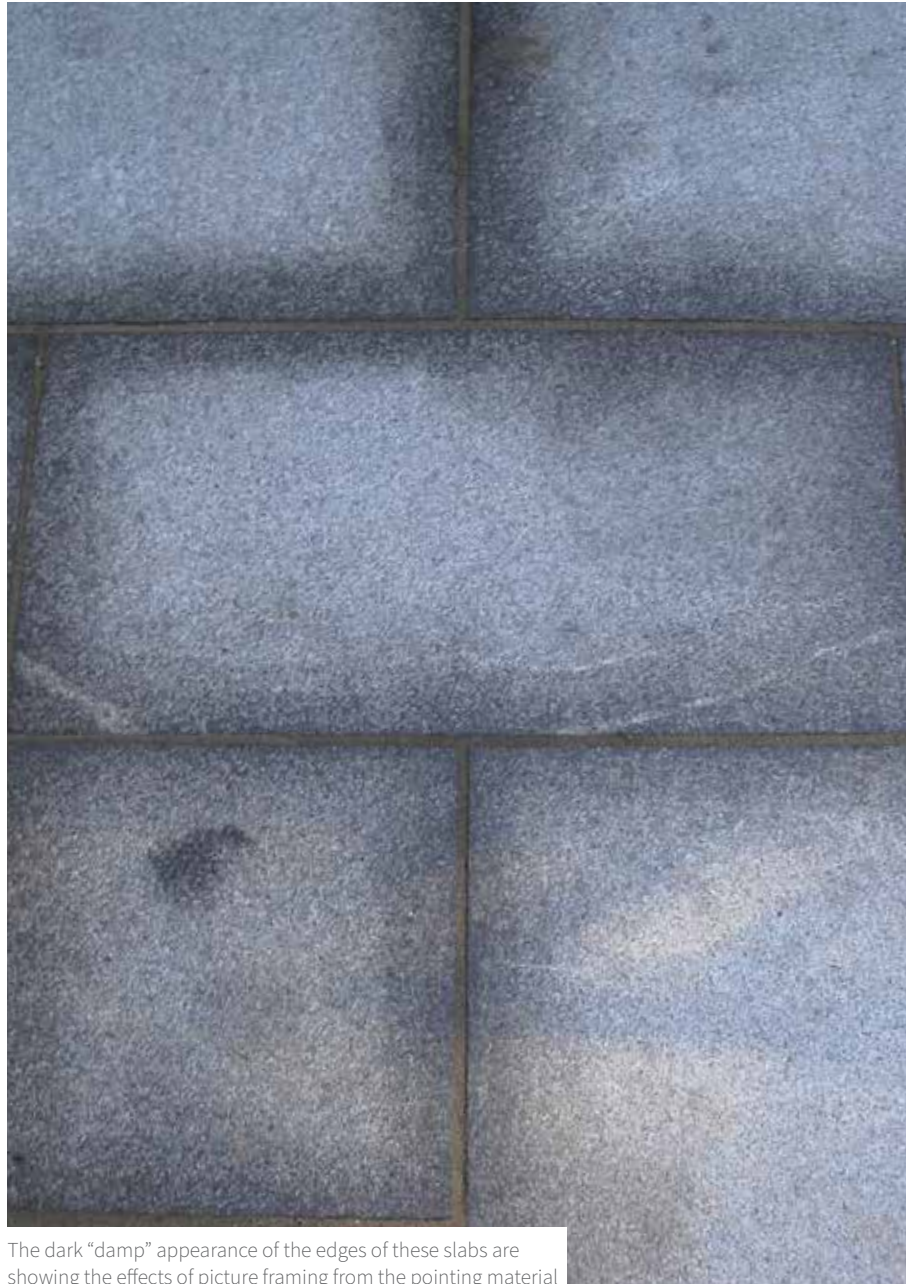
A staining effect around the edge of each paving slab after pointing. Picture framing may also look like a damp patch around the edge of the slabs. The 'staining' is caused by the use of 'self hardening' pointing mix resins.

The dark "damp" appearance of the edges of these slabs are showing the effects of picture framing from the pointing material

There is no permanent staining and therefore the only action required is to let the effects of the pointing material weather off. No cleaning solutions are required. If in doubt, speak to the manufacturer of the jointing material for further advice.

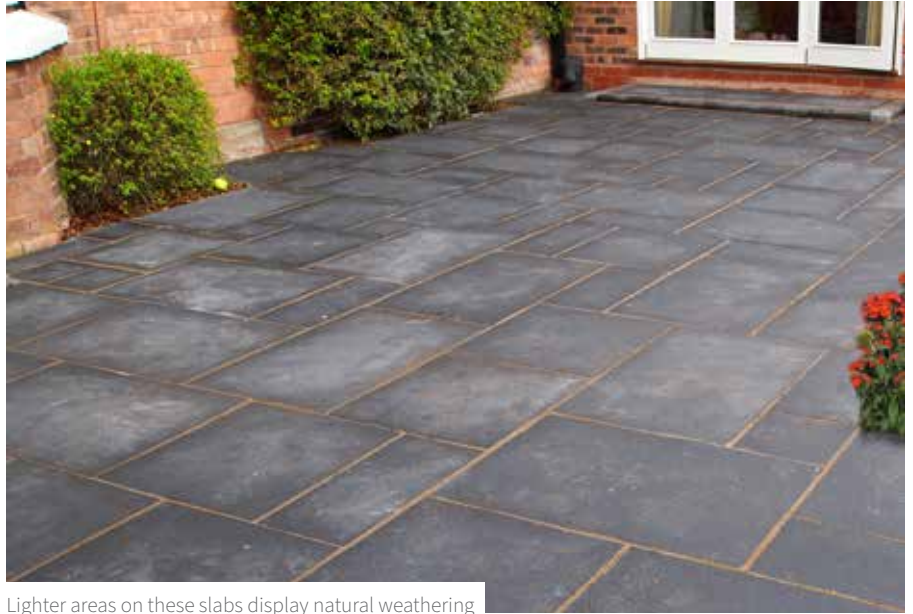
Natural weathering has caused lighter patches to appear on the stone. The visible change does not affect the durability of the slabs and happens gradually over time. Natural gradual weathering is a common occurrence with all dark coloured limestones.

Lighter areas on these slabs display natural weathering

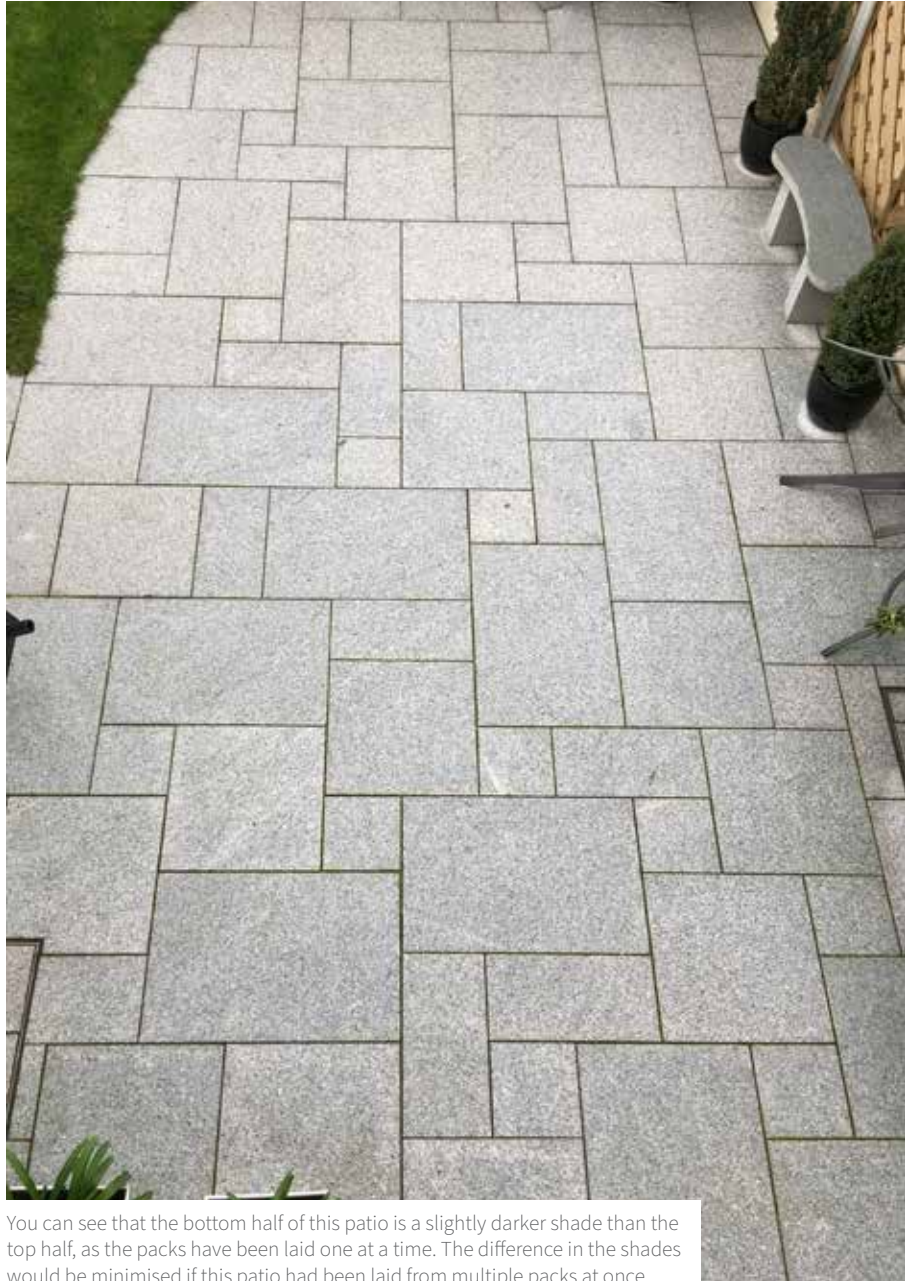
You can see that the bottom half of this patio is a slightly darker shade than the top half, as the packs have been laid one at a time. The difference in the shades would be minimised if this patio had been laid from multiple packs at once.

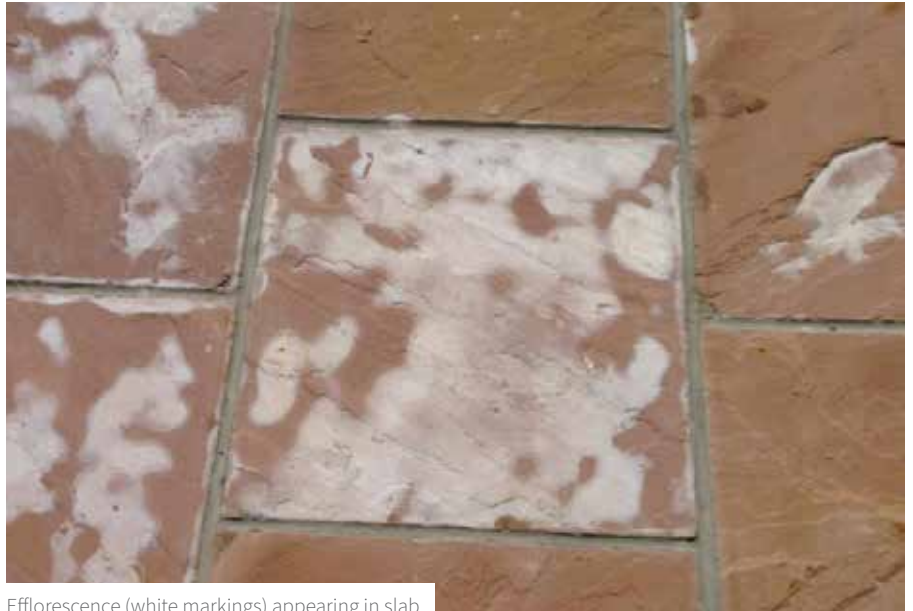
Efflorescence (white markings) appearing in slab

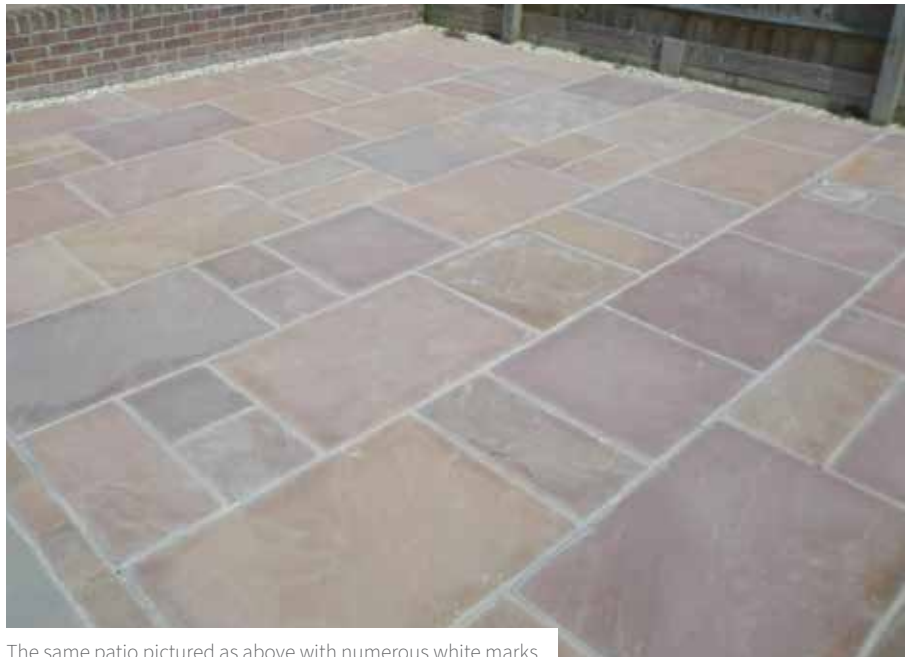
The same patio pictured as above with numerous white marks

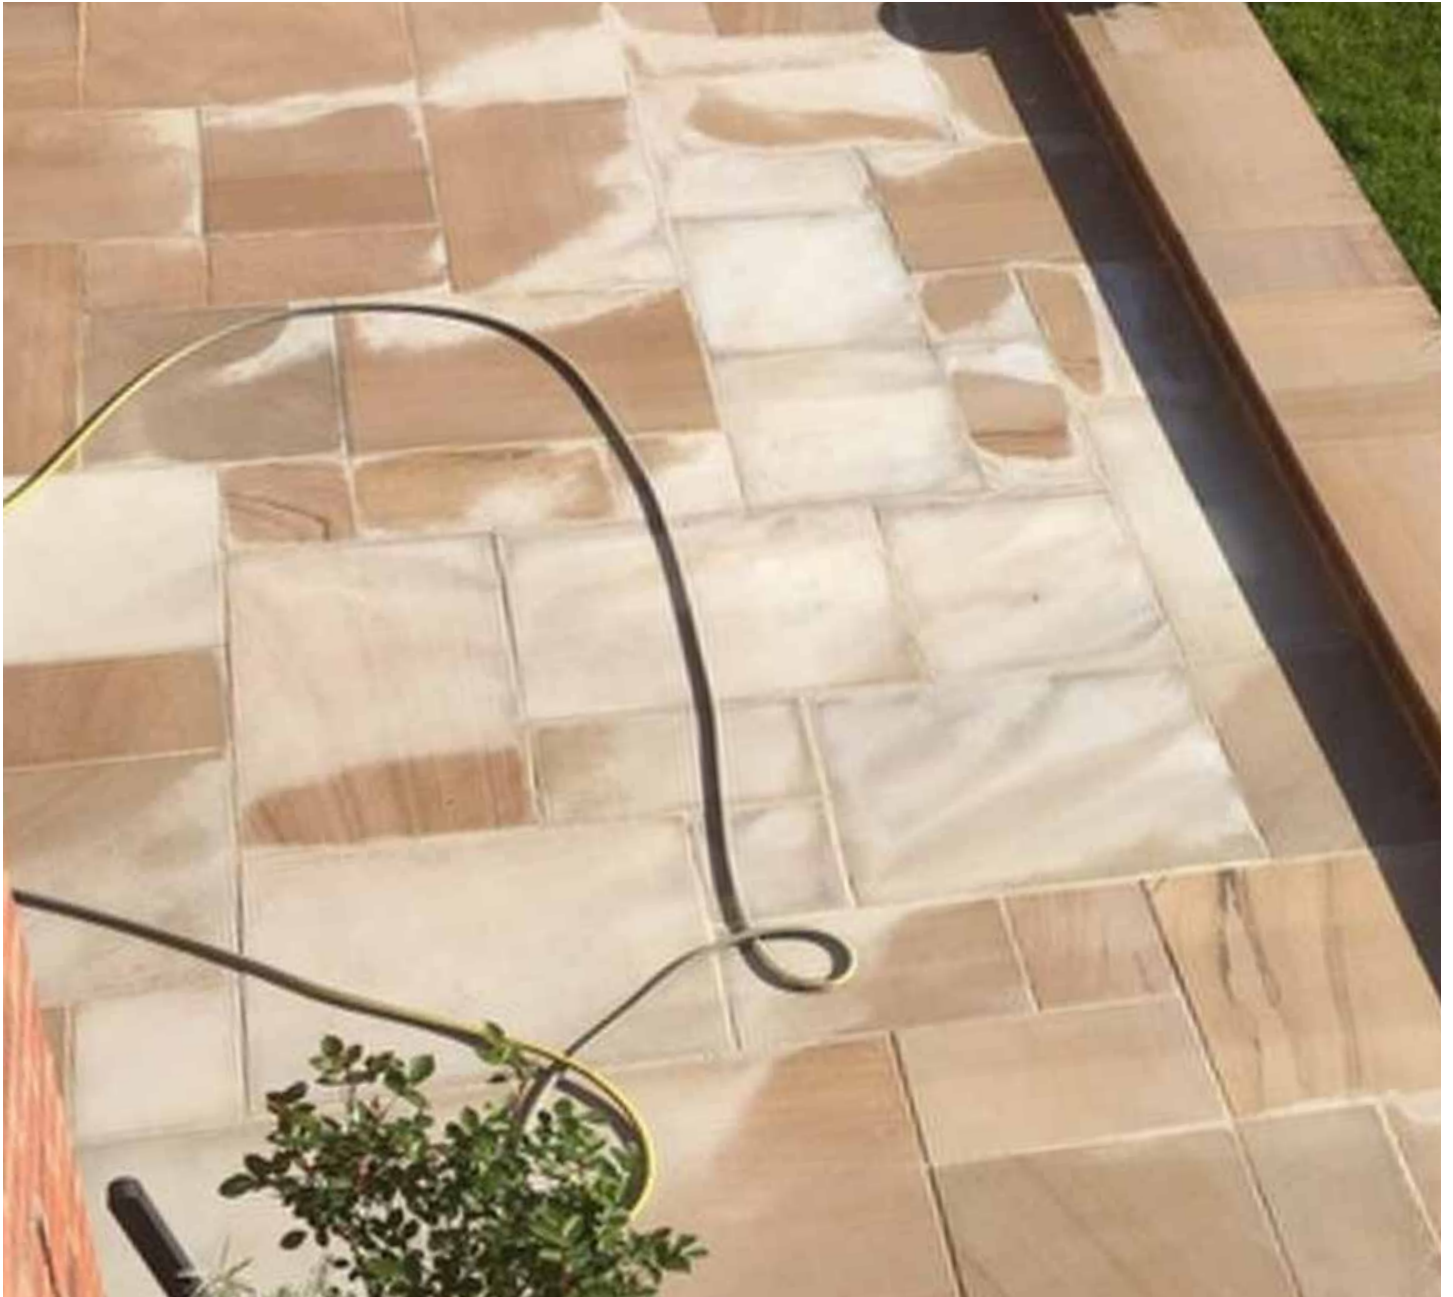
In this example, the efflorescence effect has been exaggerated – this patio has been laid without adequate drainage, causing water build up both below and on the surface of the patio. The areas which appear white here are the areas which have been affected by excess water, which has accelerated the effects of efflorescence. The effect has arisen from the ingredients within the cement and impurities below the patio, and is not a fault with the paving itself. This effect should naturally dissipate over time.

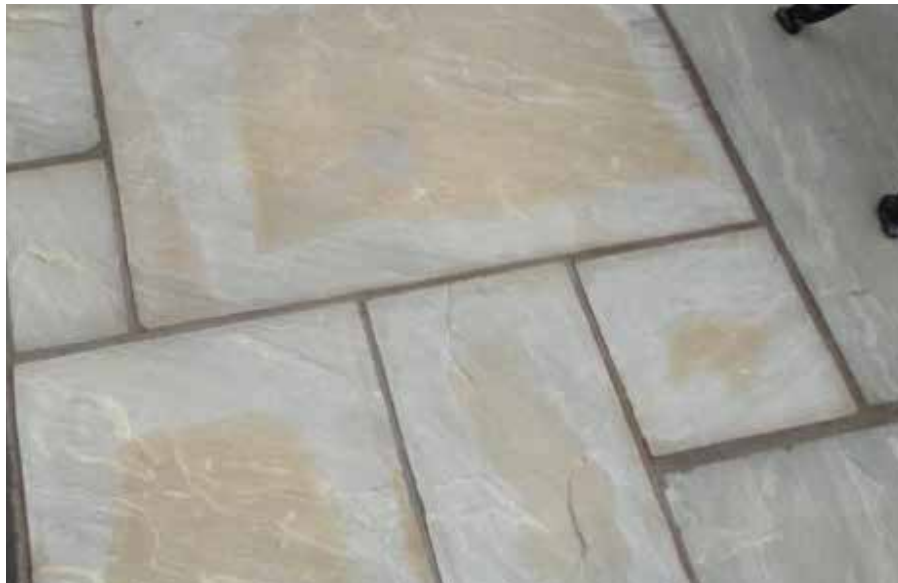
Rectangular beige marks on the slabs here are characteristic of chemical reaction

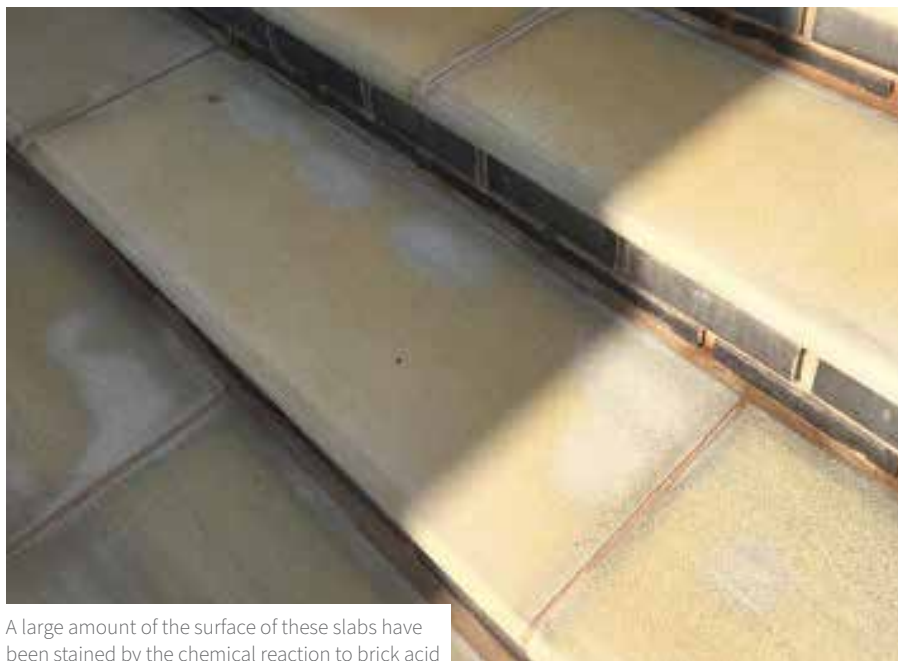
A large amount of the surface of these slabs have been stained by the chemical reaction to brick acid

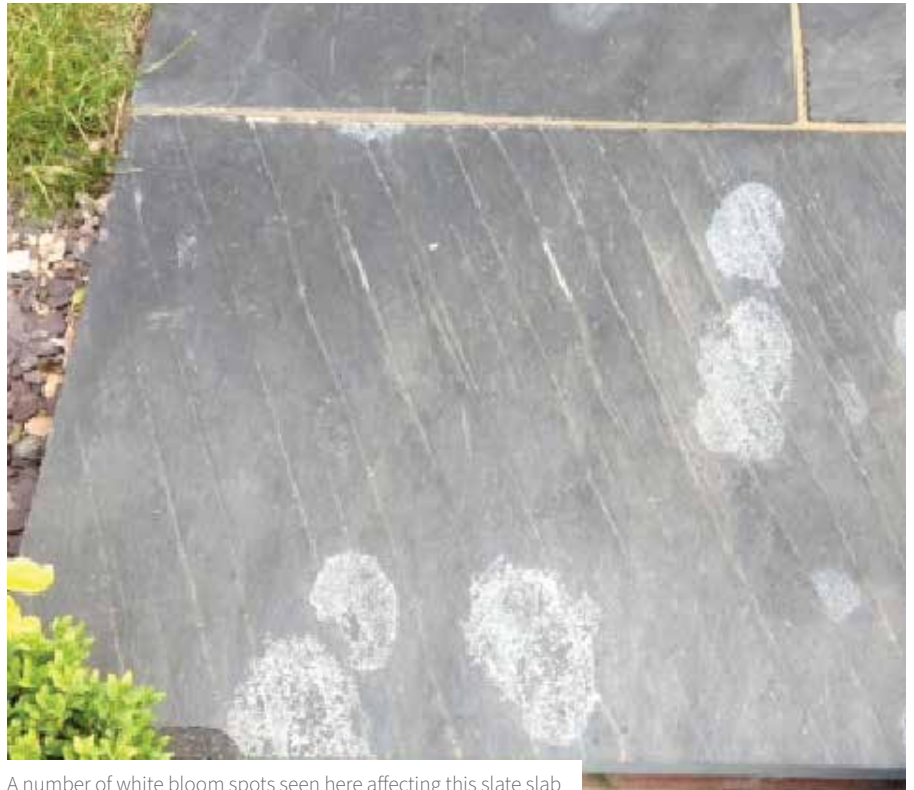
A number of white bloom spots seen here affecting this slate slab

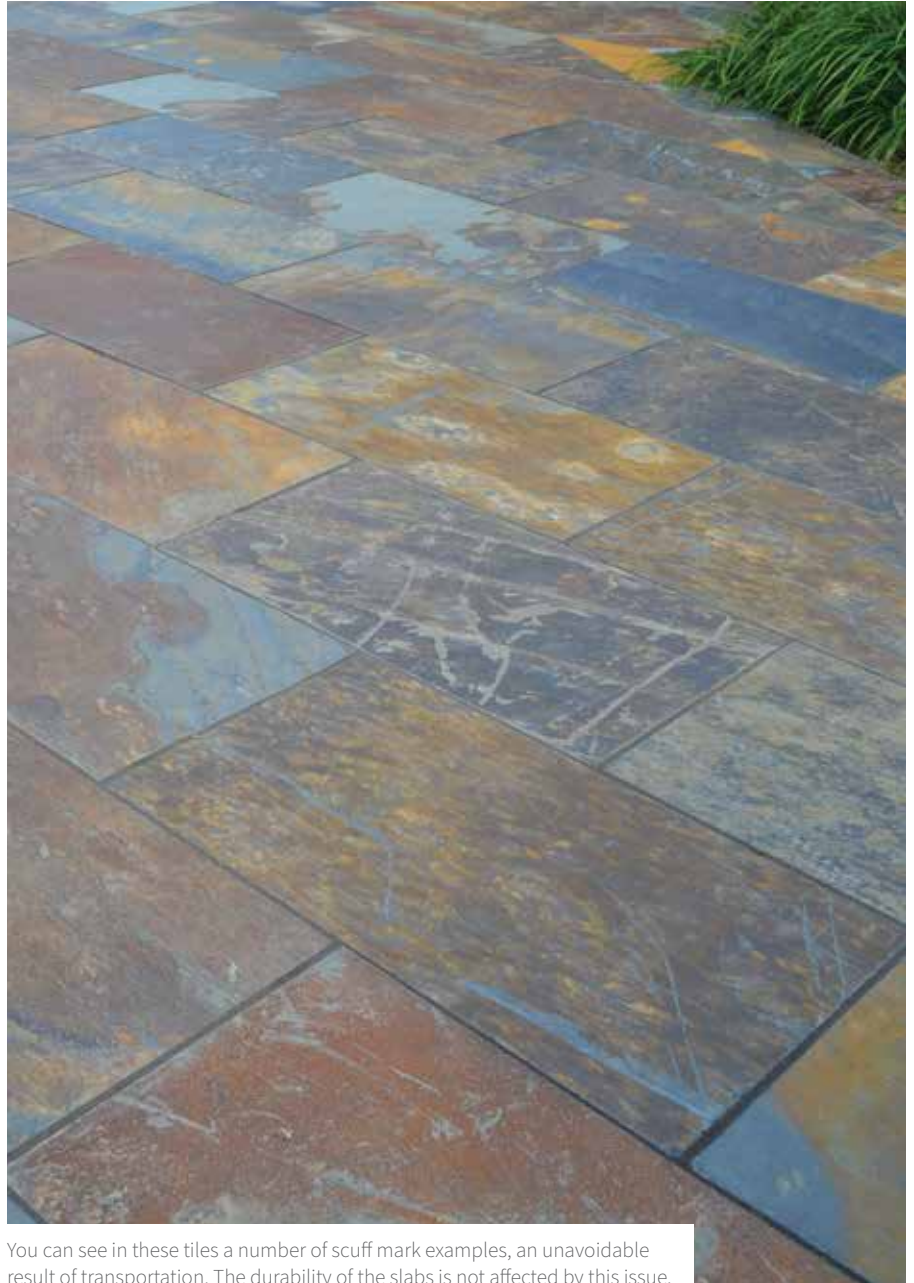
You can see in these tiles a number of scuff mark examples, an unavoidable result of transportation. The durability of the slabs is not affected by this issue.

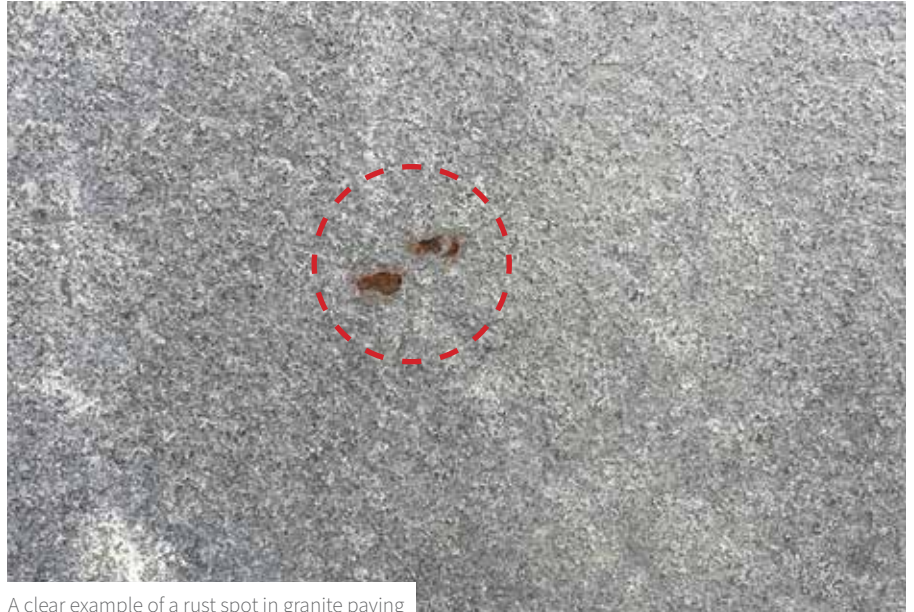
A clear example of a rust spot in granite paving

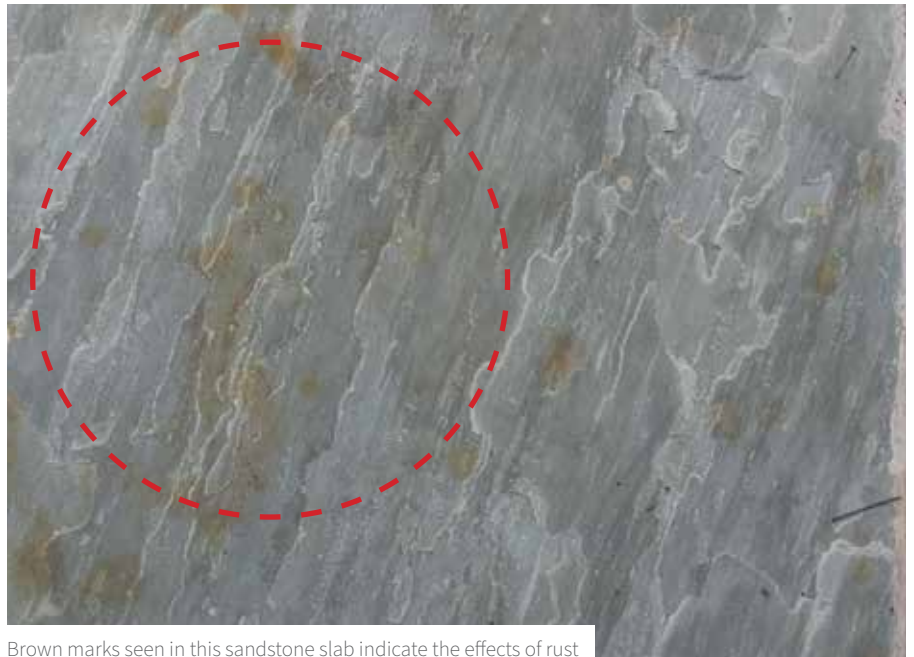
Brown marks seen in this sandstone slab indicate the effects of rust

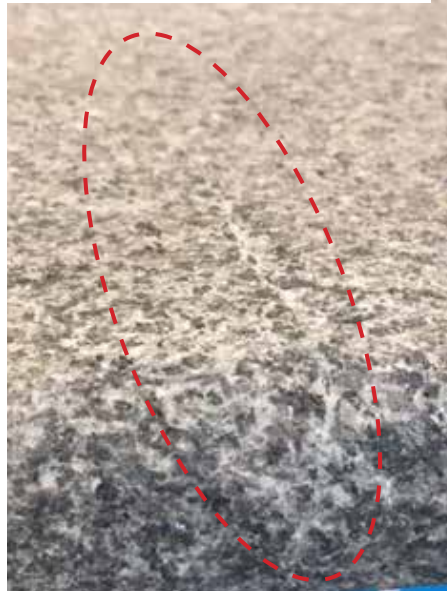
This Granite bull-nosed step has a white vein running across and through the depth of the flag

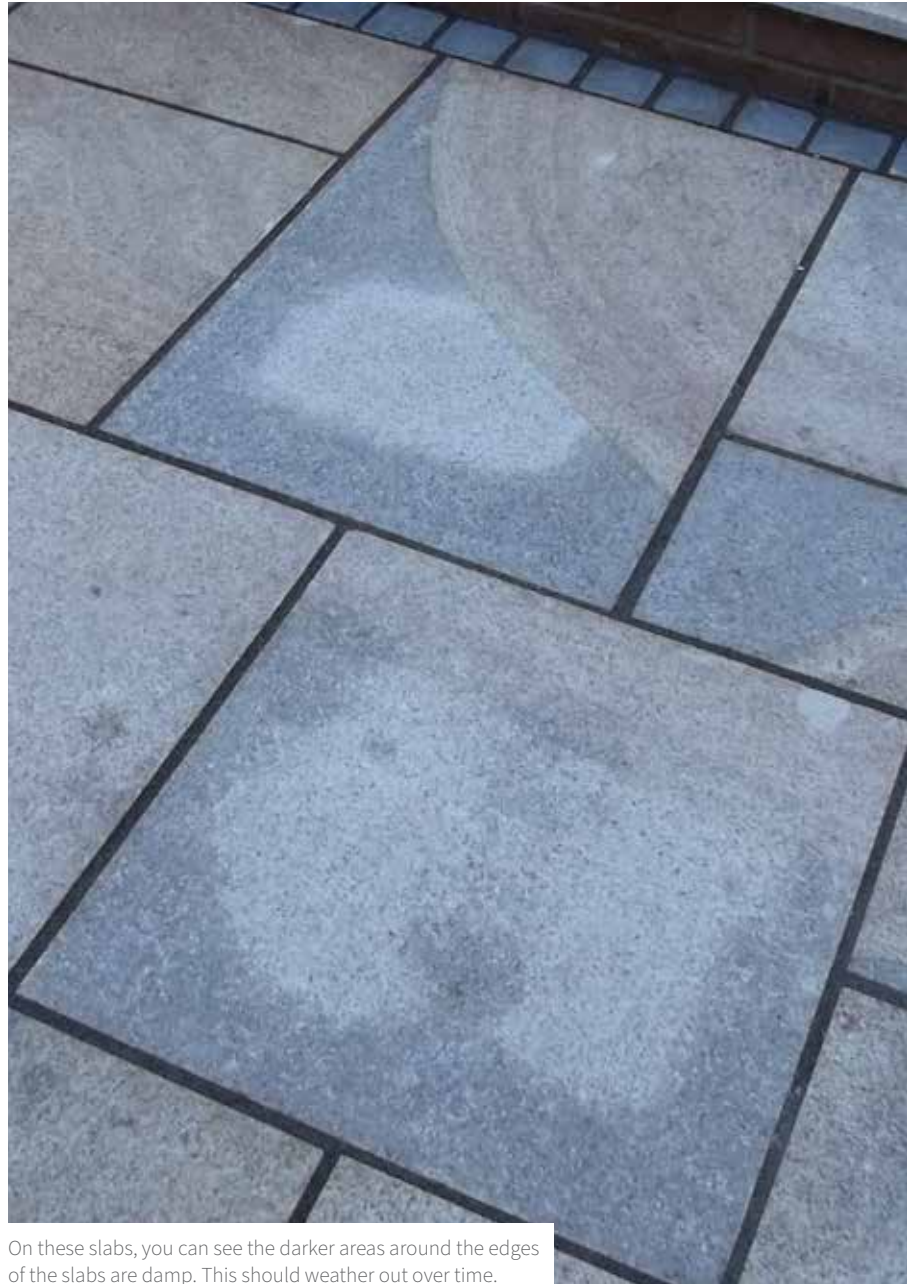
On these slabs, you can see the darker areas around the edges of the slabs are damp. This should weather out over time.

Moisture transparency occurs when a product is drying out naturally and should disappear over time. The best course of action is to let the patio dry out naturally.

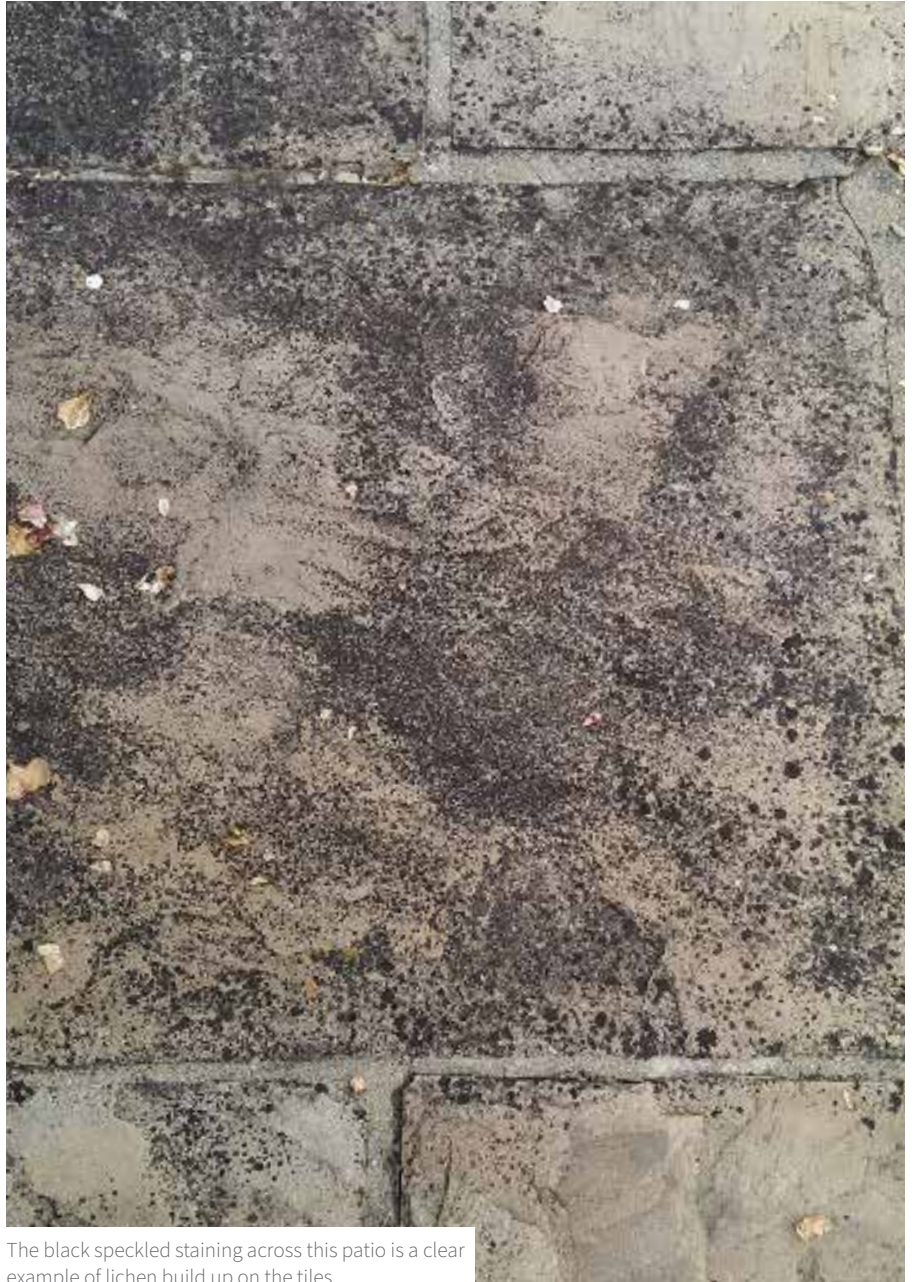
The black speckled staining across this patio is a clear example of lichen build up on the tiles.

This is a natural weathering occurrence. Using a pressure washer may not work on lichens and could do more damage than good. A specialist cleaning service may be required, but there are also specific products available off the shelf to aid removal.

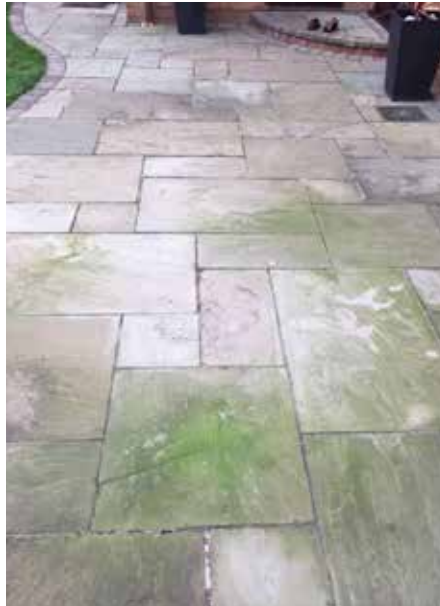
Extensive green stains before cleaning

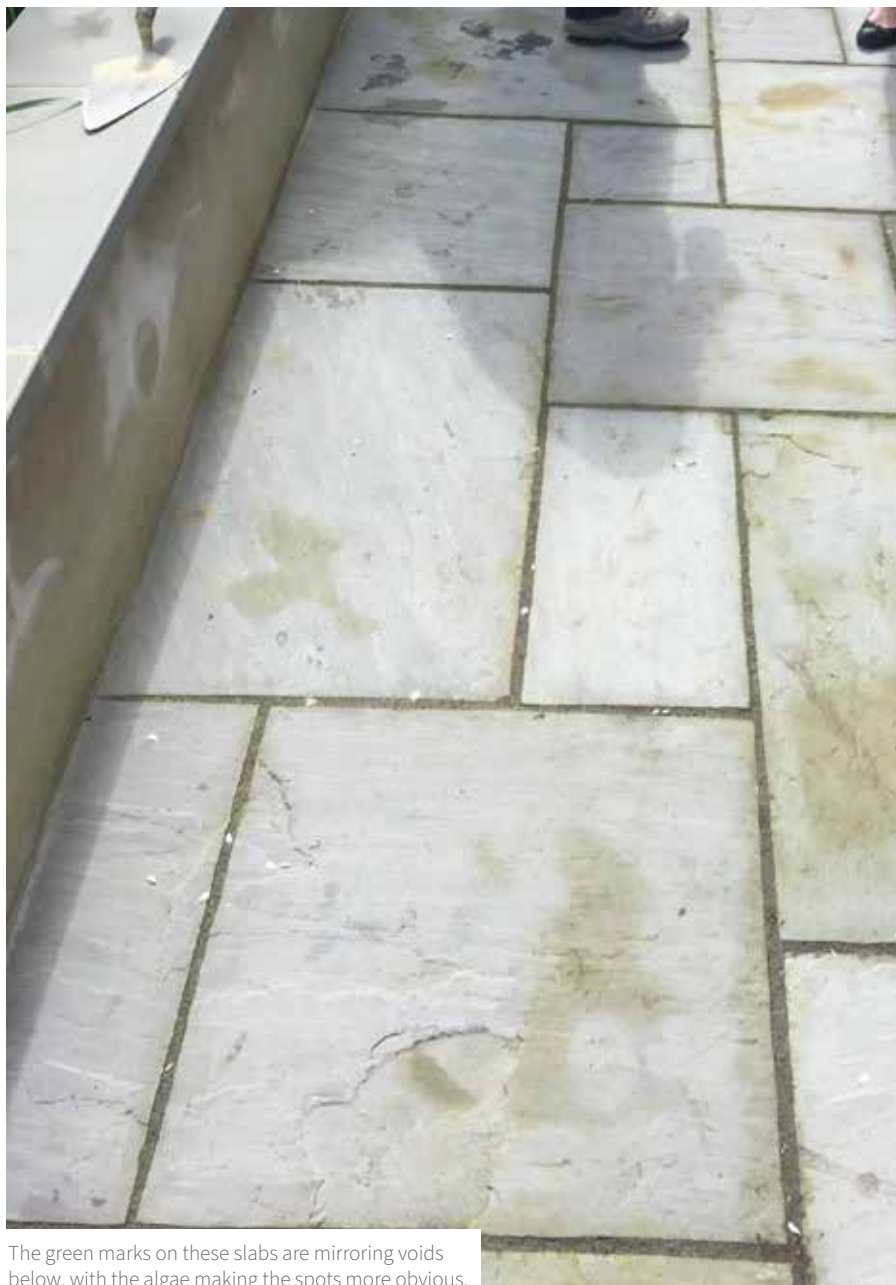
The staining shown here is highlighting areas which have voids below the slabs – in order to prevent further issues it is advised that the patio be re-laid on a full bed of mortar.

The green marks on these slabs are mirroring voids below, with the algae making the spots more obvious.

The staining shown here has penetrated the stone, so it will be more difficult to fully remove – the appearance of the staining can be improved by cleaning using warm soapy water and a stiff brush. With more extensive staining there are many cleaning products on the market which can be used, provided that they are formulated specifically for natural stone.
