GLOBAL STONE

TROUBLESHOOTING GUIDE
www.globalstonepaving.co.uk

WELCOME TO THE GLOBAL STONE TROUBLESHOOTING GUIDE

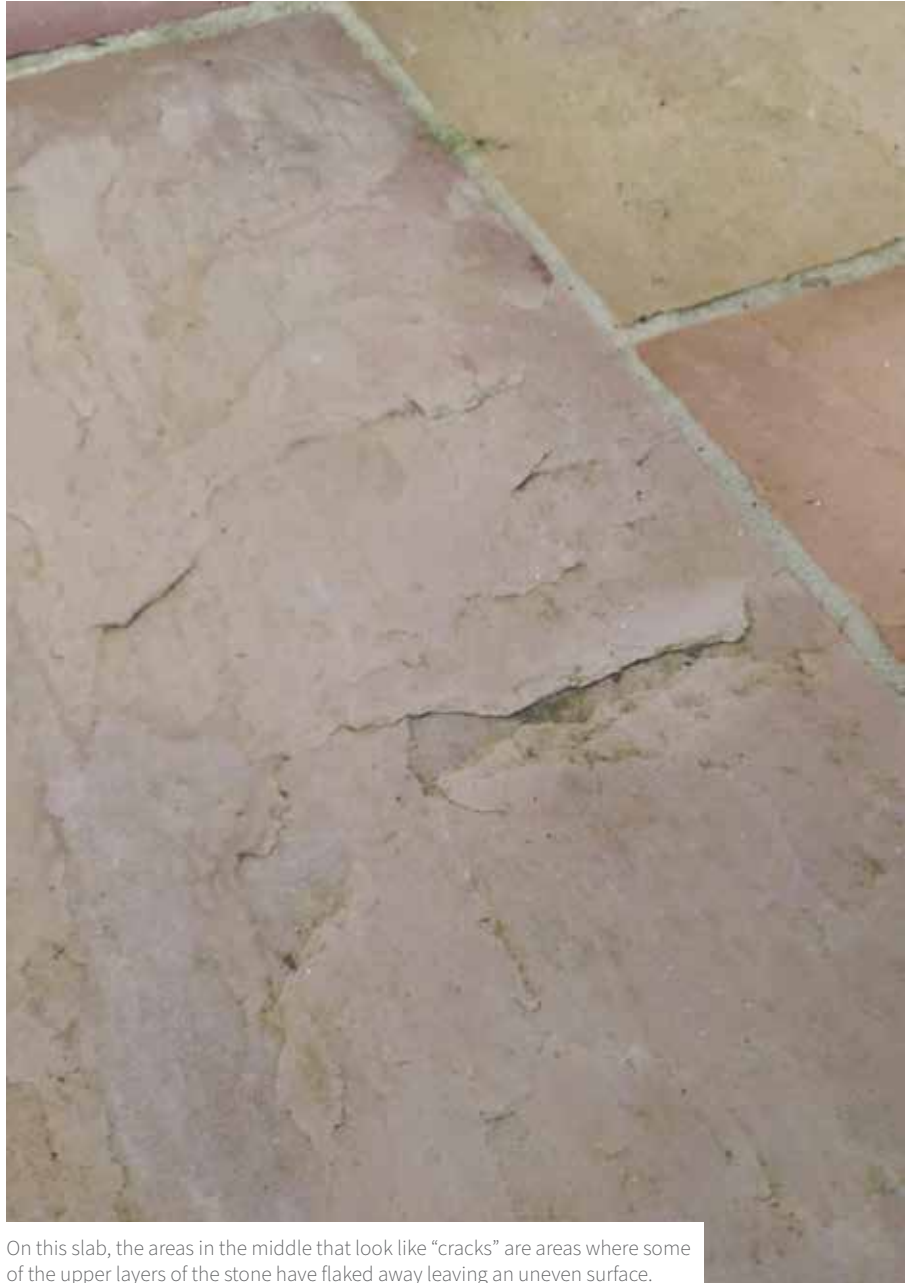
On this slab, the areas in the middle that look like “cracks” are areas where some of the upper layers of the stone have flaked away leaving an uneven surface.

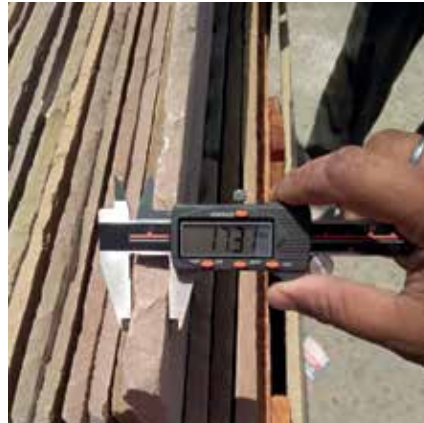
This stone has been calibrated at 18mm and should be (+/-3mm) but this is from the thickest point. It will show different results if checked at different places. On this image it's measuring at 17mm.

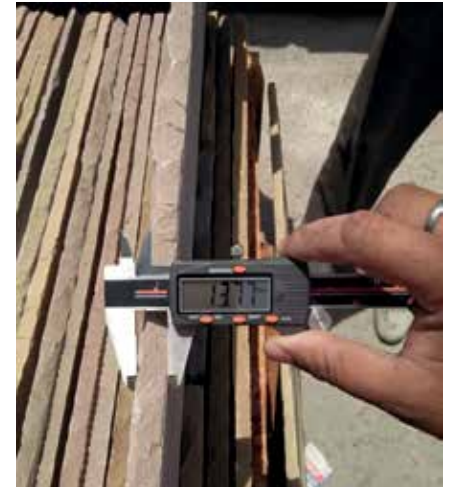
And on this image it's measuring at 13mm. This is the incorrect way of measuring the product.

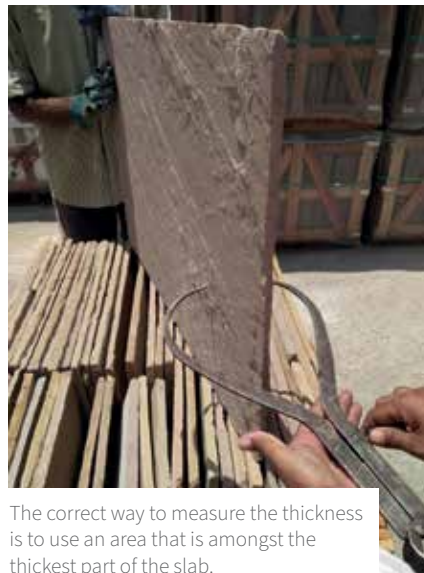
The correct way to measure the thickness is to use an area that is amongst the thickest part of the slab.

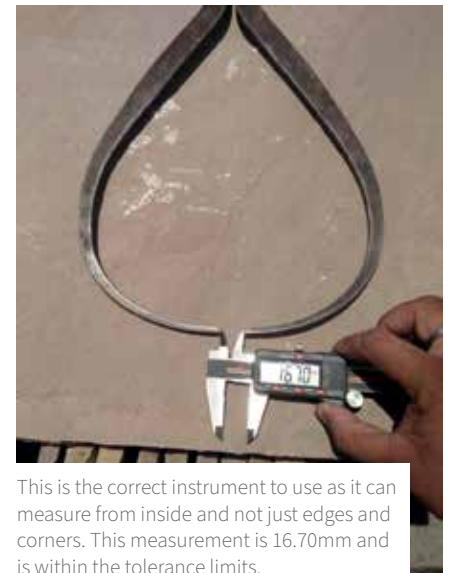
This is the correct instrument to use as it can measure from inside and not just edges and corners. This measurement is 16.70mm and is within the tolerance limits.

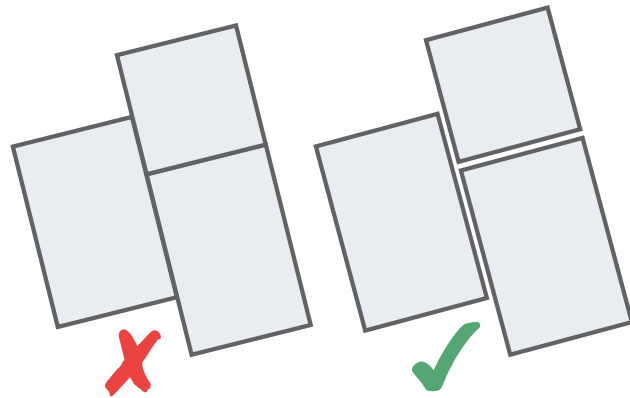
Butt jointed tiles – tiles are laid with no space in between, meaning that edges are touching. The tiles have no protection therefore with movement tiles would chip.

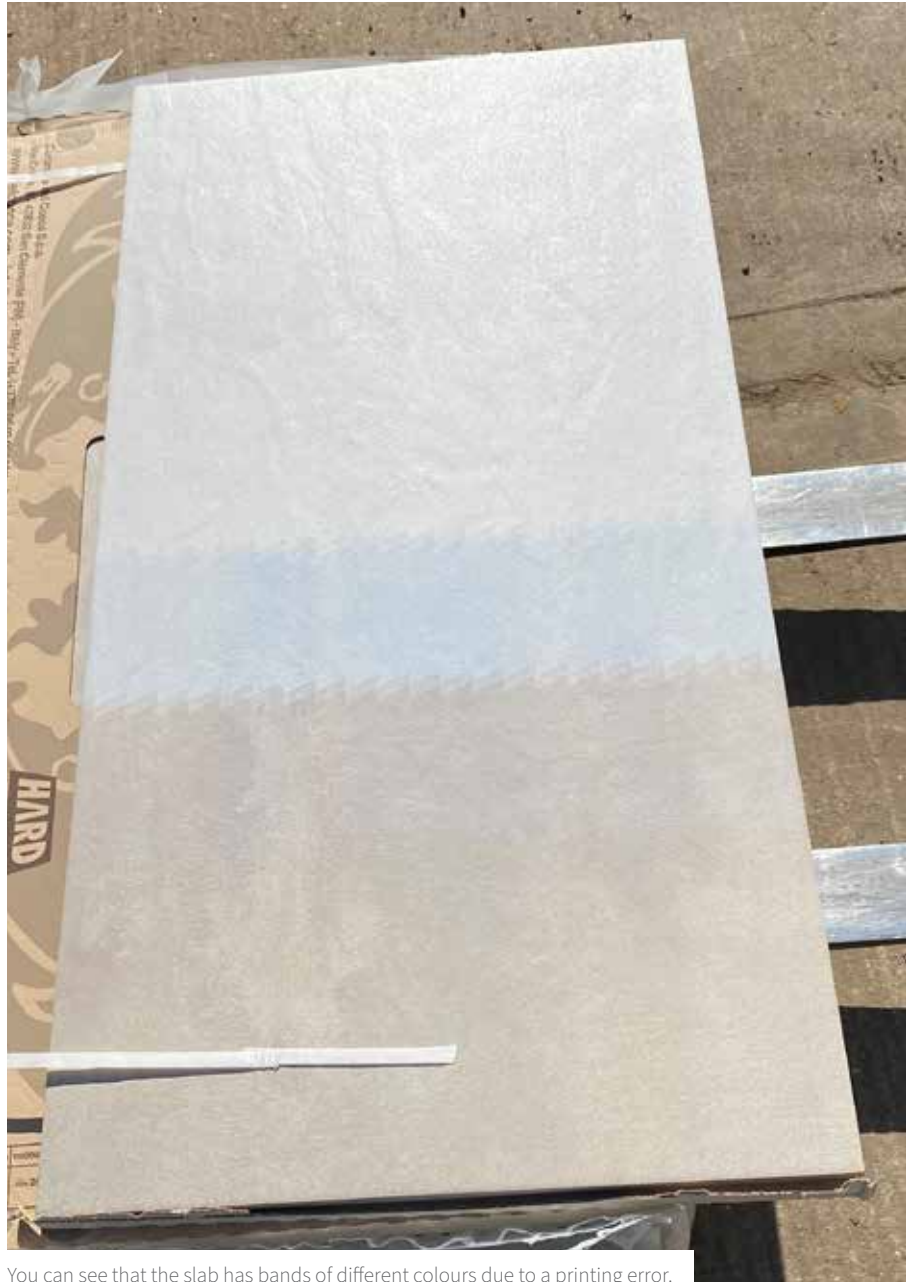
You can see that the slab has bands of different colours due to a printing error.
