Safety Recall Notice

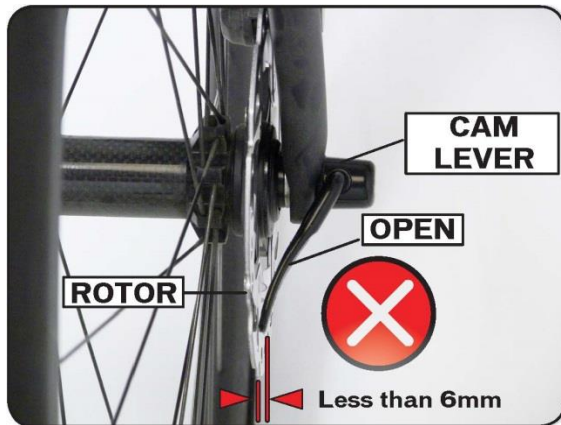
Some **GT** bicycles were sold equipped with disc brakes and a front quick release lever that can come into contact with the front disc brake when improperly adjusted or left open while riding. An example of a bicycle with a front quick-release cam lever that is able to be opened far enough to create this potential contact is shown in Figure 1 below. An example of a bicycle with a front quick-release cam lever that does not have the potential for contact with the disc brake is shown in Figure 2. When a quick release like the one shown in Figure 1 is improperly adjusted or left open on a bicycle which also has a front disc brake, the quick release lever can become caught in the front disc brake assembly. If this happens, the front wheel could separate or come to a sudden stop and the rider could lose control of the bicycle posing a serious risk of injury.

Figure 1. Quick-release lever with potential for contact Figure 2. Quick-release lever with adequate clearance

WHAT GT WILL DO FOR OWNERS OF A RECALLED BICYCLE: If you own a bicycle that is subject to this recall, **GT** will provide you—through your **GT** retailer—a free replacement quick release, including free installation. Please see your local **GT** retailer or contact **GT** with questions at **800 – 843 -2453**.

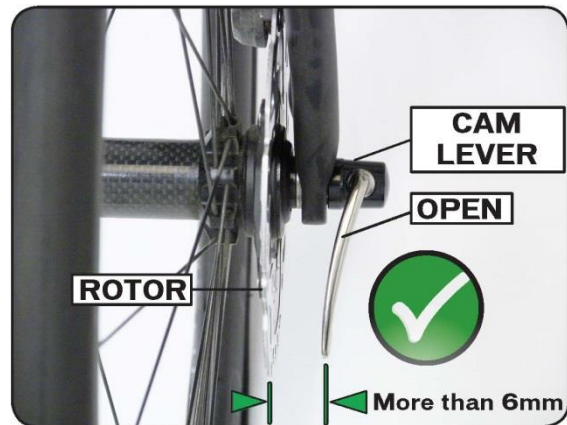
AFFECTED MODELS: Any **GT** bicycle equipped with disc brakes and a front quick release lever that can contact the disc brake assembly when fully opened is subject to this recall. Bicycles with front quick-release cam levers that have a clearance of at least 6 millimeters, which is the width of a #2 pencil, between the edge of the lever in its most open position and the disc brake rotor are not considered affected models. If you can pass a #2 pencil between a fully opened quick release lever and your bike's disc brake rotor, your bike is not an affected model. For a video demonstration of how to check this, please visit www.quickreleaserecall.com.
