Repair Manual

GENERAL PUMP A member of the Interpump Group

HTCK3623S

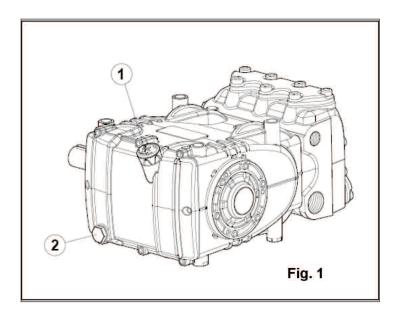
Mechanical parts repair must be performed after the oil has been removed from the casing. To drain the oil, remove the oil dipstick, (1, fig. 1) and then the draining plug (2, fig. 1).

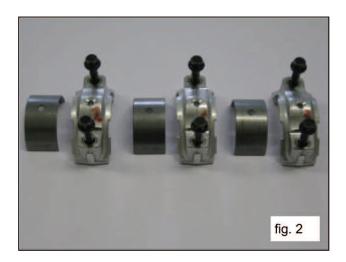
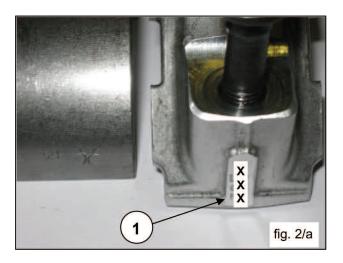
unscrew the cap fixing screws, remove the connecting rod caps with their lower half-bearings (fig. 2) paying attention to the numbered sequence during disassembly.

To avoid possible errors, caps and connecting rod shanks have been numbered on one side (fig. 2a, 1).

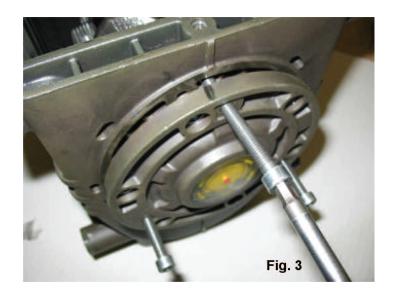
- the side covers using - for extraction - 3 fully threaded M6x50 screws, inserting them in the threaded holes as indicated in fig. 3.

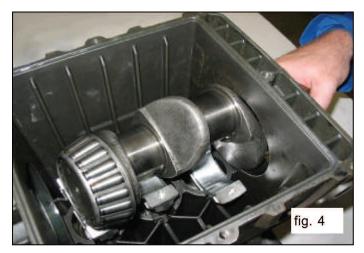
Ref 300935 Rev.A 09-13 -push the plunger guides forward with their con-rods to facilitate side extraction of the pump shaft as shown in fig. 4

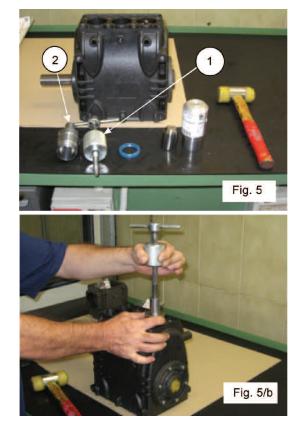
Use the extractor, p/n 26019400 (fig. 5, 1) and the gripper p/n 27503900 (fig. 5, 2). Insert the gripper as far as possible onto the seal ring with the aid of a hammer (fig. 5a), subsequently screwing the extractor to the gripper, and use the extractor hammer (fig. 5b) until the ring to be replaced is removed (fig. 5c).

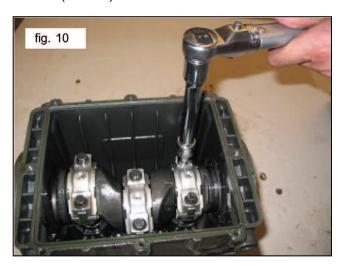
Fasten the caps to their respective con-rod shanks by means of M8x1x42 screws (fig. 10) lubricating both the underhead and the threaded shank. Proceeding in two different stages.

- 1. Manually turn the screws until they begin to tighten
- 2. Tighten torque: 22 ft.lbs. (30 Nm)

- 1. Pre-tightening torque: 7-11 ft.lbs. (10-15 Nm)
- 2. Tightening torque: 22 ft.lbs. (30 Nm)

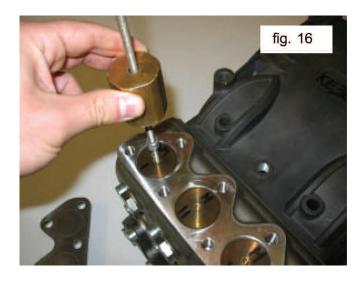
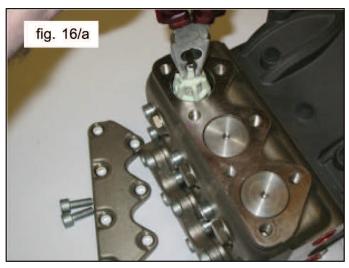
- -Unscrew the 7 M12x35 valve cover fixing screws and remove covers (fig. 16, 16a).
- -Extract valve plugs by means of an extractor hammer or an M6 threaded car (fig. 16)
- -Extract valve units using a gripper (fig. 16a).

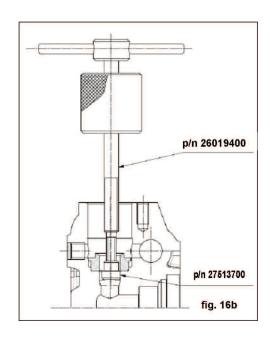
-using extractor tool p/n 26019400 combined with tool p/n 27513700 (fig. 16b).

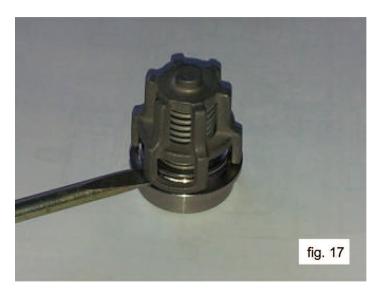
- To dismantle the suction-outlet valves, simply use a tool as indicated in fig. 14

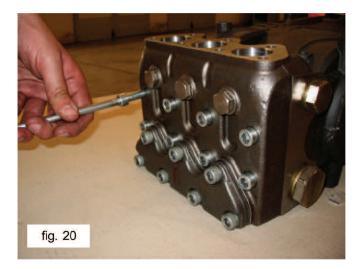
A) Unscrew the M10x110 head fixing screws as indicated in fig. 20.

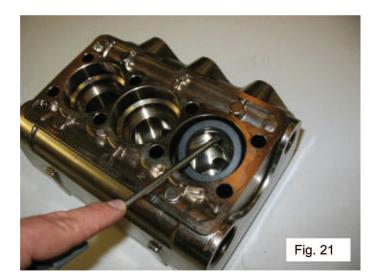
- B) Separate the head from the pump casing
- C) Extract the high pressure seals from the head and the low pressure ones from the support, using simple tools as indicated in (fig. 21) being careful not to damage the respective housing.

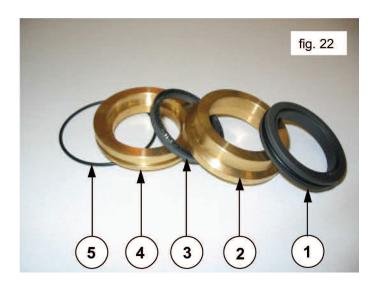
Pay attention to the order of seal pack disassembly as indicated in fig. 23 composed of:

- 1. High pressure seal ring
- 2. Intermediate ring
- 3. Low pressure seal ring
- 4. Bottom ring
- 5. O-ring

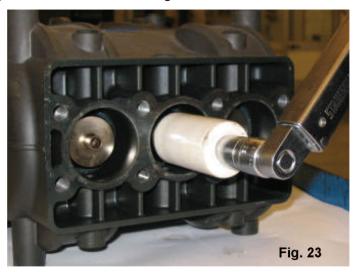
A) Unscrew the piston fixing screws as indicated in fig. 23.

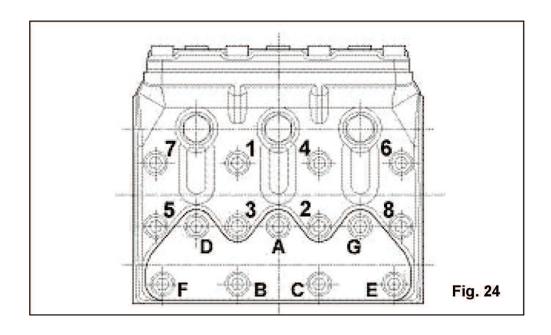
^{***} The valve cover fixing screws must be tightened with a torque wrench, lubricating the underhead, respecting the order in fig. 24

^{**} The head fixing screws must be tightened with a torque wrench, lubricating the underhead, respecting the order in fig. 24

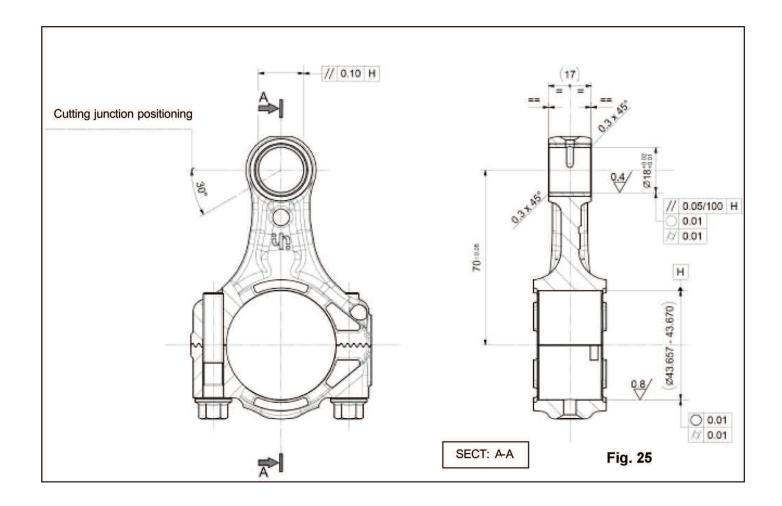
- the lubrication hole coincides with the corresponding hole on the connecting rod;
- the cutting junction is directed as shown in fig. 25

Then perform mechanical processing. The dimensions and tolerances shown in fig. 25 MUST be respected.
