**Part number SES1582T**

**2017-18 Honda Civic**

**Type R FK8**

**1- 3 piece cat back dual exhaust**

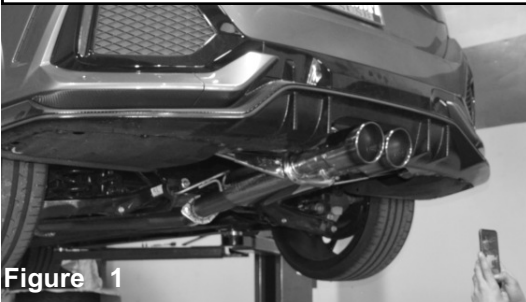
Figure 1

**Complete kit:**

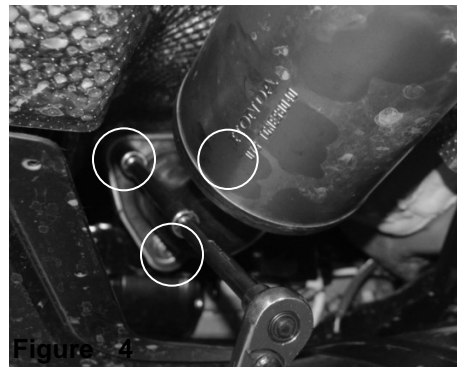
Figure 4

Loosen the 3 nuts holding in the pipe using 14 mm socket with wrench. Save these 3 nuts for later install.

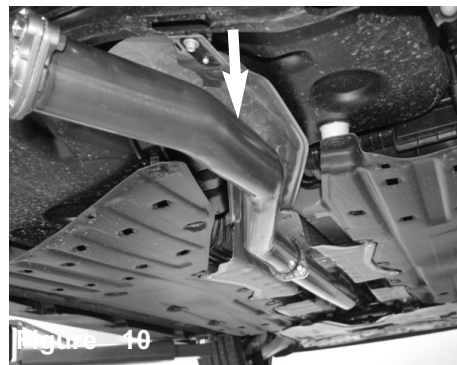
**Figure 10**

Now install the mid-pipe to the exhaust. Secure using provided 3" gasket and bolts with nuts. **Do not tighten.**

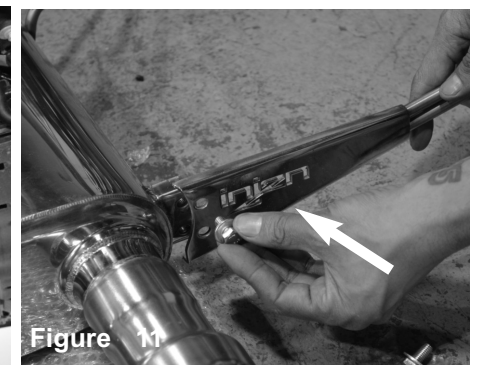
**Figure 11**

install the hanger bracket assembly to the exhaust using provided M8 screws. **Do not tighten.**

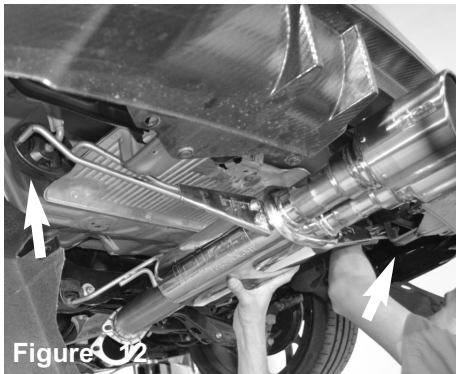
**Figure 12**

Position all the hangars to the isolation mounts. **(look for UP sign on mount)** Position and adjust fitment. **Do not tighten.**

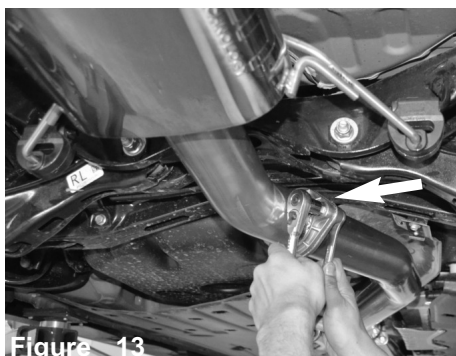
**Figure 13**

Position for best fit and clearance. Once the exhaust is in correct position, Secure and tighten. Secure the bracket assembly also. **Note: Exhaust system has room for adjustment, re-position and tighten for best fit.**

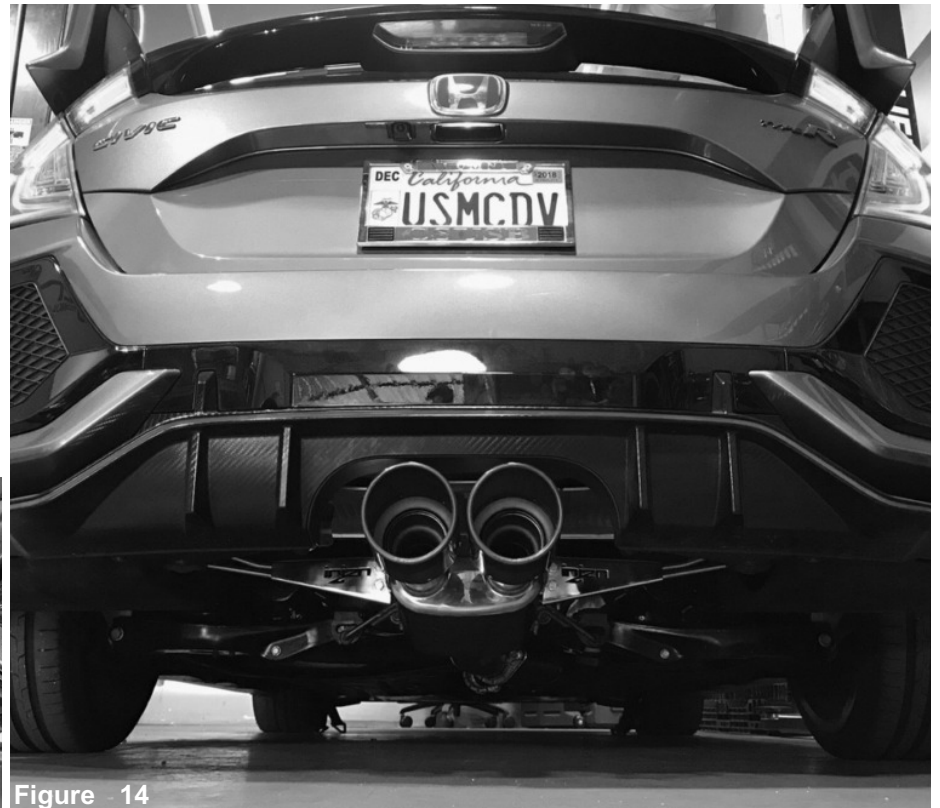
**Figure 14**

Congratulations! You have just completed the installation of this exhaust system. Verify and adjust the rear section of the exhaust, make sure muffler and tip do not touch any plastics or it can melt. Periodically, check the alignment of the exhaust, normal wear and tear can cause nuts and bolts to come loose. **Note: Check clearance and adjust if needed! Failure to check the alignment and adjust the exhaust can cause damage that will void the warranty. Injen Technology is not responsible for any damages caused by/from improper installation.**
