Verify settings:

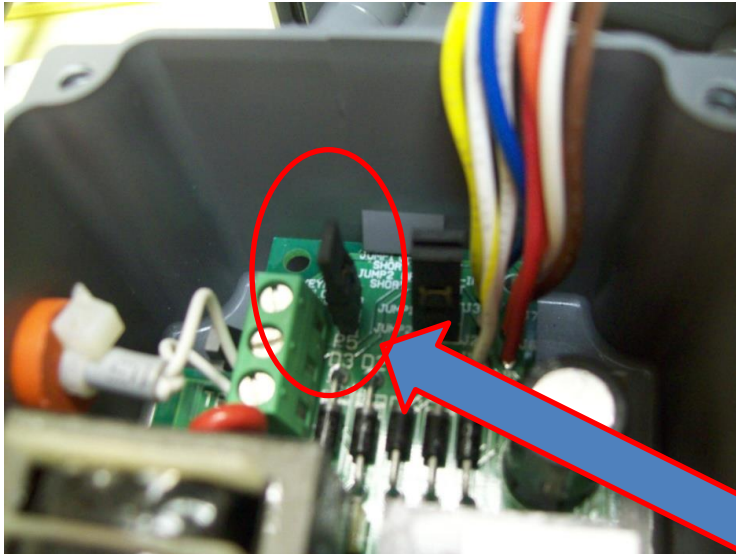
Before

Unplug controller. Remove cover.

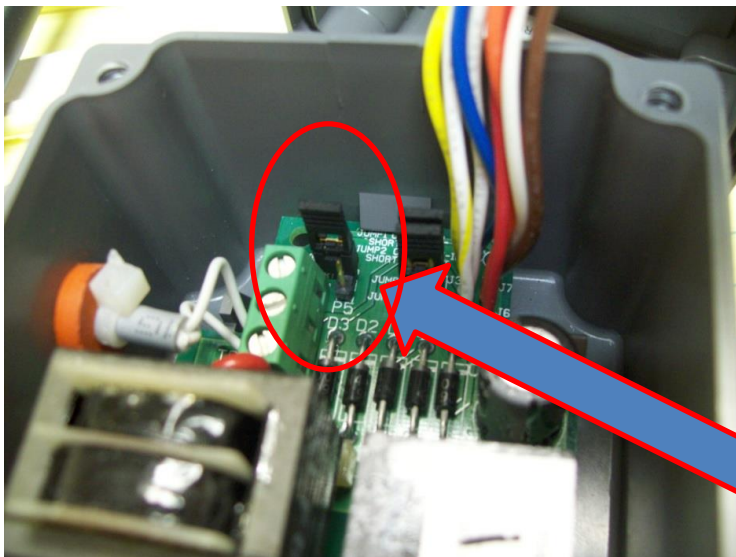
After, now it is locked.

Reinstall cover. TAKE CARE TO FIND THE EXISTING THREADS WITH THE SCREWS. Cutting new threads may result in a stripped hole.
