Products: **Liquid Rubber A-205**

Application: **Metal Roof Waterproofing**

Location: **Swift Current, SK**

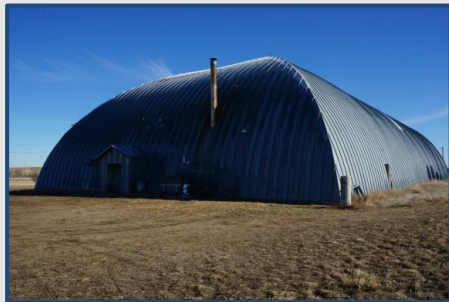
A small community Ice Arena leaked for years and years. The users got used to the drips until they learned of a solution that fit within their budget to become leak free.

LEAKING ICE ARENA

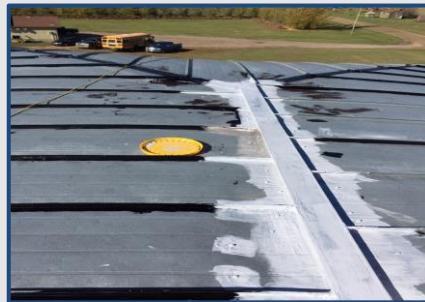
PREPPING

The roof structure was first cleaned of any contamination and loose rust.

Fasteners were tightened and/or replaced, then sealed with a brush application of HighBuild S-200.

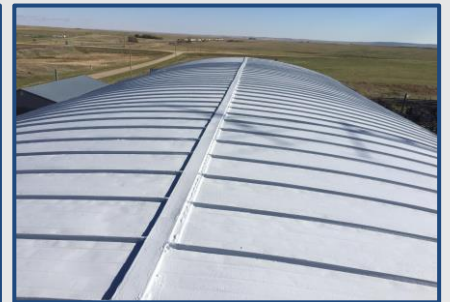
COMPLETED PROJECT

Liquid Rubber Seam Tape bridged joints, gaps, seams, skylights, protrusions...

2 coats of Liquid Rubber A-205 were applied to achieve a final dry film thickness of 30 mil.
