Understanding the electromechanical process of galvanic corrosion

By Steve Goodale

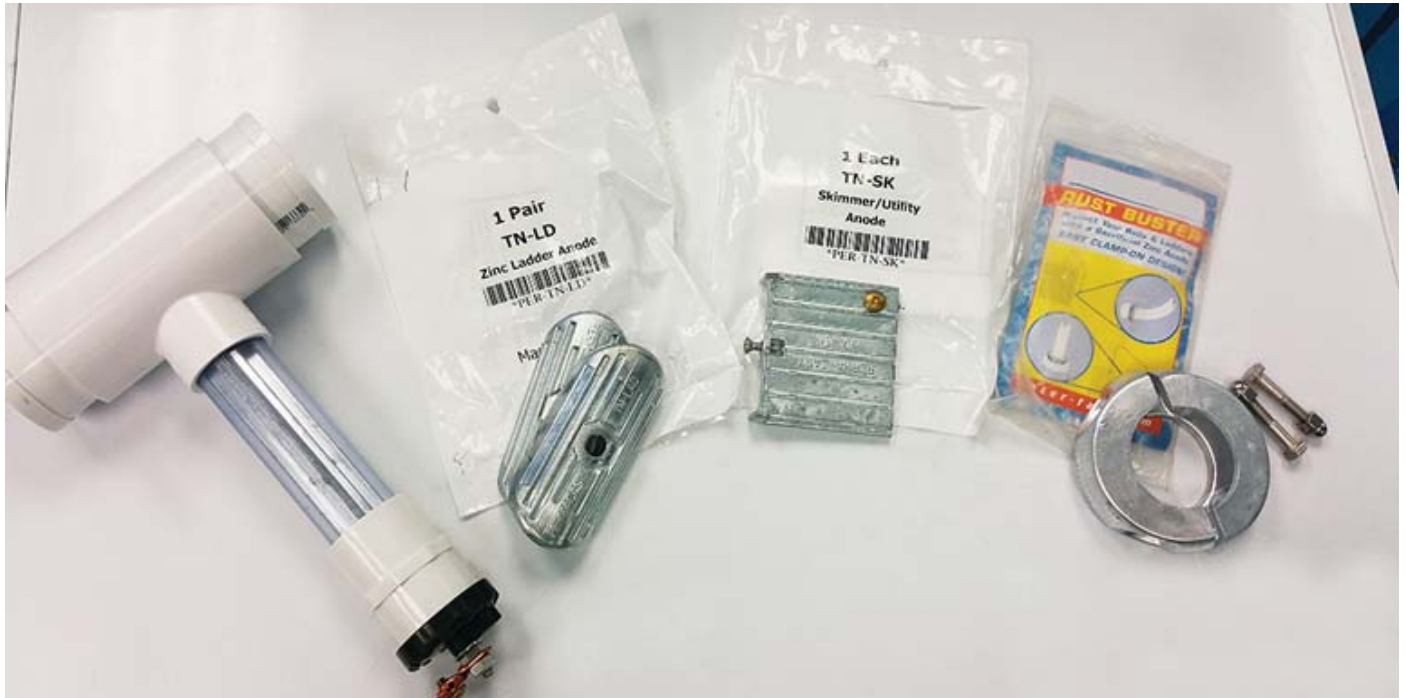
[1]

An active metal such as zinc (Zn) (i.e. sacrificial anode) will be the most inclined to decay as it will become the least noble metal in the pool.

Cathodic protection involves adding sacrificial anodes to the pool to become the primary line of defense against galvanic corrosion. For example, an active metal such as zinc (Zn) will be the most inclined to decay as it will become the least noble metal in the pool.

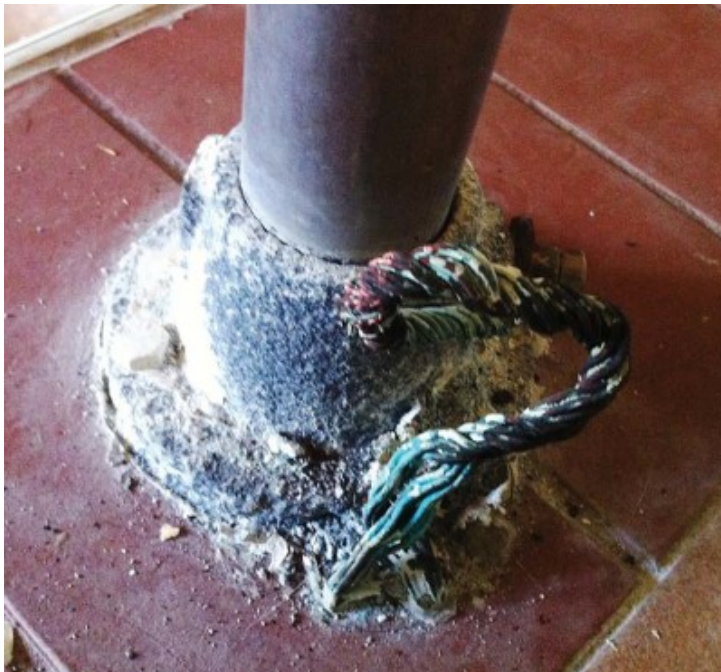
[2]

Here, the bonding wire as well as the metal ladder anchors has experienced severe decay, while the stainless rail is relatively corrosion-free.

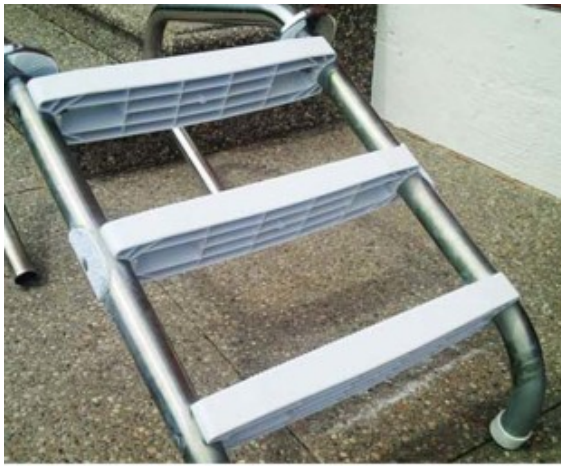
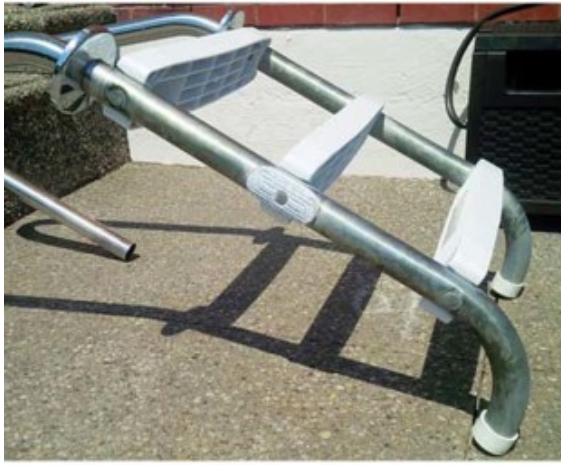
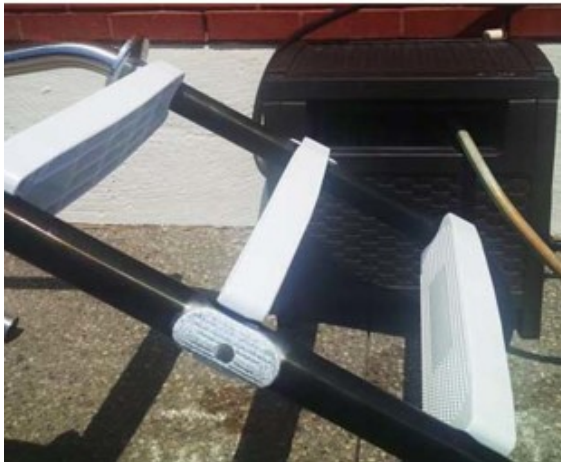
[3]
This new ladder was installed on a saltwater pool with a broken/non-existent bonding grid. Within a week the ladder had blue streaks that looked like it had been struck by lightning. Another week later the ladder was completely black despite the existence of an inline sacrificial anode as well as anodes bolted directly to the ladder. The ladder was replaced and within another week, it also turned black.

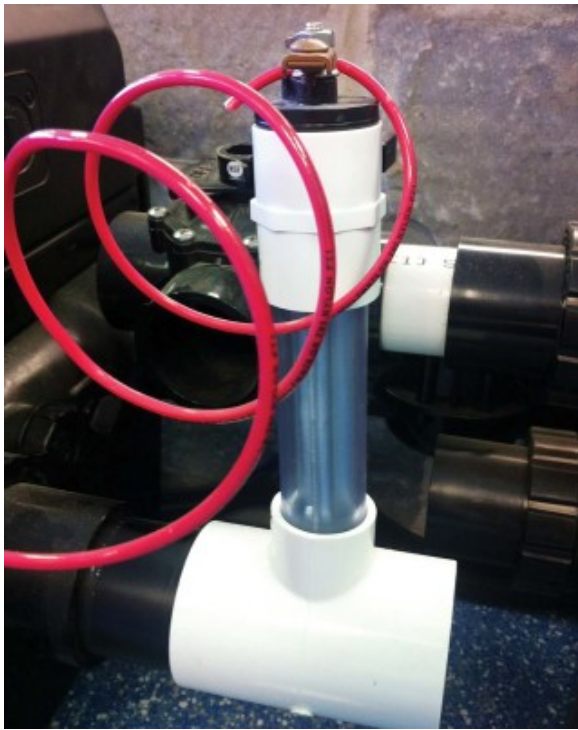
[4]
An inline sacrificial anode installed on a pool system.

Since it is not possible to stop or prevent galvanic corrosion given the nature of how pools are built, the next best thing is to try and control any possible damage by providing a sacrificial anode to decay rather than less serviceable pool components. An inline sacrificial anode is a small plumbing fixture typically made with a zinc rod connected to a bonding lug. The zinc will be the least noble metal in the pool water and the bonding lug will provide an additional low-resistance path to ground for any currents that develop as part of the galvanic corrosion process. While the sacrificial anode will serve to provide a general level of protection for the pool system, localized anodization of components can still occur in some areas.

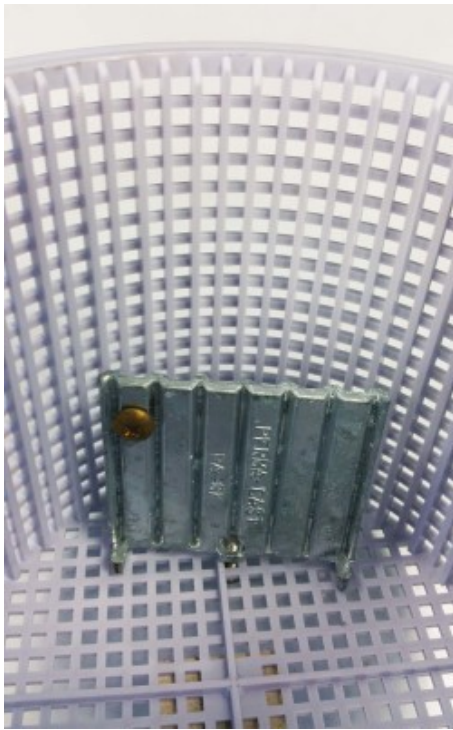
[5]
Zinc anode discs, intended to sit in the skimmer basket, are also available.

The amount and, more importantly, location of metal components in the pool system is such that it is not always possible to have anodes everywhere they need to be. Much as the name suggests, the anode metal is sacrificed in providing protection to the cathode and must be able to be replaced as it deteriorates. Zinc anodes made to connect directly to handrails and ladders, as well as zinc discs which are intended to sit in the skimmer basket are available.
