## Water is dripping from the mixer knob

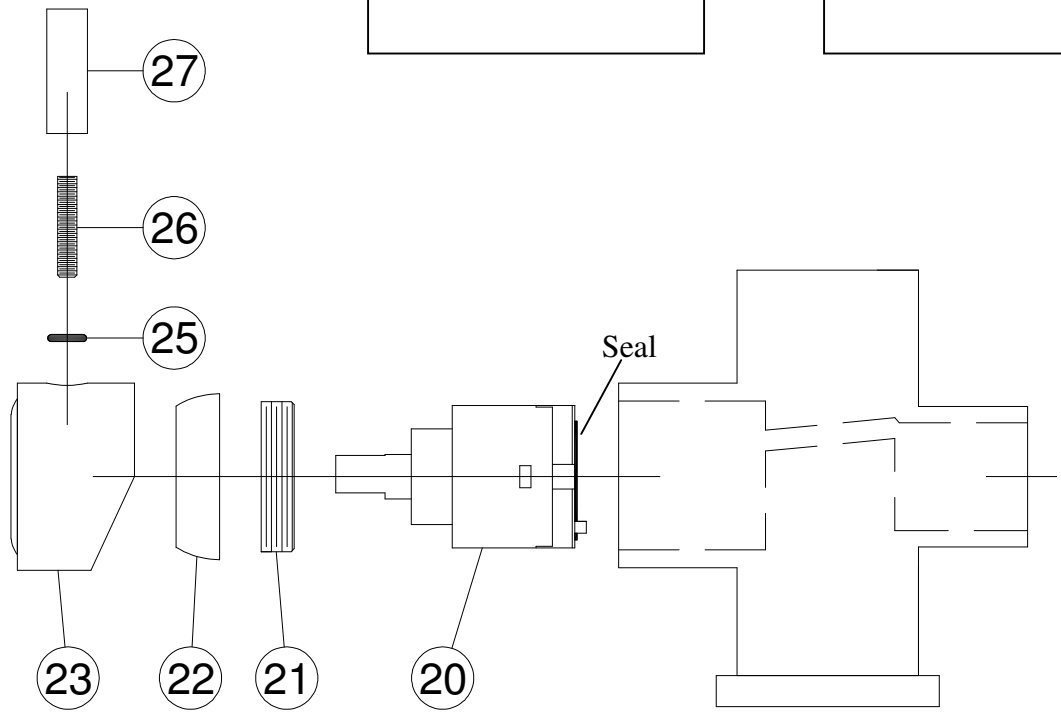
Unscrew 27

Loosen 26  
2.5mm Allen wrench

Remove 23

Unscrew 22

Tighten 21  
There are four 'tabs' on the face of 21. Place the tips of a pair of needle nose pliers against two opposing tabs. Turn clockwise.

Reassemble by reversing Step 1

If leak has not stopped  
P4020 Mixer Cartridge may need replaced
