**LABORATORY MEASUREMENT OF
THE REDUCTION OF TRANSMITTED
IMPACT SOUND OF EASY LAY VINYL
PLANKING**

AUCKLAND UNISERVICES LIMITED
a wholly owned company of
THE UNIVERSITY OF AUCKLAND

**LABORATORY MEASUREMENT OF THE
REDUCTION OF TRANSMITTED IMPACT
SOUND BY FLOOR COVERINGS ON A
STANDARD FLOOR.**

**Reduction of impact sound pressure level according to ISO 10140-3
Laboratory measurements of the reduction of transmitted impact sound by floor coverings on a heavyweight reference floor**

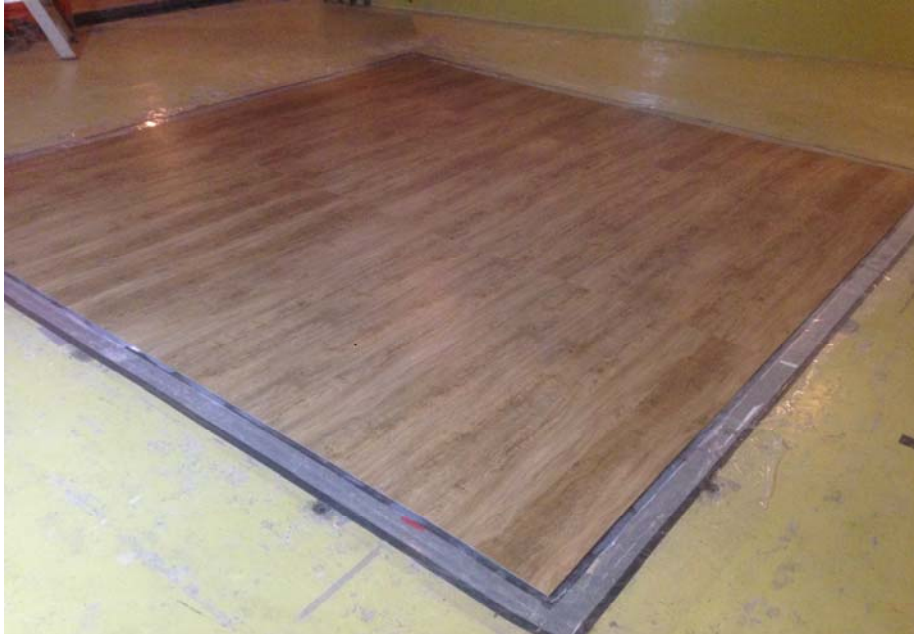
A 3.18m x 3.17m sample of 1200mm x 185mm x 5mm thick *JQL 05 Easy Lay Luxury vinyl woodplank* flooring adhered to the test slab with *ProjectStik 2 Carpet Tile Adhesive*.

Figure 1: Sample installed in chamber.

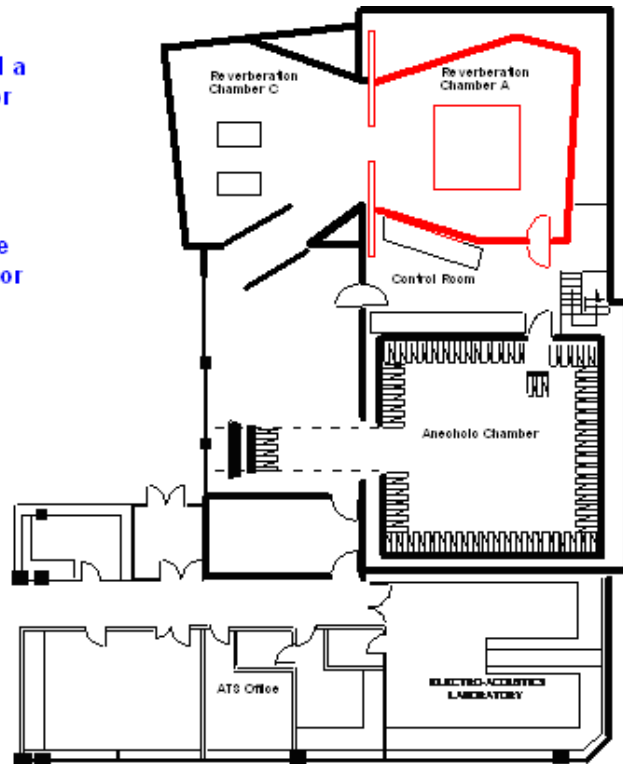
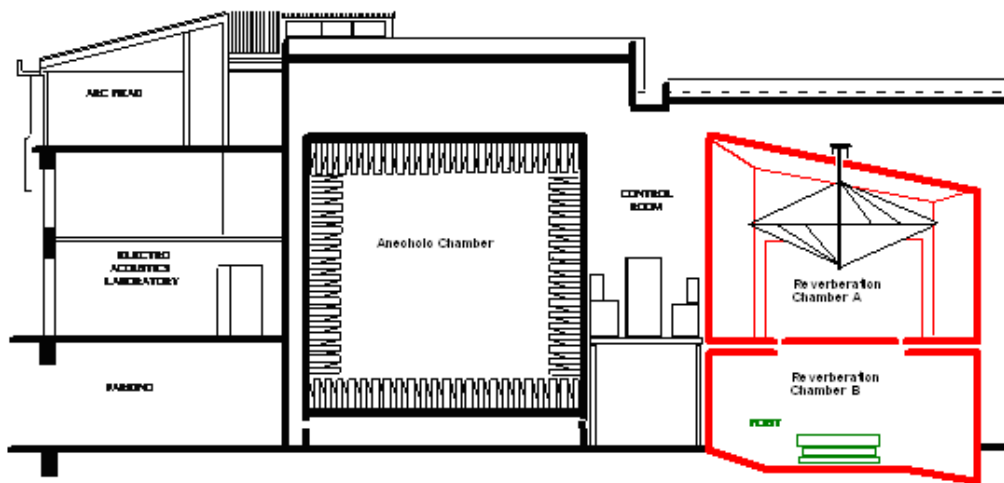
There are three large interconnected reverberation chambers at the Acoustics Research Centre, two at ground level (Chambers C and A) and the third (Chamber B) below A.

All three reverberation chambers may be described as hexagonal prisms; each have 6 vertical sided walls, perpendicular to the floor. The roofs of chamber A and C are plane, but inclined at 12 degrees from horizontal. Chamber B has a plane, horizontal roof which is the floor of chamber A above it. The floor of chamber B is also horizontal, but has two angled sections at its north west and south east ends. The centre section is horizontal because a floor jack is installed there. The floor jack may be raised hydraulically to the ceiling of chamber B, the centre of which consists of a floor plug between the two chambers. This plug may be disconnected from chamber A and lowered down into chamber B, leaving a 3.2m x 3.2 m opening between the two chambers. This allows for the measurement of airborne and impact insulation of floor and roof elements.

The three Reverberation Chambers are linked by heavy steel doors and a removable Standard Industrial Floor Section which is removed and repositioned by a hydraulic hoist. The three chambers are vibration isolated from one another so that sound can only pass from one to the other via the intervening Test Wall or Test Floor/Ceiling Section.
