TECHNICAL SERVICE BULLETIN

BCS Two Wheel Tractors PowerSafe® models OPC Operating Cable Adjustment

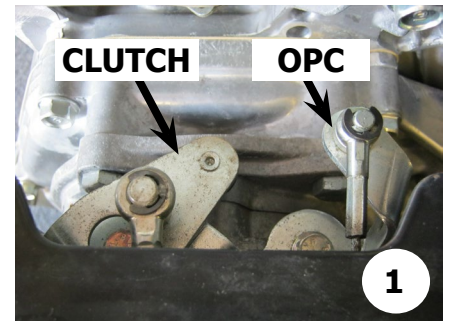
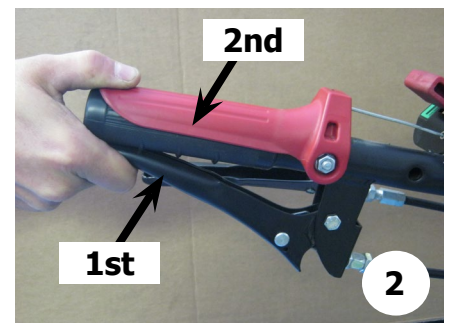
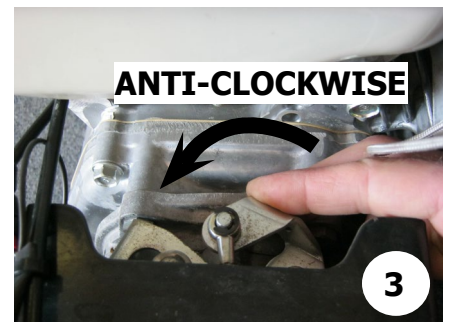
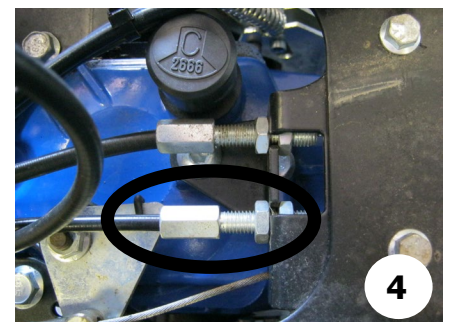
Symptom: No drive to the tines and/or wheels.

1. On top of the PowerSafe® clutch unit on the gearbox are 2 operating arms, one is for the operation of the clutch and one for the activation of the Operator Presence Control (OPC).

3. With the clutch lever and OPC levers depressed check by using finger pressure that the OPC operating arm on the PowerSafe® clutch unit is not able to be rotated any further **anti-clockwise**, a firm stop should be able to be felt.

Solution: Cable adjustment.

2. With the engine turned OFF pull the clutch lever up and depress the OPC lever down fully. The clutch and OPC levers need to be kept in this position by assistance from a colleague or by using a cable tie, elastic band, or equivalent.

4. If there is any **anti-clockwise** movement of the OPC operating arm on the PowerSafe® clutch unit a simple cable adjustment is required. Using the cable adjuster on top of the gearbox adjust the OPC operating cable until the OPC operating arm on top of the PowerSafe® clutch unit is no longer able to move **anti-clockwise**.
