TECHNICAL SERVICE BULLETIN

BCS Two Wheel Tractors PowerSafe® models

OPC Operating Cable Adjustment

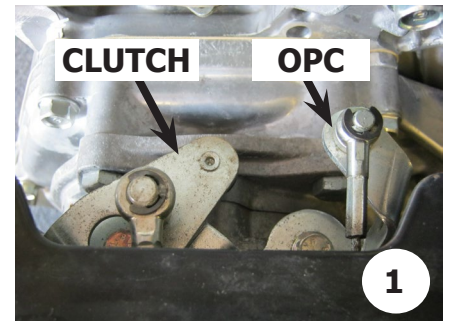
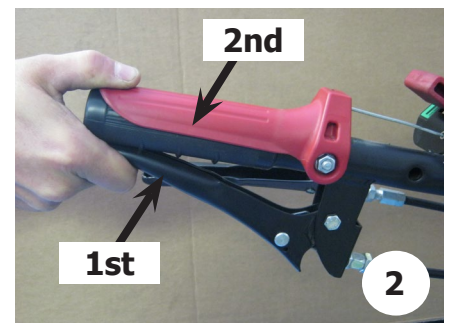
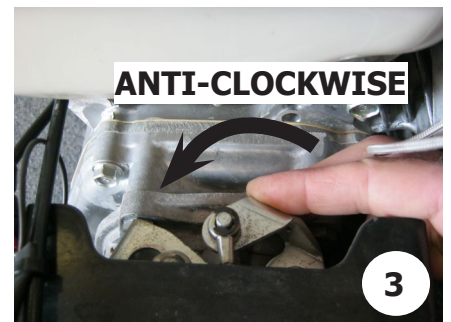
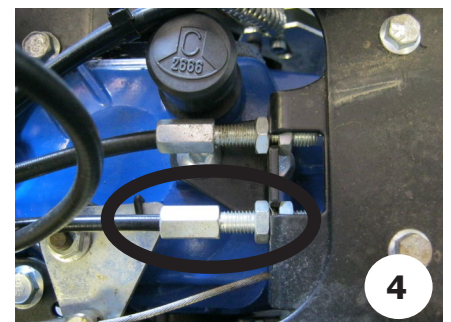
Symptom: No drive to the tines and/or wheels.

1. On top of the PowerSafe® clutch unit on the gearbox are 2 operating arms, one is for the operation of the clutch and one for the activation of the Operator Presence Control (OPC).

3. With the clutch lever and OPC levers depressed check by using finger pressure that the OPC operating arm on the PowerSafe® clutch unit is not able to be rotated any further **anti-clockwise**, a firm stop should be able to be felt.

Solution: Cable adjustment.

2. With the engine turned OFF pull the clutch lever up and depress the OPC lever down fully. The clutch and OPC levers need to be kept in this position by assistance from a colleague or by using a cable tie, elastic band, or equivalent.

4. If there is any **anti-clockwise** movement of the OPC operating arm on the PowerSafe® clutch unit a simple cable adjustment is required. Using the cable adjuster on top of the gearbox adjust the OPC operating cable until the OPC operating arm on top of the PowerSafe® clutch unit is no longer able to move **anti-clockwise**.
