# SUBJECT: TROUBLE SHOOTING GUIDE FOR R.O. BOOST PUMP SYSTEMS

## DESCRIPTION

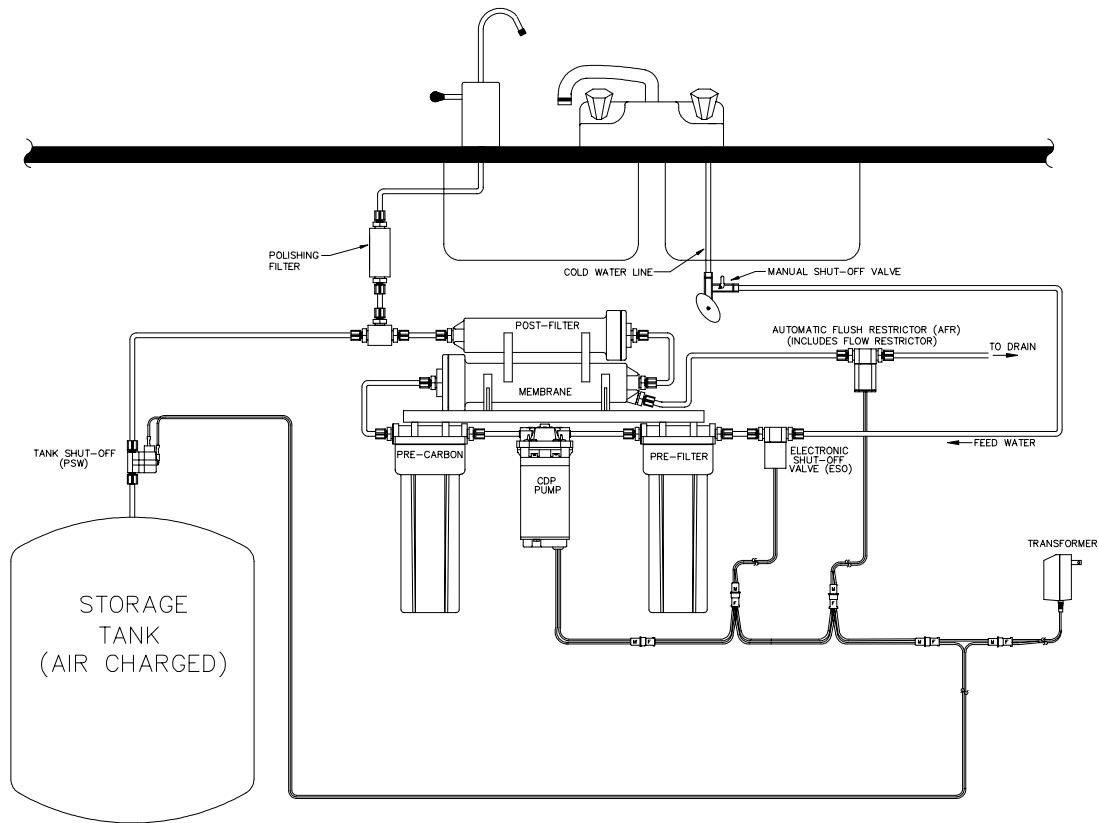
**DIAGRAM 1**

The R.O. boost pump system normally includes at least 3 components (see diagram #1):

1. A 6800 or 8800 series pump, fitted with an integral by-pass mechanism, and driven by a low voltage permanent magnet motor.
2. A step down transformer designed to power the motor and one or more accessories.
3. A switch that cuts the electricity from the transformer to the pump when the air charged storage tank pressure reaches a pre-established switch shut off setting, then re-starts the pump as purified water is withdrawn from the tank.

Other performance enhancing accessories that can be powered by our .8 amp, or 2.0 amp transformers, are a feed water shut off valve (ESO), and an automatic membrane fast flush valve (AFT), that can also double as a flow restrictor (AFR).

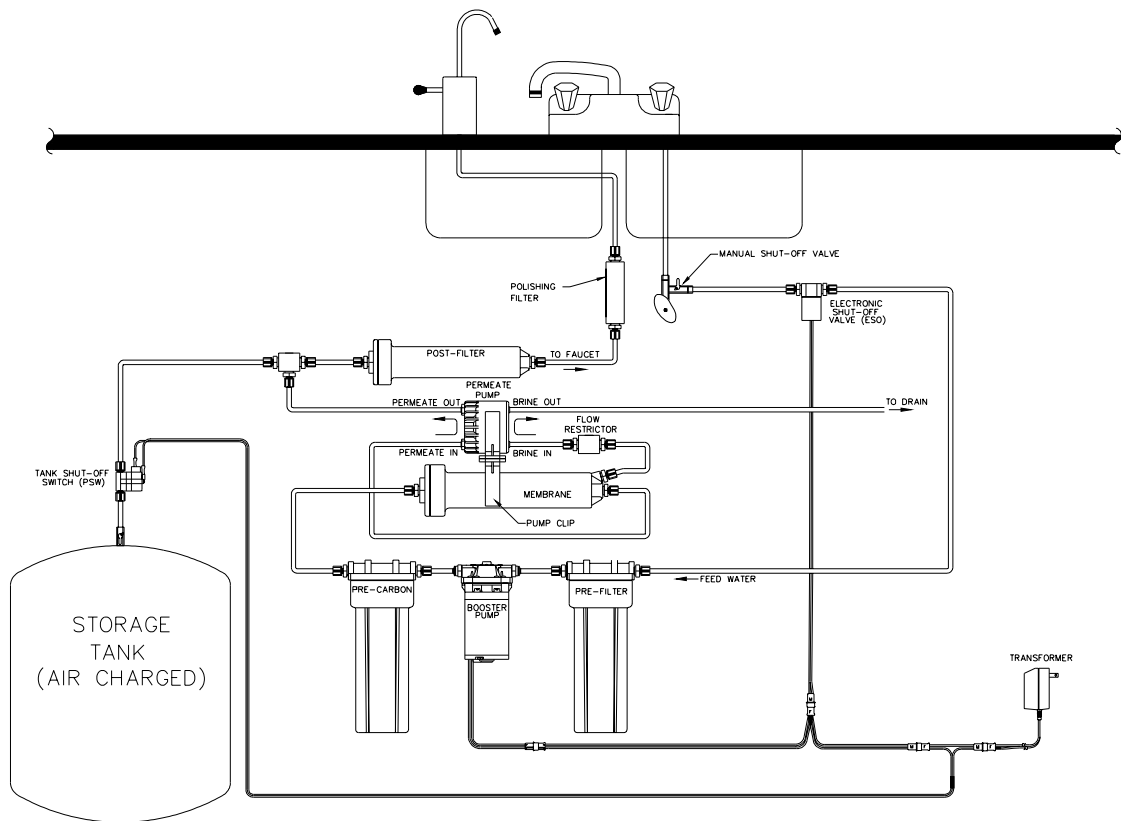
**DIAGRAM 2**

- E. The pump is causing electrical noise interference:
1. Try locating the pump on a dedicated electrical circuit, separate from the device that is being interfered with.
  2. Consult factory for pumps available with electronic noise suppression.
- F. Can a Permeate Pump and a Booster Pump be used together in an R.O. system?  
 Yes. The Booster Pump increases the feed water pressure to the membrane, while the Permeate Pump is located after the membrane and eliminates the performance robbing back pressure created by a full, or filling, air charged storage tank (see diagram # 2).
