Testing Certification

VISIPLAS Pallet Racking Upright Protector

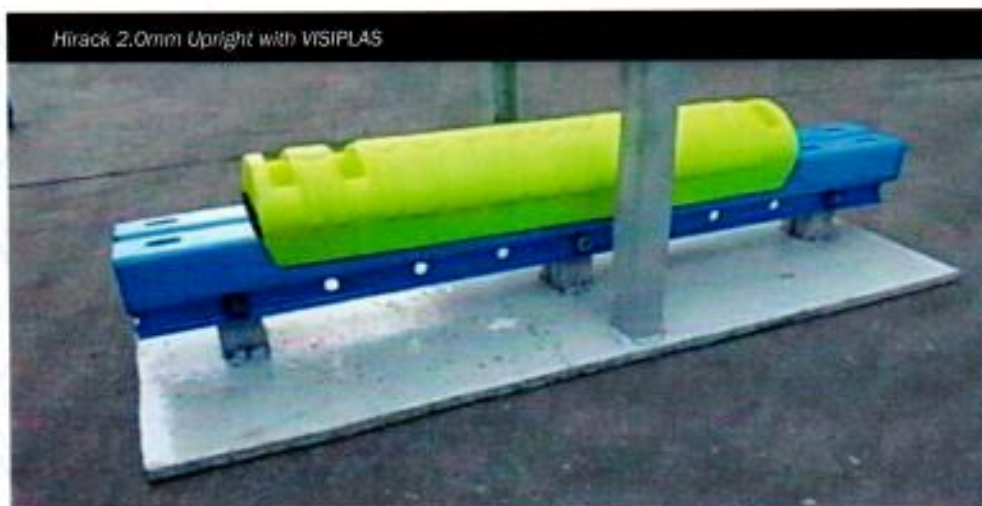
This photo shows the VISIPLAS fitted to upright prior to impact.

The test weight was dropped from a height of 800mm above the impact surface.

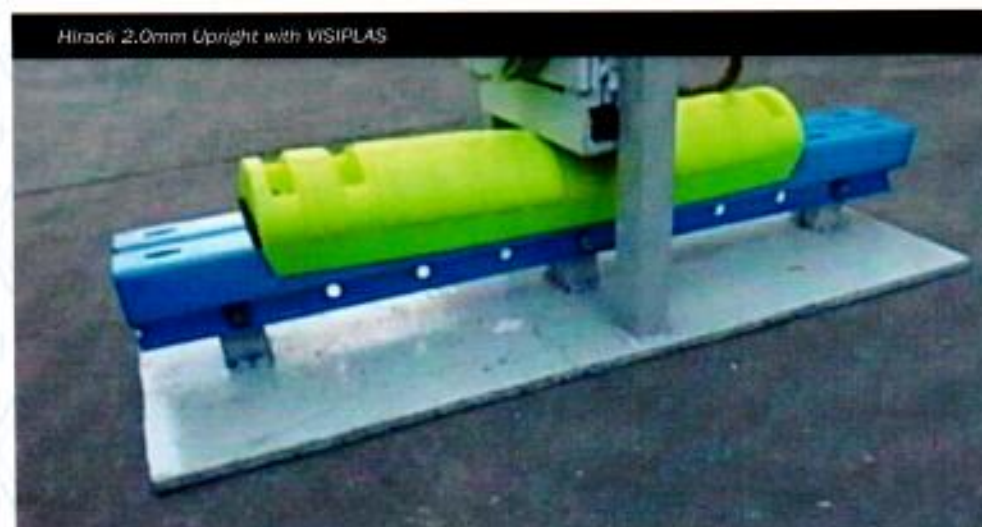
This photo shows the VISIPLAS during the impact.

Note the deflection of the VISIPLAS as the impact force is absorbed

The VISIPLAS protector showed minor rib deformation and evidence of penetration of the ribs into the shock absorbent layer. However the VISIPLAS reformed itself to its original dimensions. The upright section sustained minor damage resulting in 0.7mm average bending of the upright in the direction normal to the aisle, which represents less than 25% of the allowable bending defined in FEM 10.2.04.

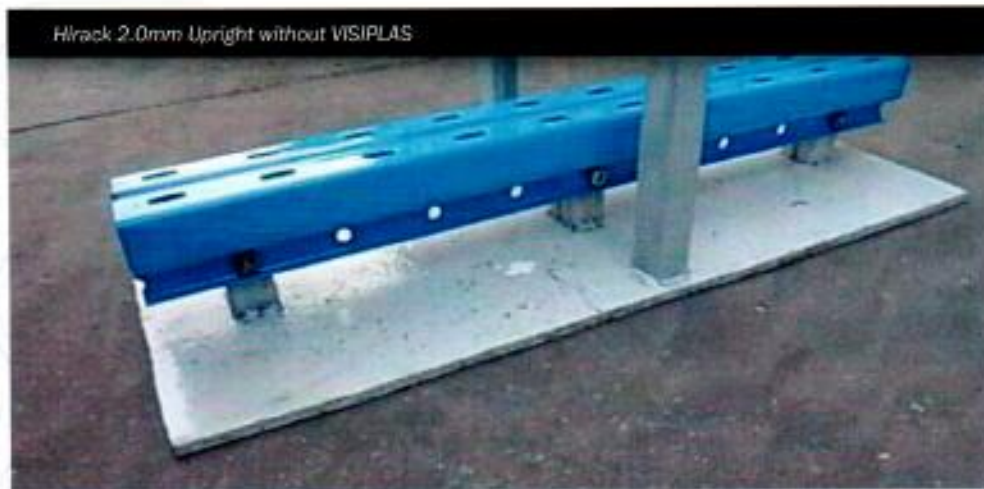
This photo shows the upright without VISIPLAS prior to impact.

The test weight was dropped from a height of 800mm above the impact surface.

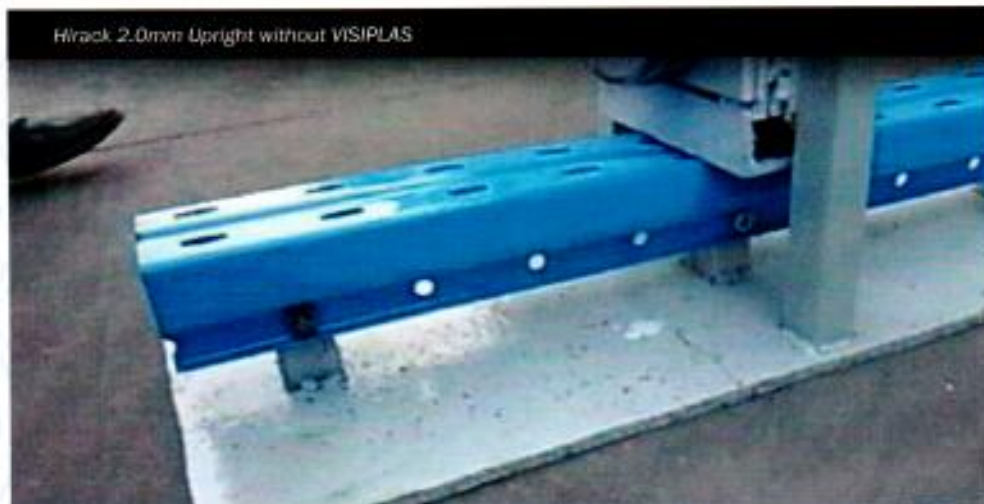
This photo shows the upright during the impact.

Test results showed that the unprotected upright section in all cases exceeded the damage level allowed by FEM 10.2.04 and would require replacement. FEM 10.2.04 allows 3mm maximum bending of the upright section in 1.0metre gauge length in the direction normal to the aisle. The average amount of bending for the upright impacted without VISIPLAS was 7.1mm, which is 235% of the allowable.
