application **Slope Reinforcement**
location **Murrieta, CA**
product **Enkagrid® PRO40**

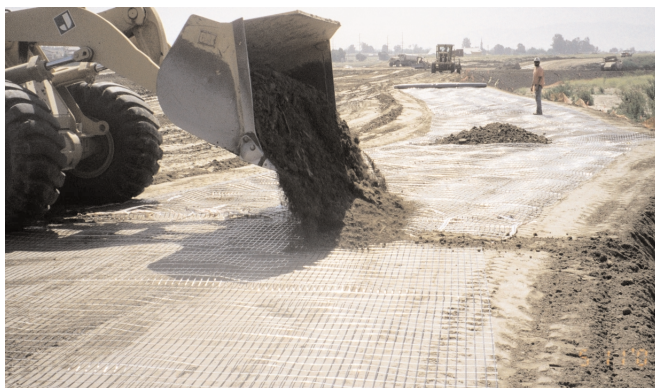
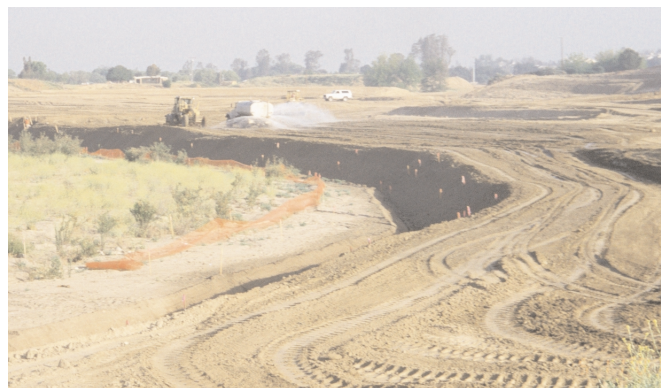
Enkagrid® PRO is placed in 3 foot intervals for a total slope of 20 feet. Enkagrid PRO was used to stabilize the slope under the water level.

The Enkagrid PRO 40 was needed to reinforce the twenty foot high 1:1 slope. the geogrid was embedded 16' and placed in three foot intervals. The slope needed to be stable enough to withstand the forces generated by the revetment system and the row of homes at the top of the slope. The bottom elevation of the slope was below the natural water level. The Enkagrid PRO 40 was also used to stabilize the bottom of the slope.

one foot deep. One option available to the contractor was to construct an elaborate drain system to drain the water away from the entire slope. This option was deemed far too expensive. The contractor, owner and engineer agreed to experiment with the Enkagrid PRO 40 to stabilize the keyway. The contractor rolled out a roll of the Enkagrid and placed an 8" lift of native material on the Enkagrid. The bottom of the keyway solidified and allowed the grading operation to commence.
