## L-Series Bearing Block Installation Instructions

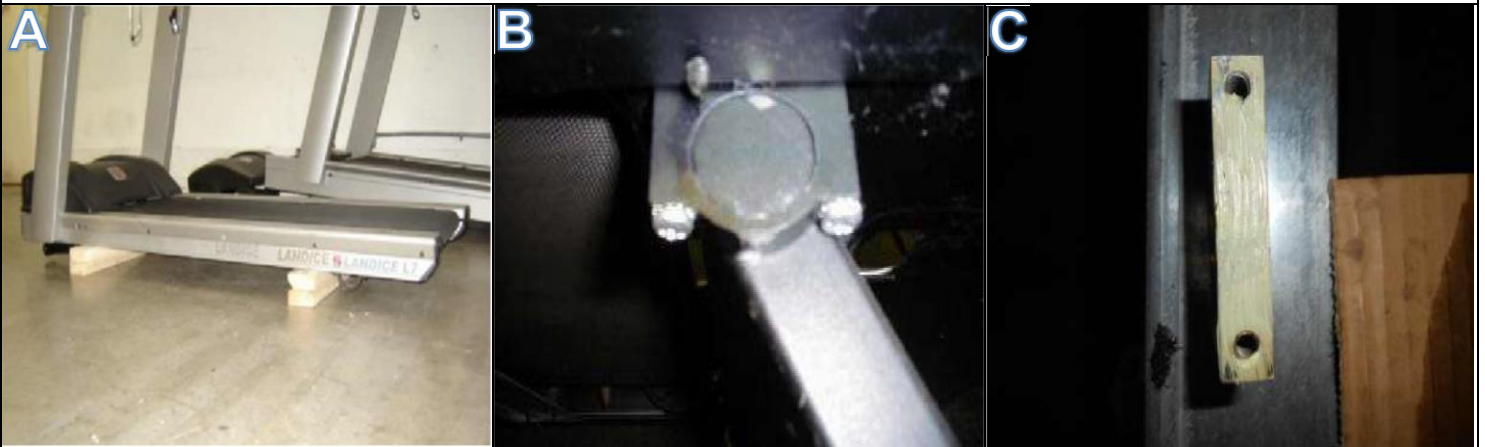
Begin by unplugging the treadmill from the wall outlet. Place the treadmill on wooden blocks to relieve pressure on the elevation leg assembly (**Fig. A**) Next, using your cordless drill and Phillips bit, remove the screws from the bearing block (**Fig. B**) Apply a thin coat of Lubriplate grease on the inside and top surface of the bearing block. (**Fig. C**)

**BEFORE YOU BEGIN:** When you remove the Bearing Blocks, check the holes for threads. If threads are found, you must remove the threads prior to installation of the new blocks.  
See Page 2 for more details.

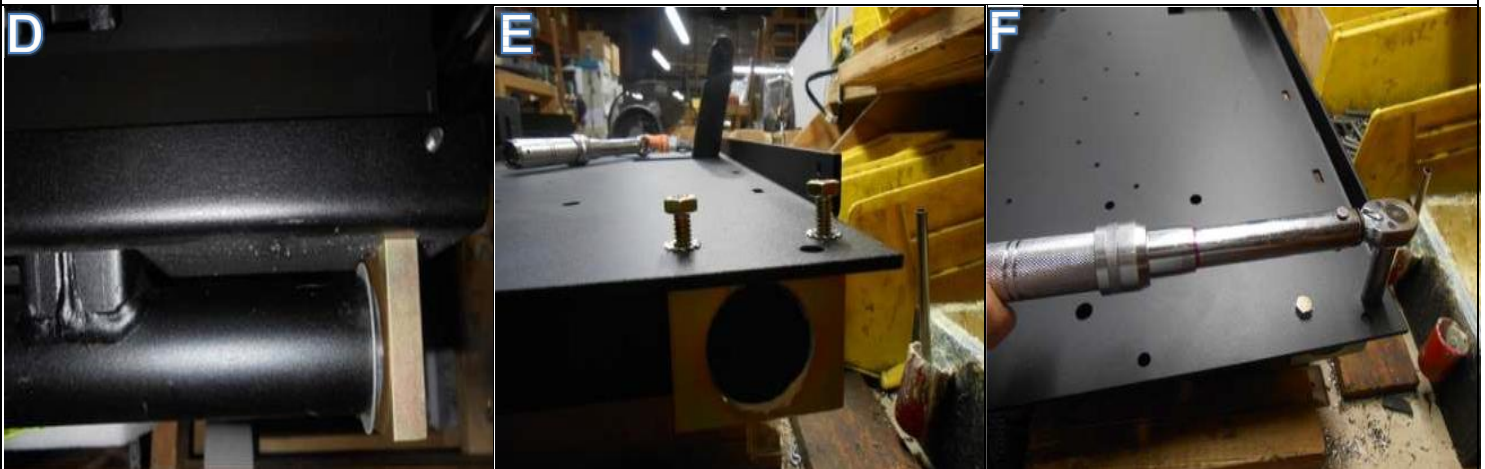
Next, slide the bearing block into the elevation leg assembly. (**Fig. D**) Align the mounting holes of the bearing block with the mounting holes of the motor pan and insert the bolts (**Fig. E**) Using a 7/16” socket and wrench, tighten the bolts and lock washers simultaneously and torque all 4 bolts at 140 in. pounds. (**Fig. F**)

If necessary, prior to installing the new bearing blocks, use the 1/4-20 drill bit to remove the threads in the bearing block holes in the motor pan. If this step is required due to the unit being older, see page 2 for further details.
