# 2003 Tiburon Front

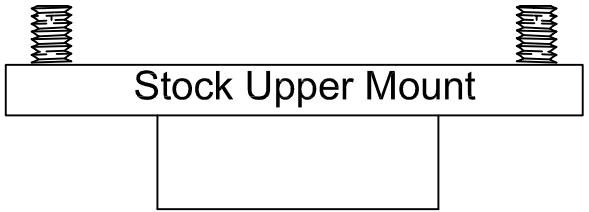
Remove Stock Upper Spring Perch

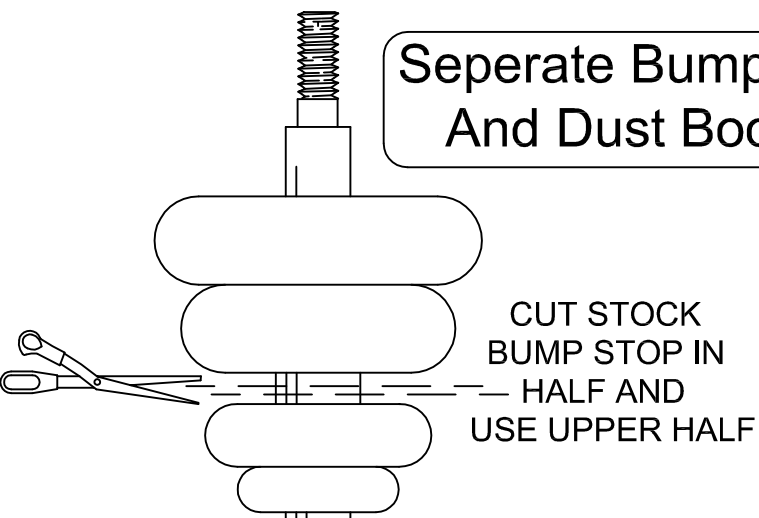
Seperate Bump Stop  
And Dust Boot

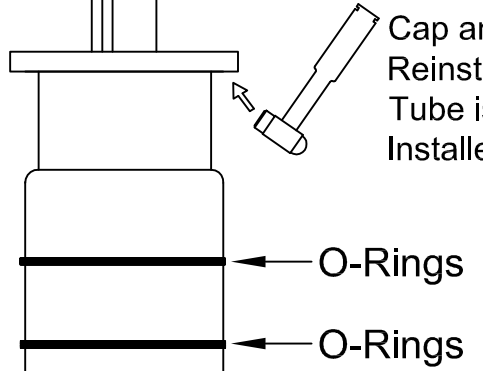
If Needed  
Knock Off  
Cap and  
Reinstall After  
Tube is  
Installed
