# MODIFICATION TO STOCK BUMP STOP MAZDA MIATA 90-97 ( NA SERIES)

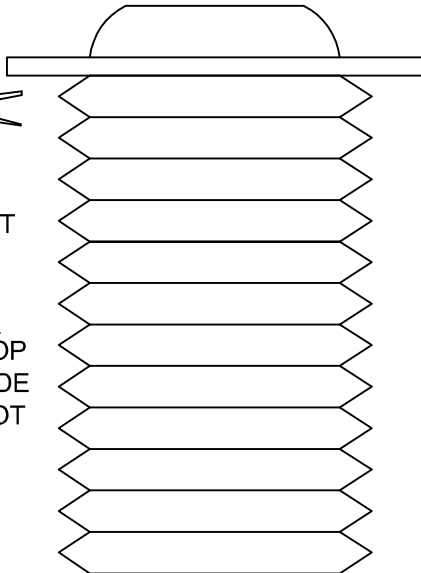
1

TRIM BOOT  
FROM  
UPPER MOUNT

DO NOT CUT  
THE BUMP STOP  
LOCATED INSIDE  
THE DUST BOOT  
UNTIL  
STEP (2) & (3)

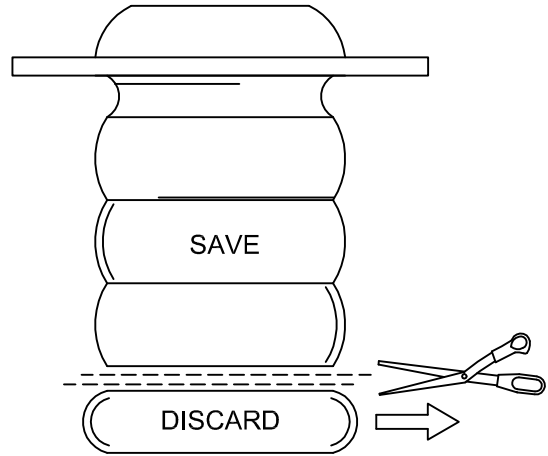
2

SAVE

DISCARD

REMOVE LOWER SECTION OF BUMP STOP

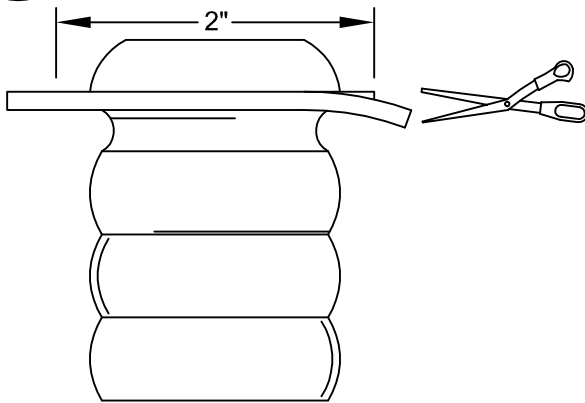
3

2"

TRIM OUTER EDGE FROM UPPER PART  
OF BUMP STOP TO A 2" (TWO INCHES)  
OUTSIDE DIAMETER

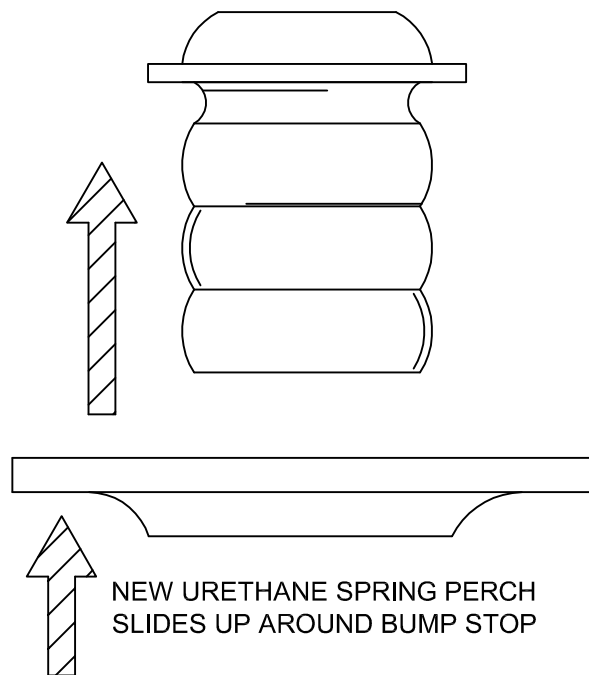
4

NEW URETHANE SPRING PERCH  
SLIDES UP AROUND BUMP STOP
