NOV'SIGHT

PRODUCT MANUAL

H1/H3/H4/H7/H13/9004/9007

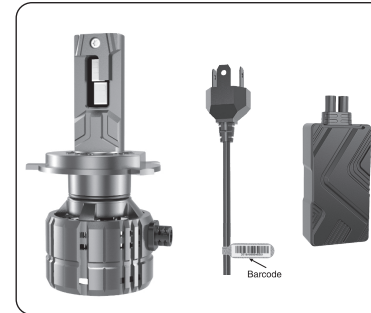
Defective lamp body and driver

Please cut down the two sides connect wires, then send back the picture to us. (Picture with barcode is necessary)
