| TruTrak Flight Systems | | | |
| TITLE RV-7,10 Right Wing | | | |
| SIZE A | DWG NO RV-7,10 roll servo | REV | |

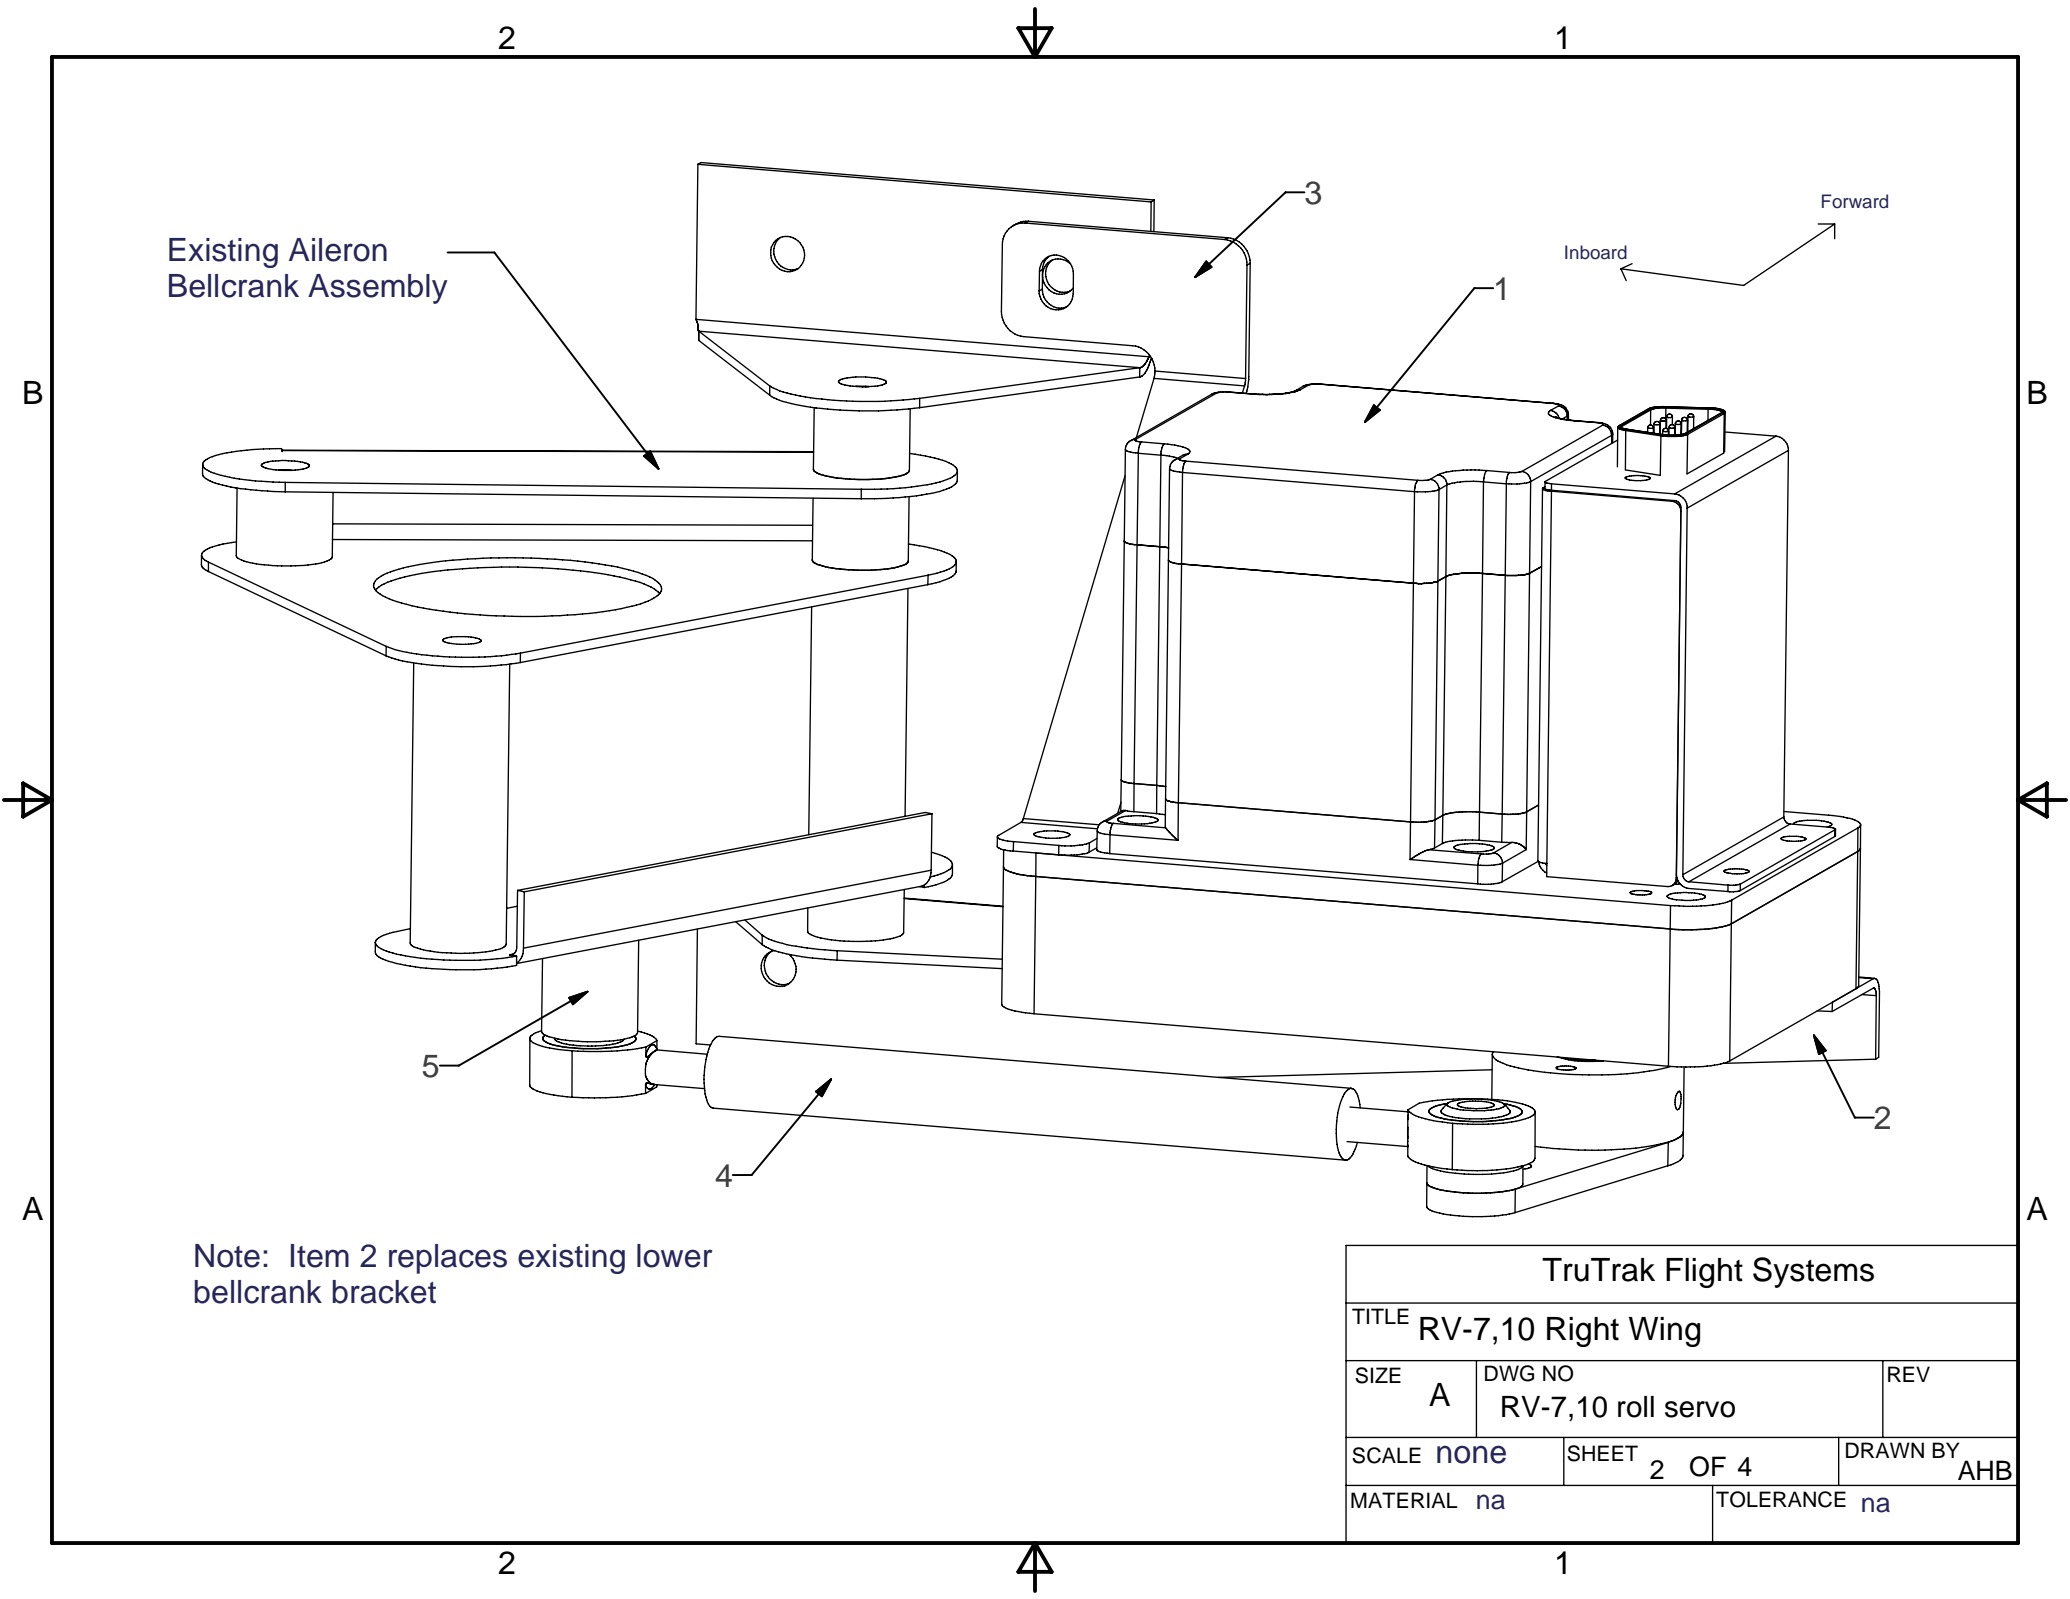
| SCALE none | SHEET 2 OF 4 | DRAWN BY AHB |

Existing Aileron
Bellcrank Assembly

Note: Item 2 replaces existing lower
bellcrank bracket

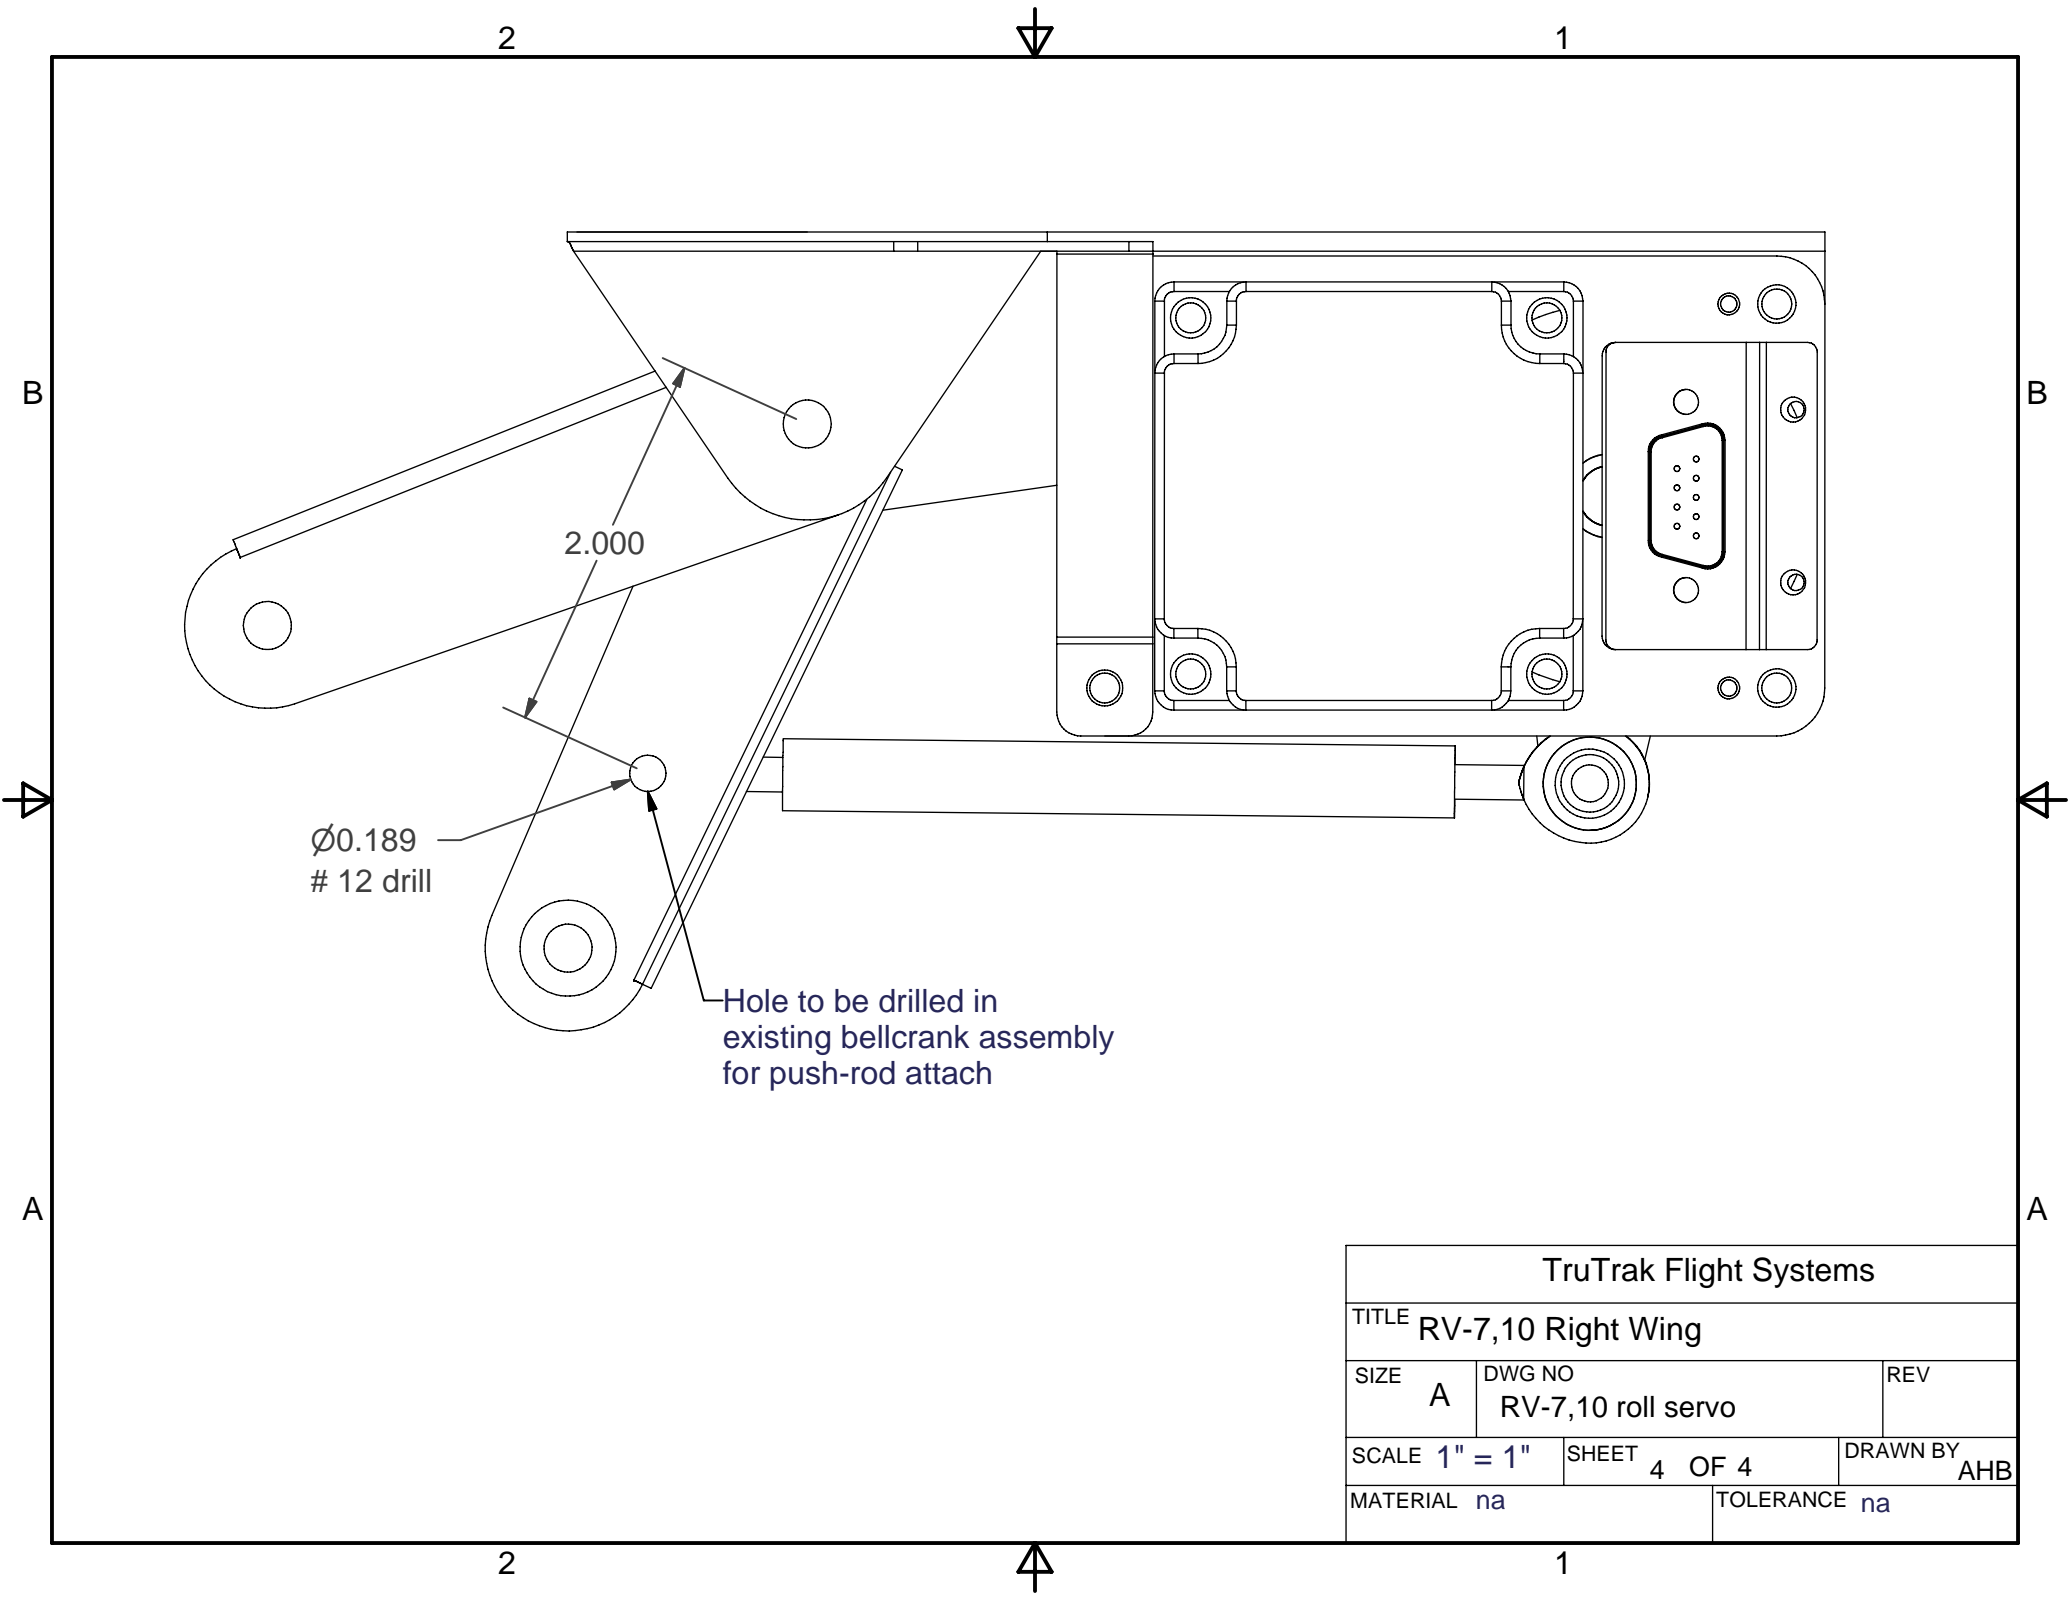
| SCALE 1" = 1" | SHEET 4 OF 4 | DRAWN BY AHB | |

Ø0.189
12 drill

2.000

Hole to be drilled in
existing bellcrank assembly
for push-rod attach
