MMR Mold Solutions Report

The following report was prepared by Aerobiology Laboratory Associates Incorporated at
the Golden Colorado location.
10/16/2012

Mold Solutions MMR Product Testing Report

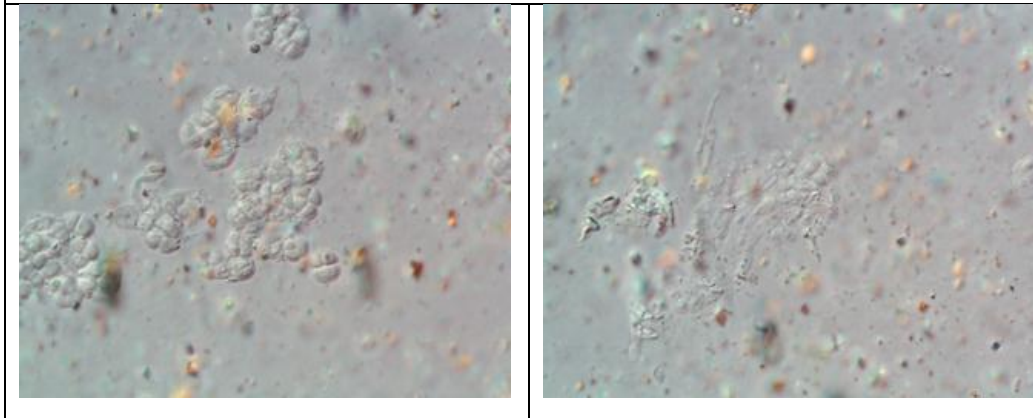
Ulocladium chartarum Plywood MMR Treatment Micrographs / Surface Sample

- **Observations of post-treated sample:** Extensive destruction and bleaching of the hyphae and conidiophores was observed. Spore morphology has been distorted and completely bleached out.

The post-treatment MMR macroscopic photos show that the wood appeared clean with little or no visible sign of fungal contamination. The micrographs show that the MMR is extremely penetrative and destructive to all fungal elements. MMR also appears to penetrate the wood and destroy subsurface mycelium.

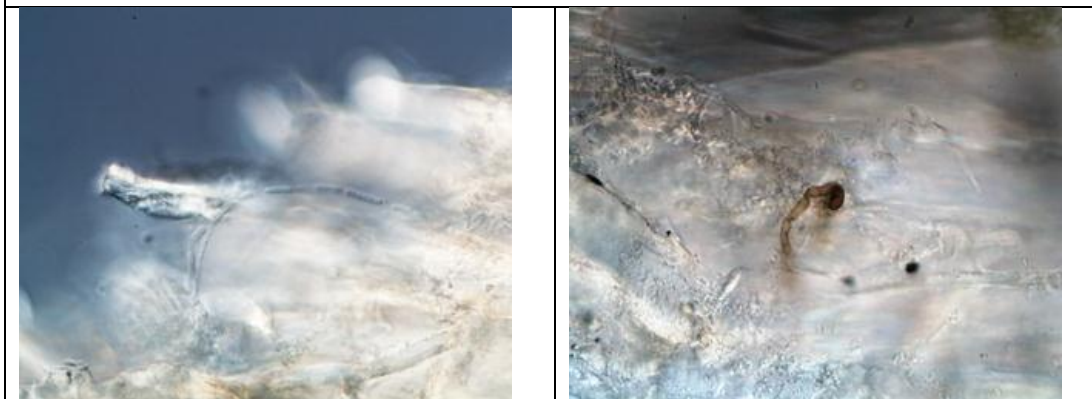
Ulocladium chartarum Plywood MMR Treatment Micrographs/ Sub Surface Sample

- **Observations of post-treated sample:** Extensive destruction of hyphae was observed. Most hyphae not destroyed was bleached out.

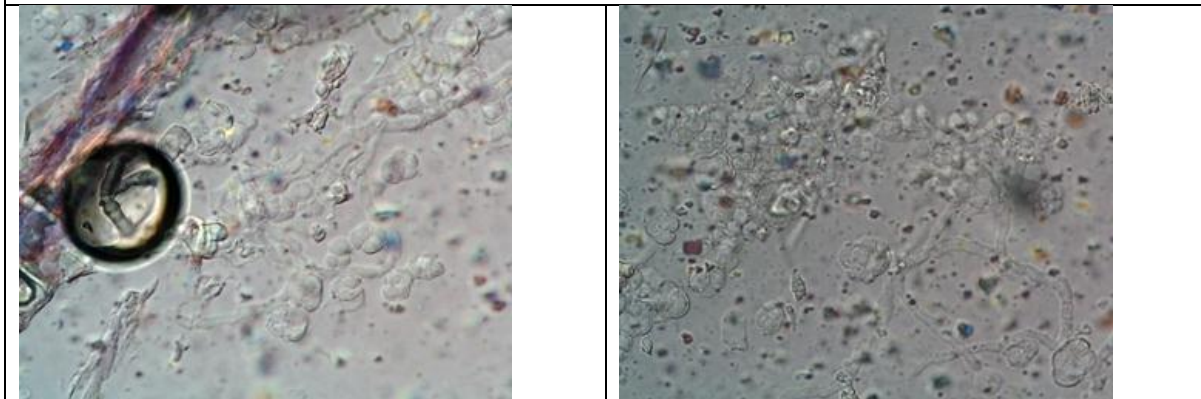
Ulocladium chartarum 2x4 MMR Treatment Micrographs / Surface Sample

- **Observations of post-treated sample:** Extensive destruction and bleaching of hyphae and conidiophores was observed. Spore morphology was distorted and completely bleached out.

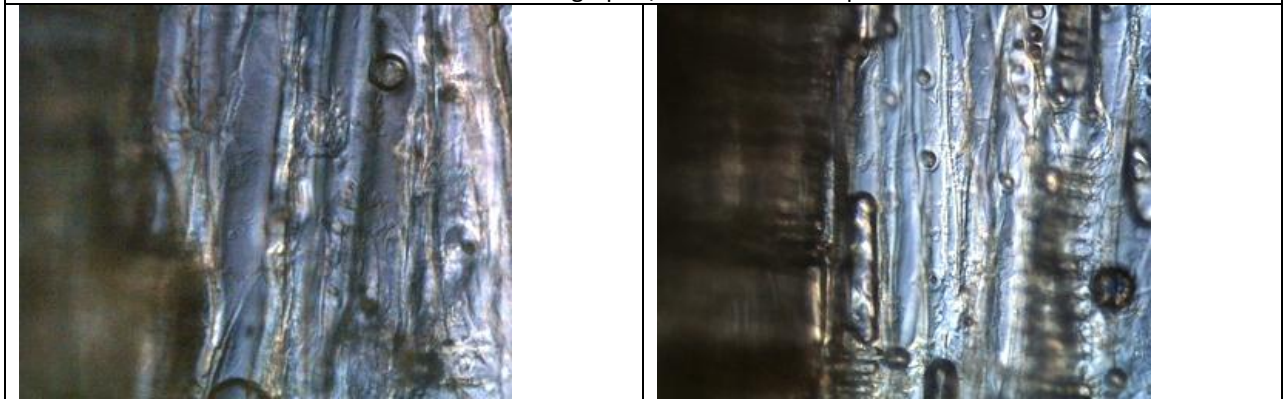
Ulocladium Chartarum 2x4 MMR Treatment Micrographs / Sub Surface Sample

- **Observations of post-treated sample:** Could not detect any subsurface hyphae.

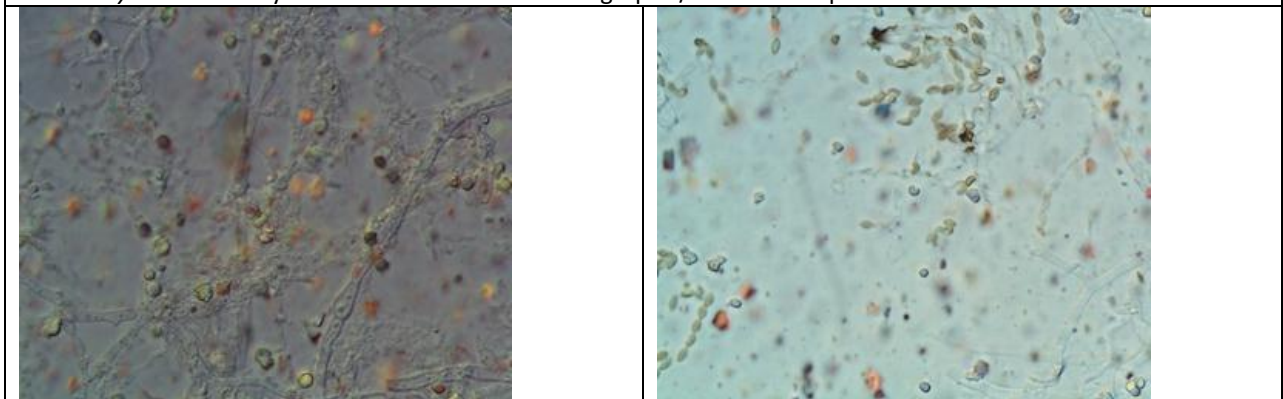
Paecilomyces variotii Plywood MMR Treatment Micrographs / Surface Sample

- **Observations of post-treated sample:** Extensive destruction of hyphae and conidiophores was observed. Hyphae and conidiophores that did remain intact showed a distorted morphology. Spore morphology remained consistent with the control.

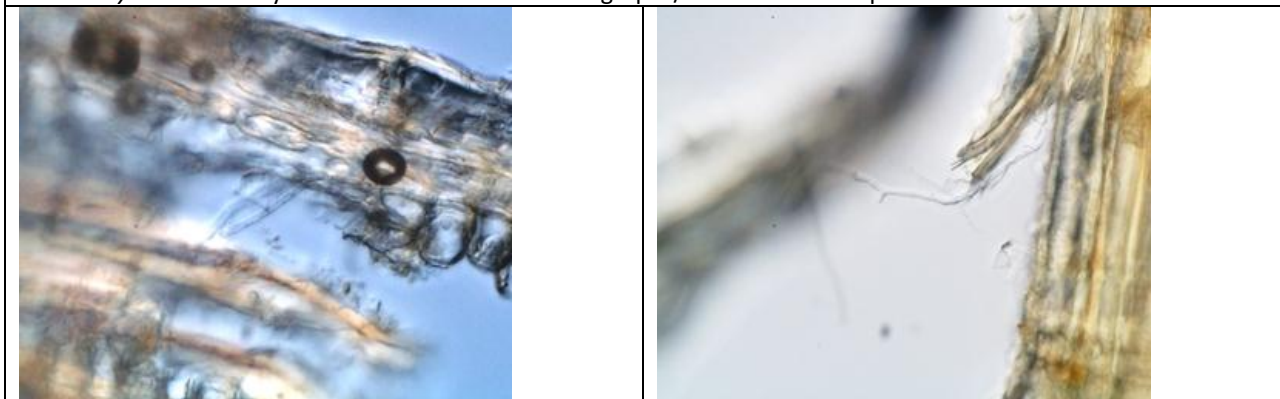
Paecilomyces variotii Plywood MMR Treatment Micrographs/ Sub Surface Sample

Observations of post-treated sample: Subsurface hyphae was hard to detect on post-treated sample. The hypha that was detected appeared fragmented.

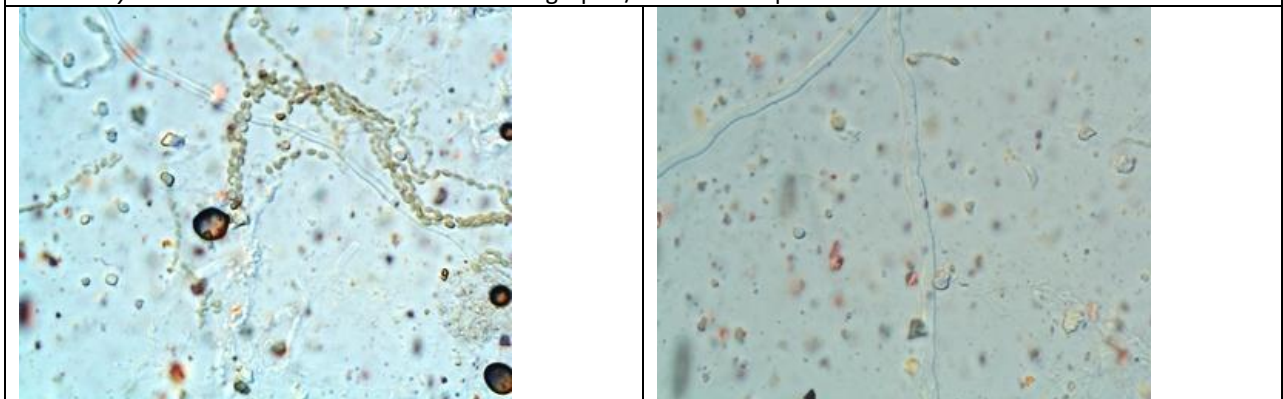
Paecilomyces variotii 2x4 MMR Treatment Micrographs / Surface Sample

- **Observations of post-treated sample:** Extensive destruction of the hyphae and conidiophores was observed. Hyphae and conidiophores that did remain intact showed a distorted morphology. Spore morphology remained consistent with the control.

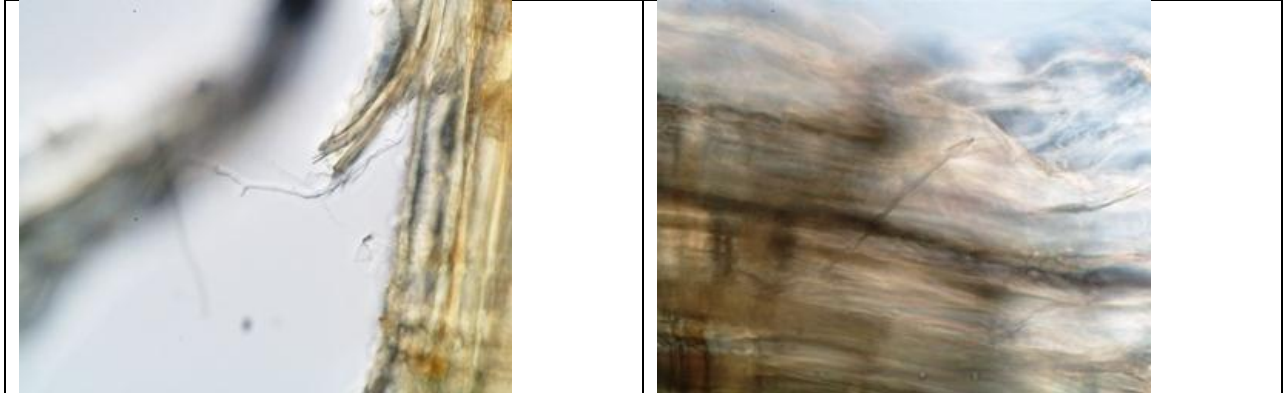
Paecilomyces variotii 2x4 MMR Treatment Micrographs / Sub Surface Sample

Observations of post-treated sample: Subsurface hyphae was hard to detect on post-treated sample. The hypha that was detected appeared fragmented.

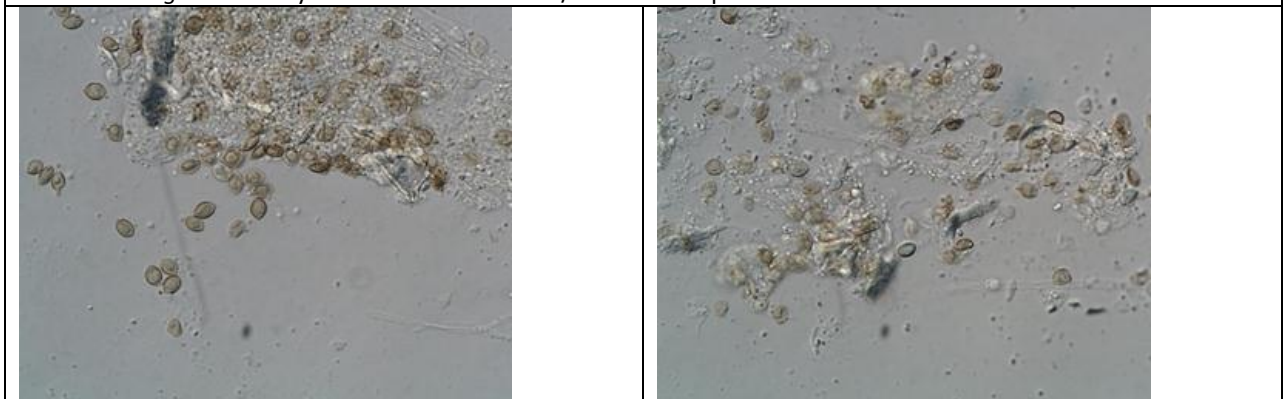
Chaetomium globosum Plywood MMR Treatment / Surface Sample

Observations of post-treated sample: Extensive destruction of ascocarps and hyphae was observed. Most spores were partially to completely bleached out and many spores showed an atypical morphology.

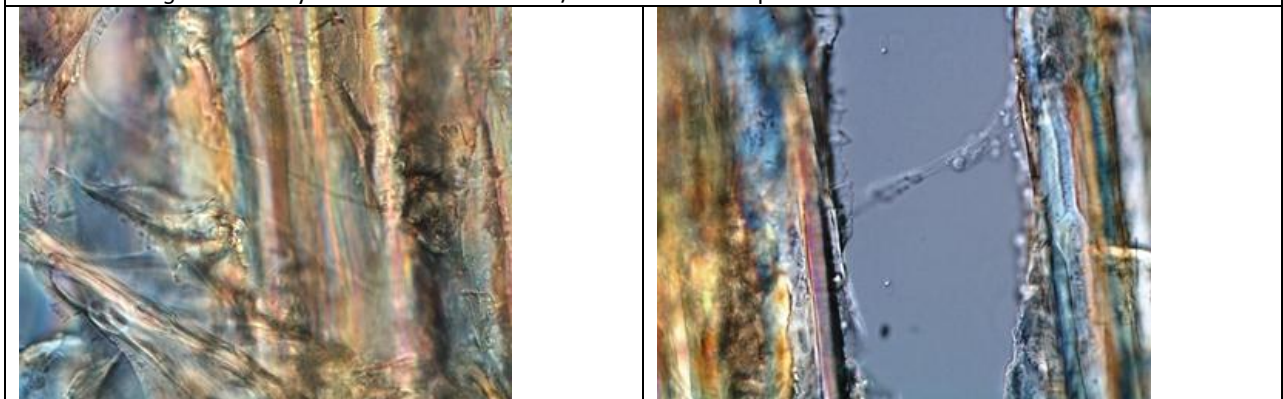
Chaetomium globosum Plywood MMR Treatment / Sub Surface Sample

Observations of post-treated sample: Extensive destruction of hyphae was observed. The hyphae that remained showed fragmentation. Ascocarps embedded in the wood below the surface were completely bleached out.

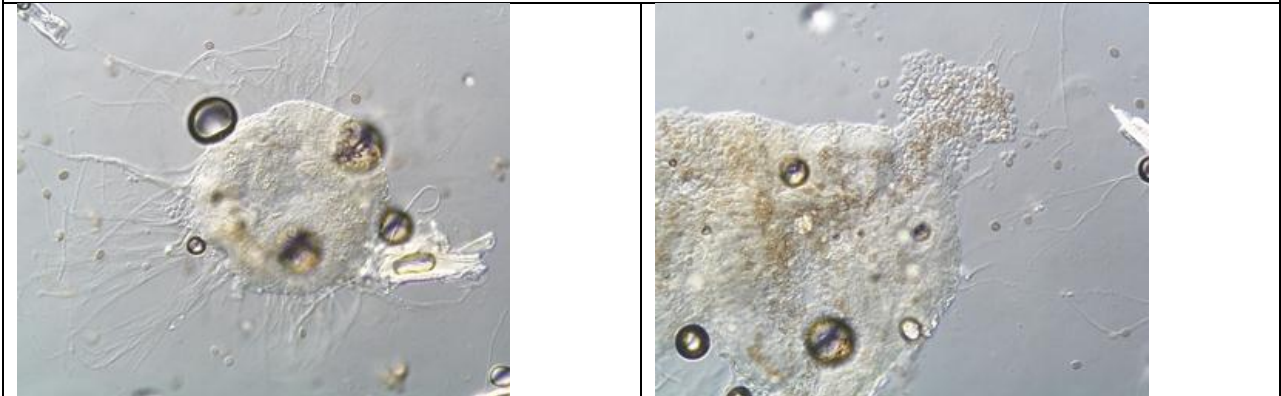
Chaetomium globosum 2x4 MMR Treatment Micrographs / Surface Sample

Observations of post-treated sample: Extensive destruction and bleaching of ascocarps and hyphae was observed. The spores showed extensive bleaching and extremely atypical morphologies.

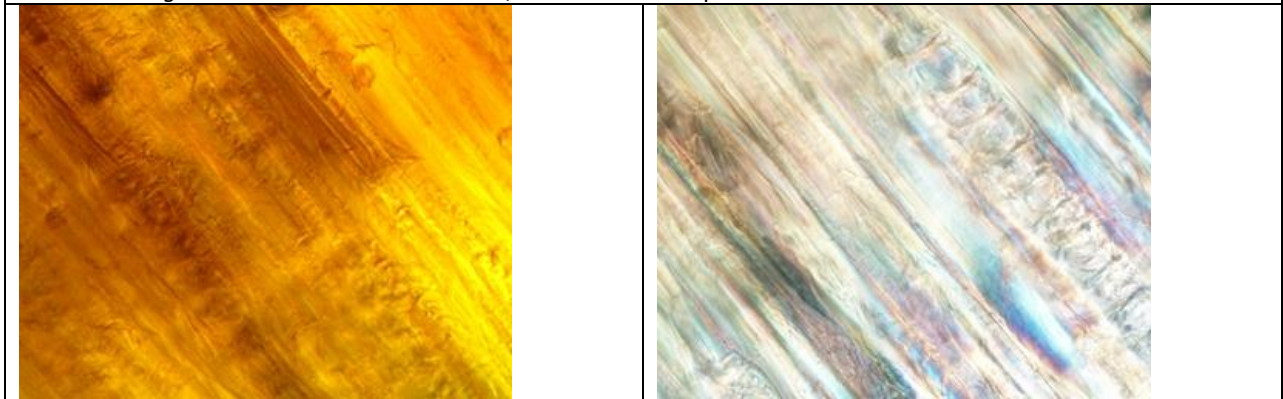
Chaetomium globosum 2x4 MMR Treatment / Sub Surface Sample

- **Observations of post-treated sample:** Could not detect any subsurface hyphae.

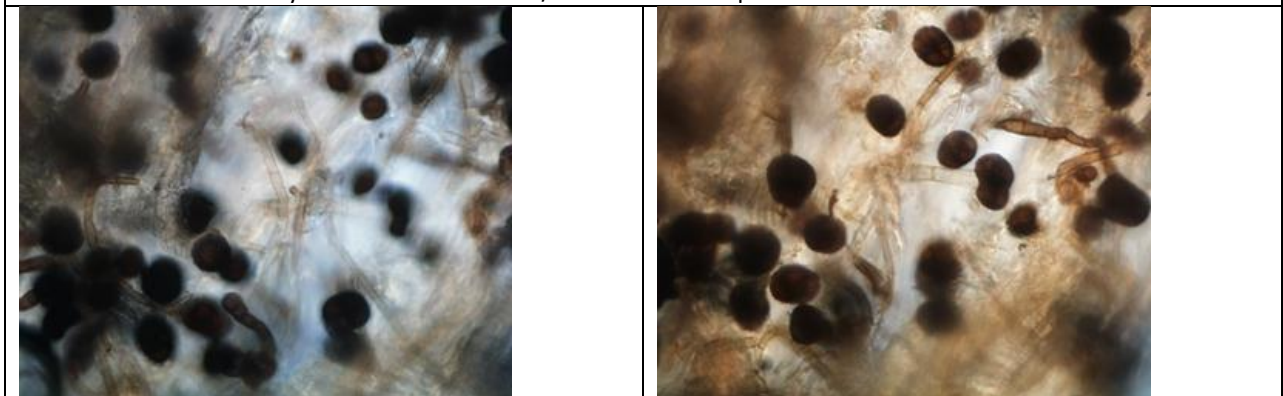
Ulocladium chartarum Plywood BND Treatment / Sub Surface Sample

- **Observations of post-treated sample:** Morphology of all elements appeared very similar to the control sample.

The post-treatment BND macroscopic photos show that the wood appeared just as contaminated post-treatment. The micrographs show little to no visible destruction of the surface growth or subsurface growth.

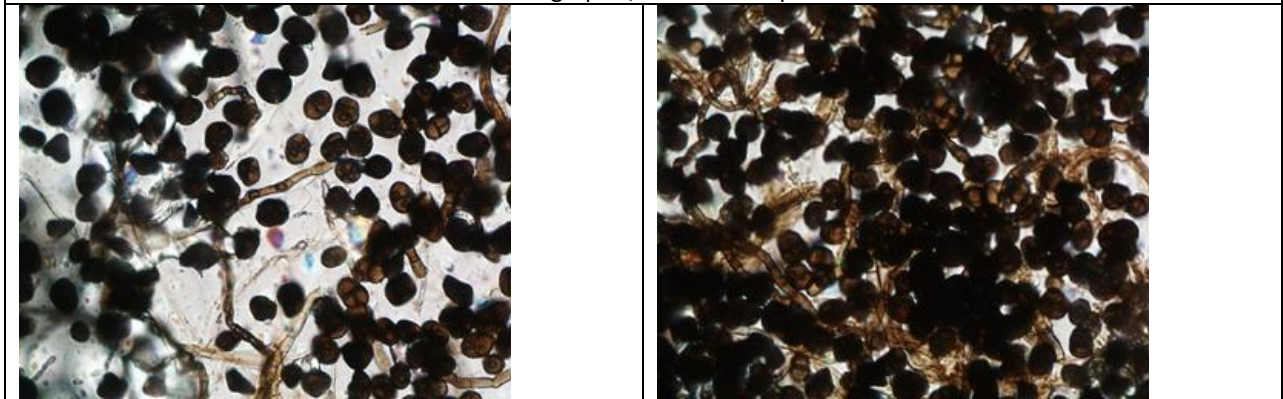
Ulocladium chartarum 2x4 BND Treatment Micrographs / Surface Sample

- **Observations of post-treated sample:** Morphology of all elements appeared very similar to the control sample.

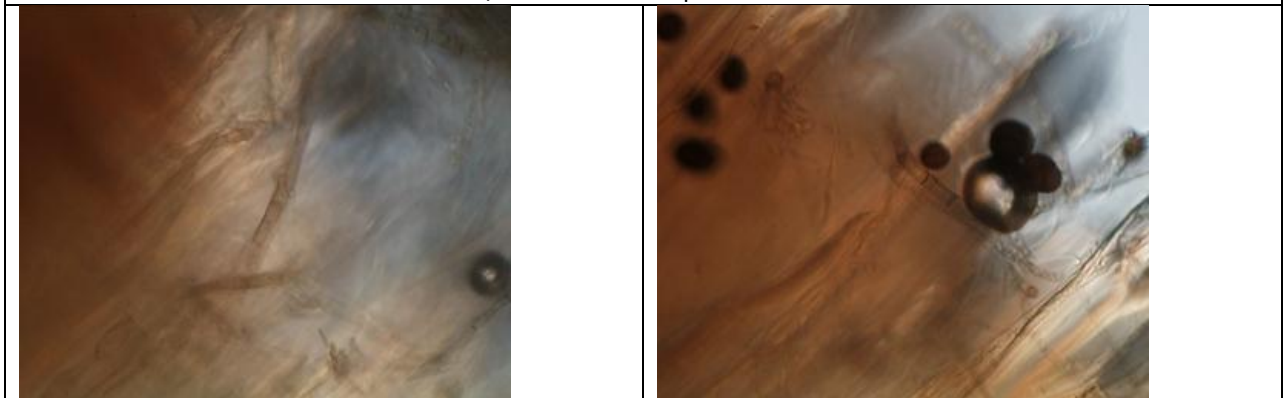
Ulocladium chartarum 2x4 BND Treatment / Sub Surface Sample

- **Observations of post-treated sample:** Morphology of all elements appeared very similar to the control sample.

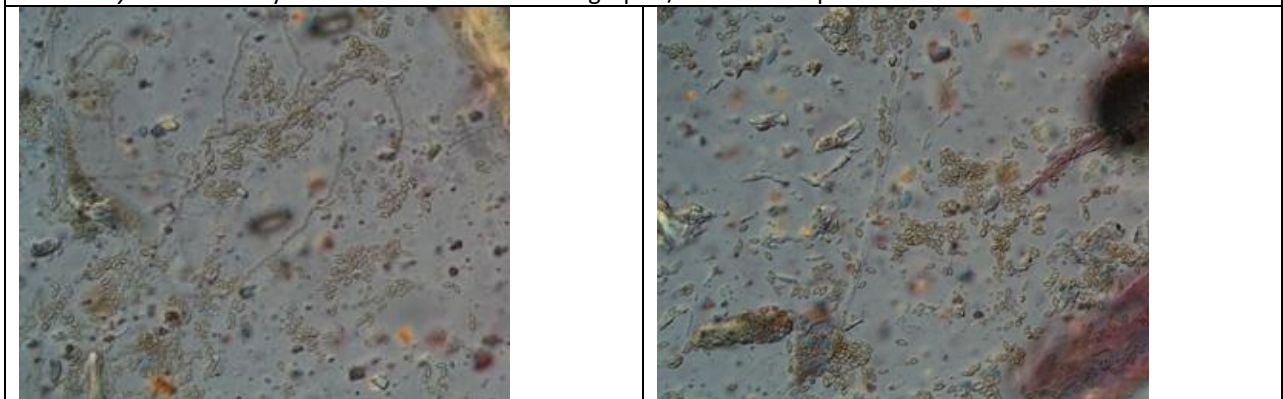
Paecilomyces variotii Plywood BND Treatment Micrographs / Surface Sample

Observations of post-treated sample: Atypical hyphal and conidiophore morphology observed. Atypical spore morphology was also observed. The spores appeared to have collapsed somewhat.

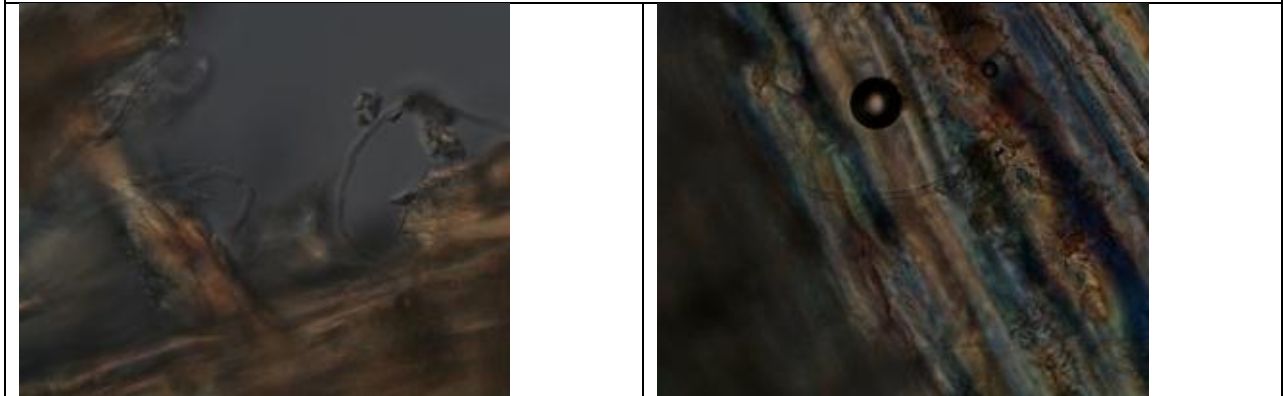
Paecilomyces variotii Plywood BND Treatment / Sub Surface Sample

Observations of post-treated sample: Hyphae appeared similar to the control.

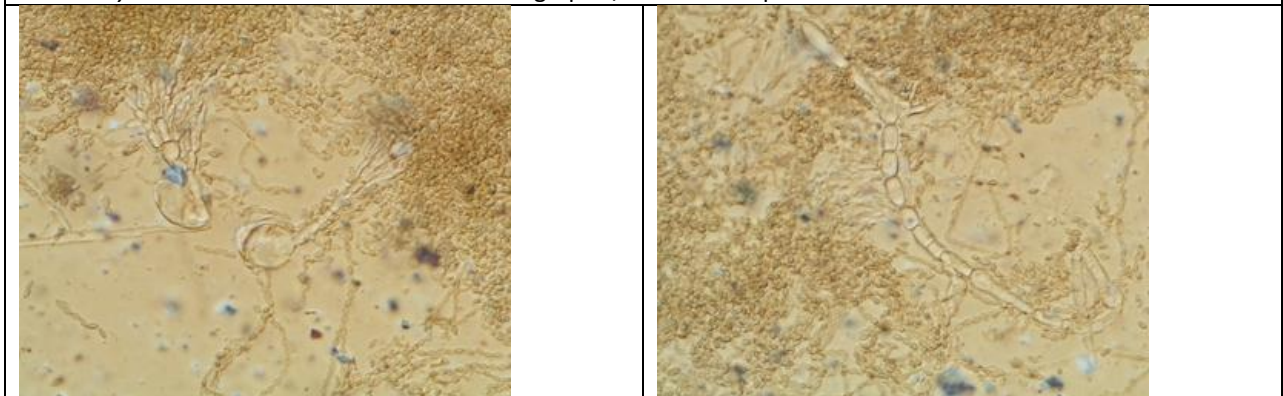
Paecilomyces variotii 2x4 BND Treatment Micrographs / Surface Sample

Observations of post-treated sample: Atypical hyphal and conidiophore morphology was observed, including swelling and fragmentation. Atypical spore morphology observed in that the spores seemed to have collapsed somewhat.

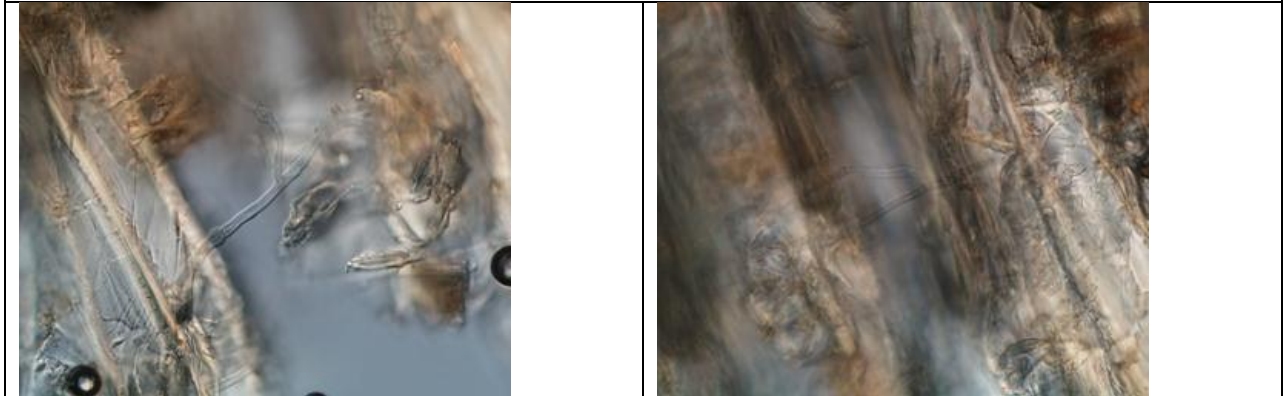
Paecilomyces variotii 2x4 BND / Sub Surface Sample

Observations of post-treated sample: Hyphae appeared similar to the control.

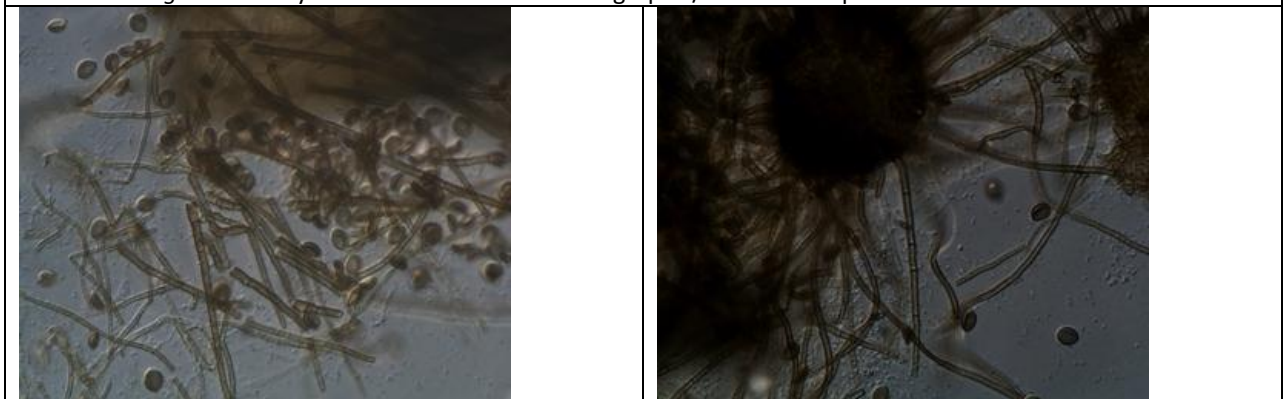
Chaetomium globosum Plywood BND Treatment Micrographs / Surface Sample

- **Observations of post-treated sample:** Morphology of all elements appeared very similar to the control sample.

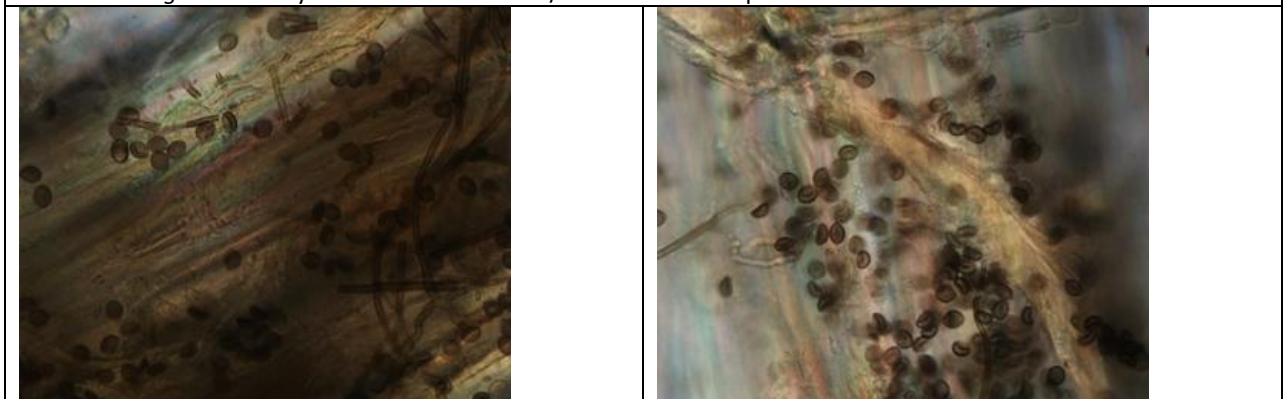
Chaetomium globosum Plywood BND Treatment / Sub Surface Sample

- **Observations of post-treated sample:** Morphology of all elements appeared very similar to the control sample.

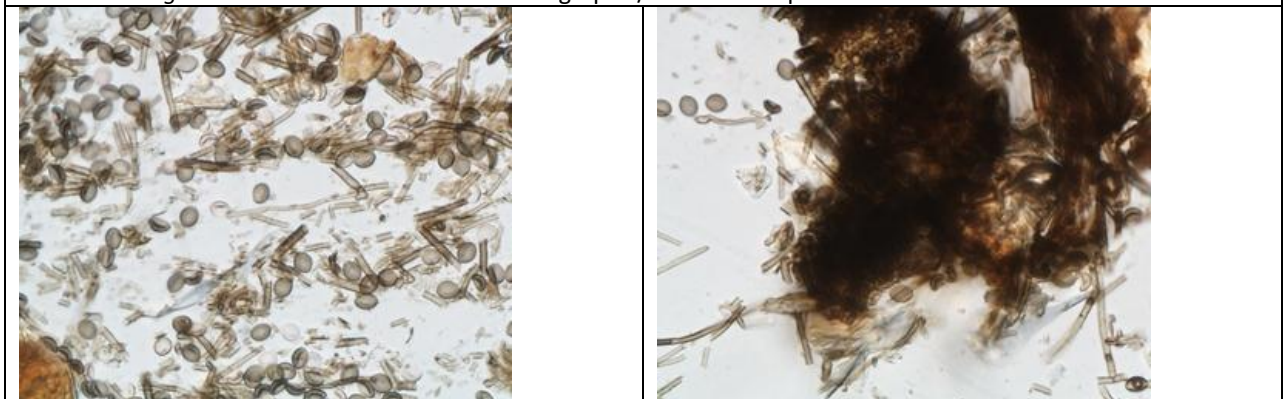
Chaetomium globosum 2x4 BND Treatment Micrographs / Surface Sample

- **Observations of post-treated sample:** Morphology of all elements appeared very similar to the control sample.

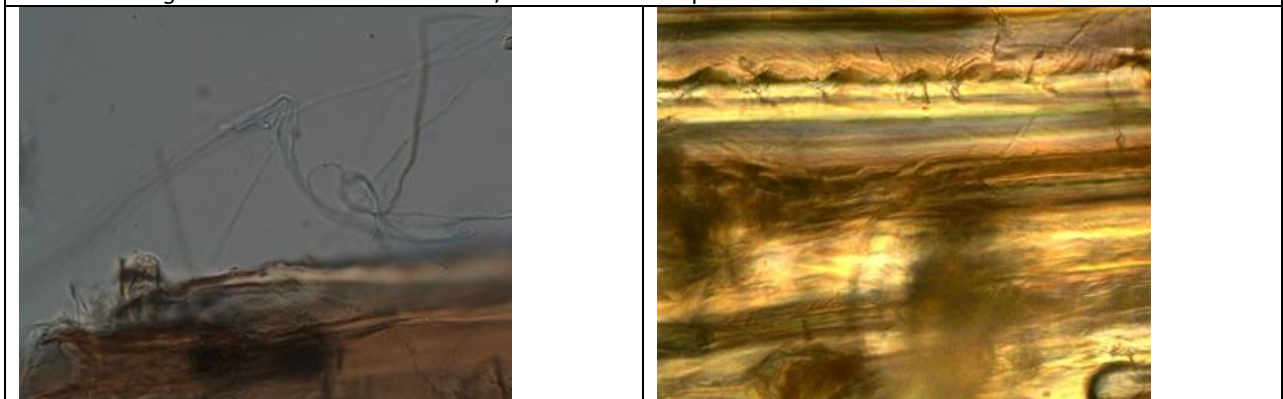
Chaetomium globosum 2x4 BND Treatment / Sub Surface Sample

- **Observations of post-treated sample:** Morphology of all elements appeared very similar to the control sample.

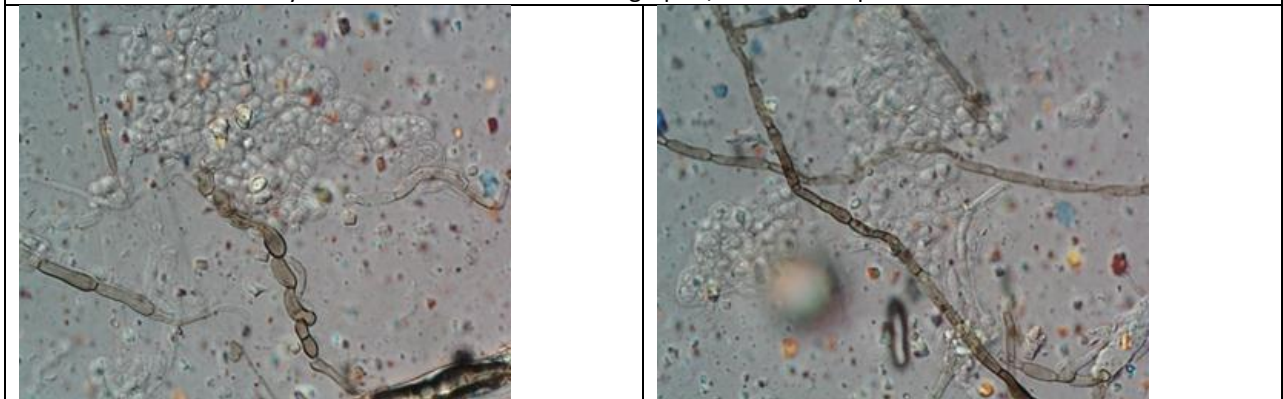
Ulocladium chartarum Plywood Bleach Treatment Micrographs / Surface Sample

- **Observations of post-treated sample:** Extensive destruction and partial bleaching of the hyphae and conidiophores was observed. Many hyphal elements did however remain intact and unbleached. Spore morphology was distorted and the vast majority of spores were completely bleached out.

The post-treatment bleach macroscopic photos show that the wood appeared much cleaner than pre-treatment; however evidence of fungal growth was apparent. The micrographs show that the bleach was extremely destructive to the surface growth, but the bleaching of surface growth was not as complete as MMR. The bleach did not appear to penetrate into the subsurface growth with the same penetrative power of the MMR and much of the subsurface growth remained unbleached and very similar to the control samples.

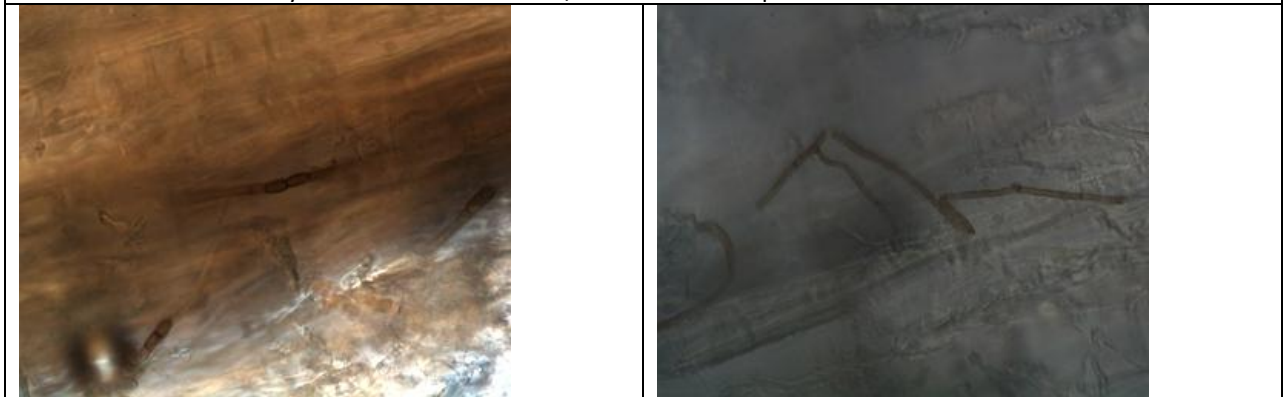
Ulocladium chartarum Plywood Bleach Treatment / Sub Surface Sample

- **Observations of post-treated sample:** Hyphae below the surface growth appeared similar to control samples.

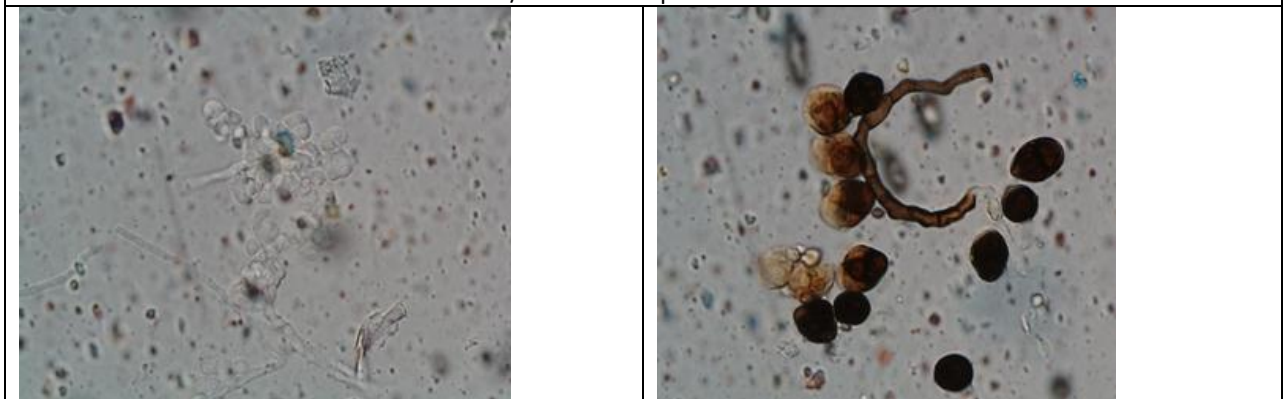
Ulocladium chartarum 2x4 bleach Treatment / Surface Sample

- **Observations of post-treated sample:** Extensive destruction and partial bleaching of the hyphae and conidiophores was observed. Many hyphal elements did however remain intact and unbleached. Spore morphology was distorted and the vast majority of spores were partially to completely bleached out.

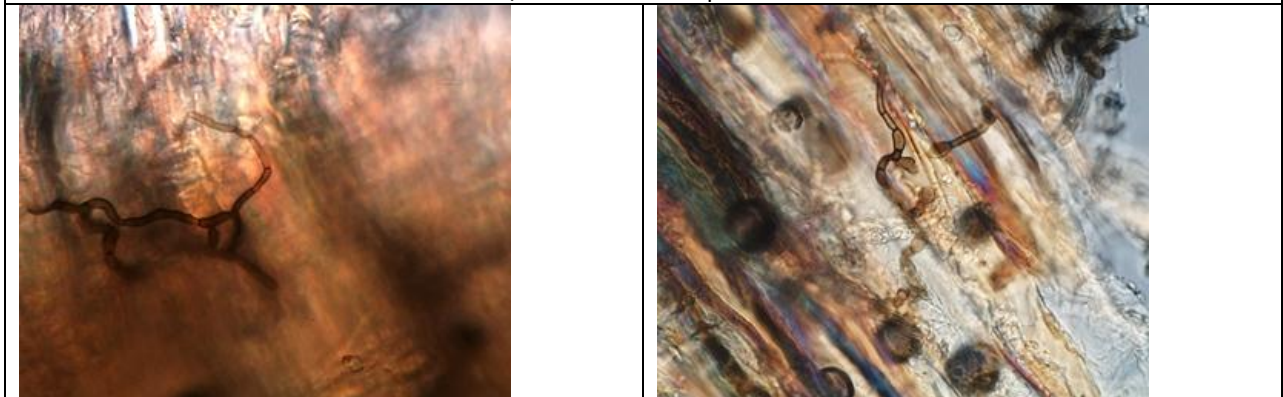
Ulocladium chartarum 2x4 Bleach Treatment / Sub Surface Sample

- **Observations of post-treated sample:** Hyphae below the surface growth appeared similar to control samples.

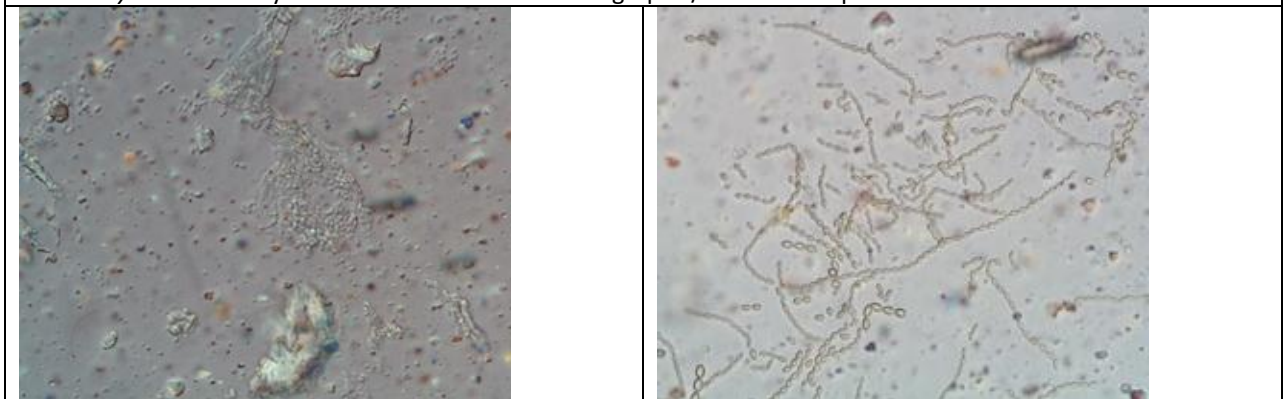
Paecilomyces variotii Plywood Bleach Treatment Micrographs / Surface Sample

- **Observations of post-treated sample:** Extensive destruction of conidiophores and hyphae was observed. Spore morphology remained consistent with the control.

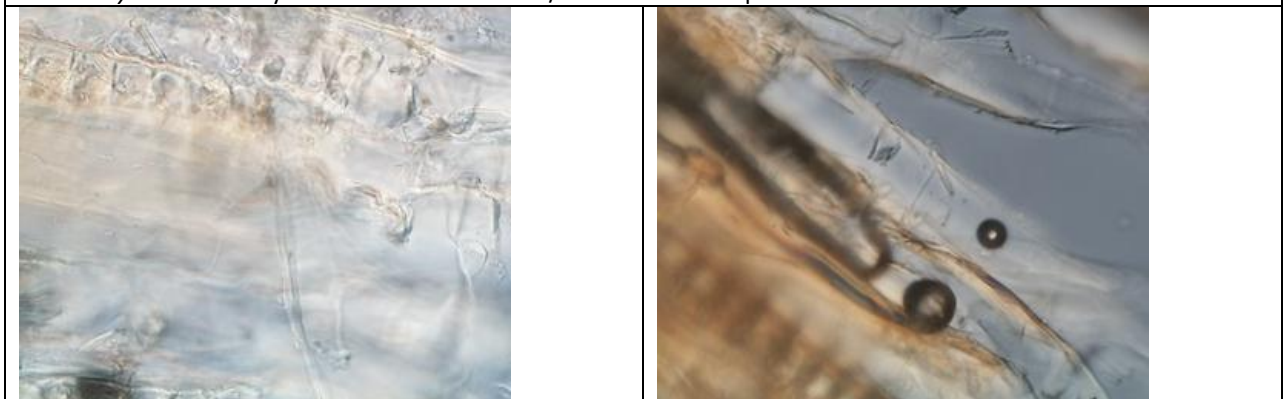
Paecilomyces variotii Plywood Bleach Treatment / Sub Surface Sample

- **Observations of post-treated sample:** Hyphae below the surface growth appeared similar to control samples.

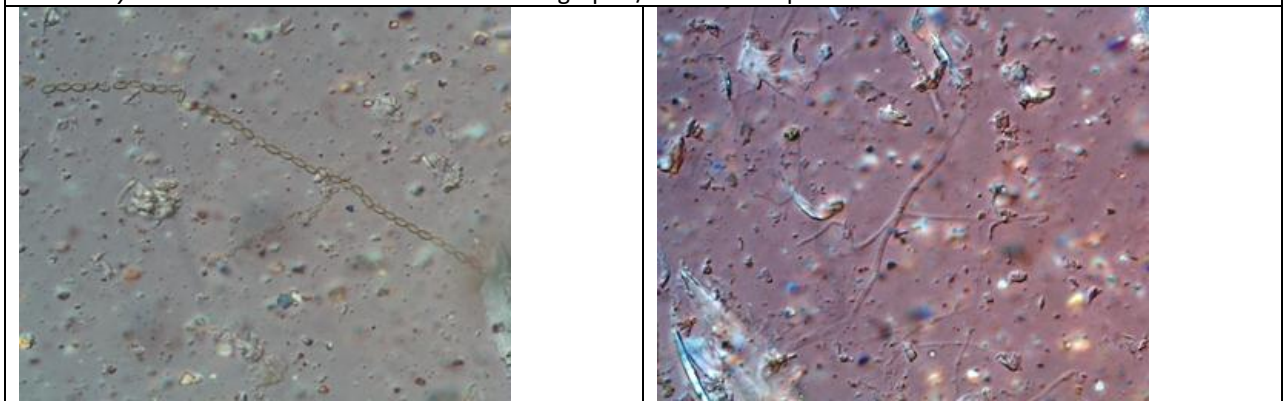
Paecilomyces variotii 2x4 Bleach Treatment Micrographs / Surface Sample

Observations of post-treated sample: Extensive destruction of hyphae and conidiophores was observed. Spores appeared very similar to control sample.

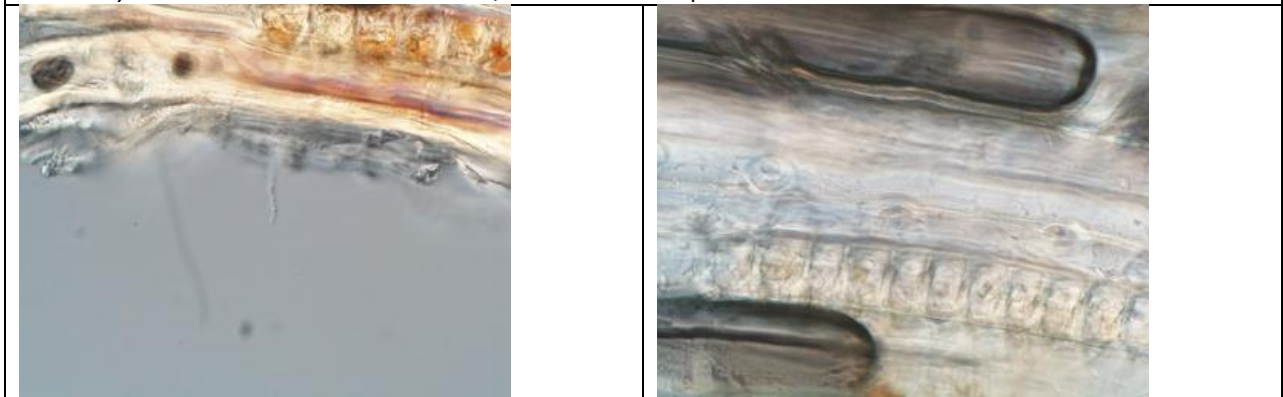
Paecilomyces variotii 2x4 Bleach Treatment / Sub Surface Sample

Observations of post-treated sample: Subsurface hyphae were hard to detect. The hyphae that was detected appeared similar to the control.

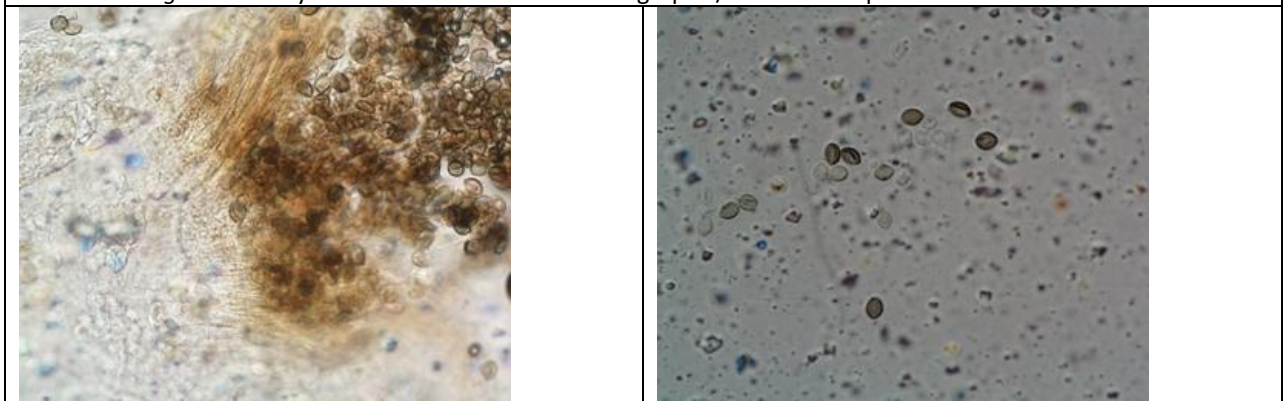
Chaetomium globosum Plywood Bleach Treatment Micrographs / Surface Sample

Observations of post-treated sample: Extensive destruction of ascocarps and partial bleaching of ascocarps was observed. Extensive destruction of hyphae was observed. Many spores were bleached out; however many remained very similar to control.

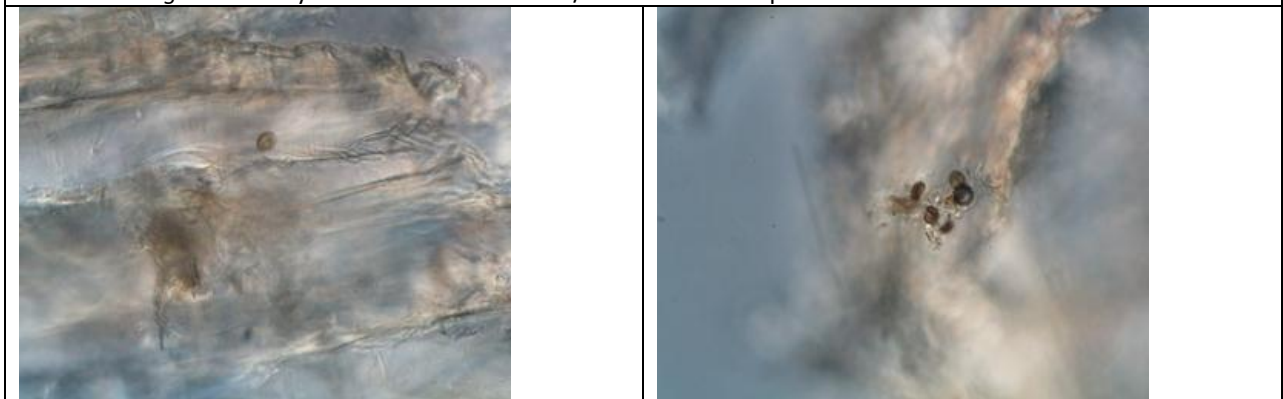
Chaetomium globosum Plywood Bleach Treatment / Sub Surface Sample

- **Observations of post-treated sample:** Subsurface hyphae were hard to detect. The hyphae that were detected appeared similar to the control.

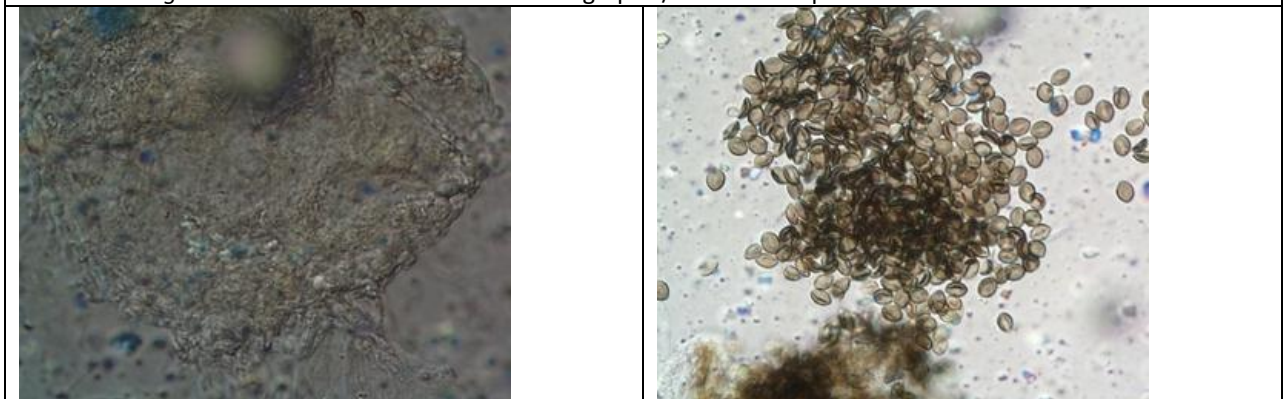
Chaetomium globosum 2x4 Bleach Treatment Micrographs / Surface Sample

- **Observations of post-treated sample:** Extensive destruction of ascocarps and partial bleaching of ascocarps was observed. Extensive destruction of hyphae was observed. Many spores were bleached out; however many remained very similar to control.

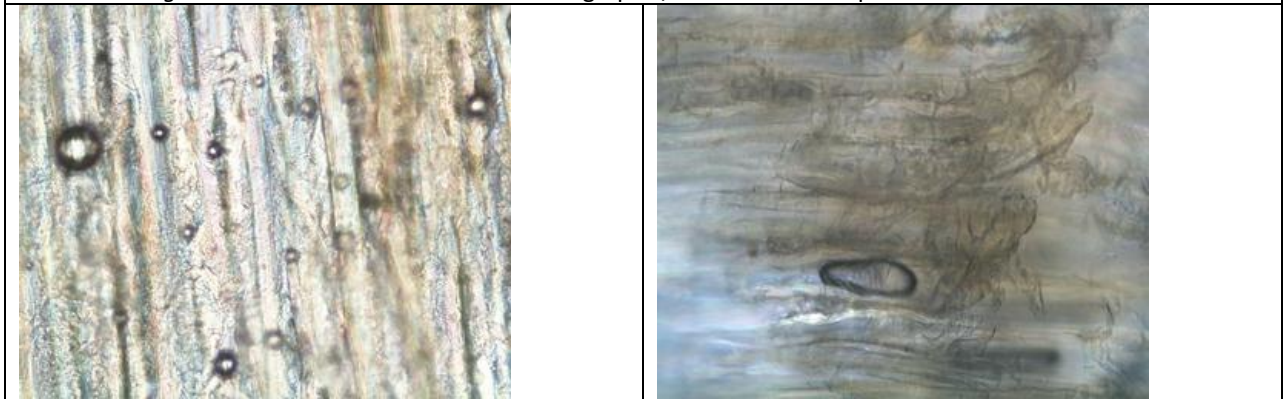
Chaetomium globosum 2x4 Bleach Treatment Micrographs / Sub Surface Sample

Observations of post-treated sample: Could not detect any subsurface hyphae.
