The guide for there' s no laser beam output when engraving

It seems to be a common problem that there' s no laser beam output before laser engraving.

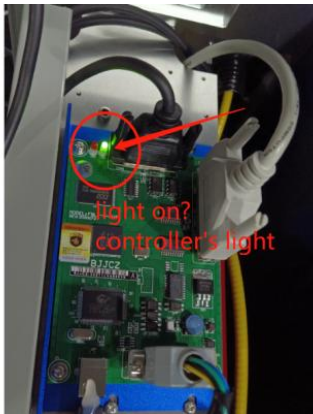
Secondly, Check the back of control board to see if there is any burns. If it is, the control board is broken.

If not, you need to do some engraving tests to check the red dot and green dot on the control board. If the dot does not light, the control board is broken.

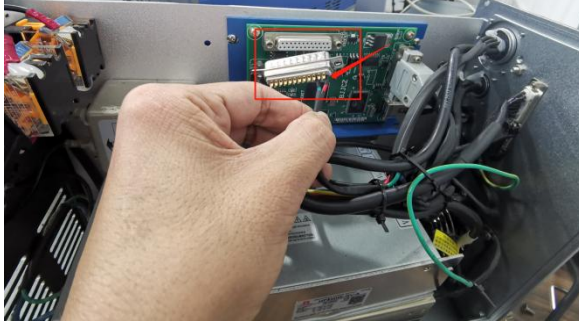
If the 48V power supply is normal, after removing the CN2 plug connected to the laser on the control board, do some engraving test with 100% power and measure the voltage on the two signal lines in the plug.

If the voltage is far away 4.5V, the control board is faulty.

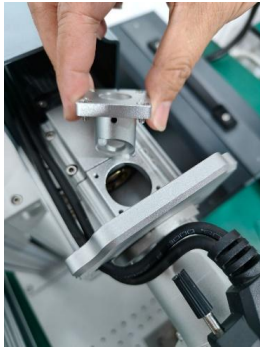
If the voltage is about 4.5V, remove the beam combiner inside the laser path and replace it with a wooden board.

If there is no laser, the RF tube is broken,

If there is the laser output, check whether the mounting holes of the galvanometer and beam combiner are aligned with the laser.
