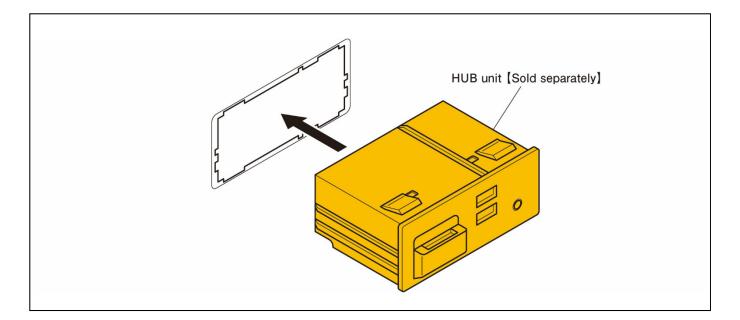
4. HUB UNIT INSTALLATION

- 1. Remove the AUX unit from the vehicle, and then install the HUB unit (sold separately).
 - $m
 m
 m \Lambda$ caution -
 - For details on removal and installation of parts, refer to the corresponding vehicle's Workshop manual.
 - Parts that have been removed will not be reused.

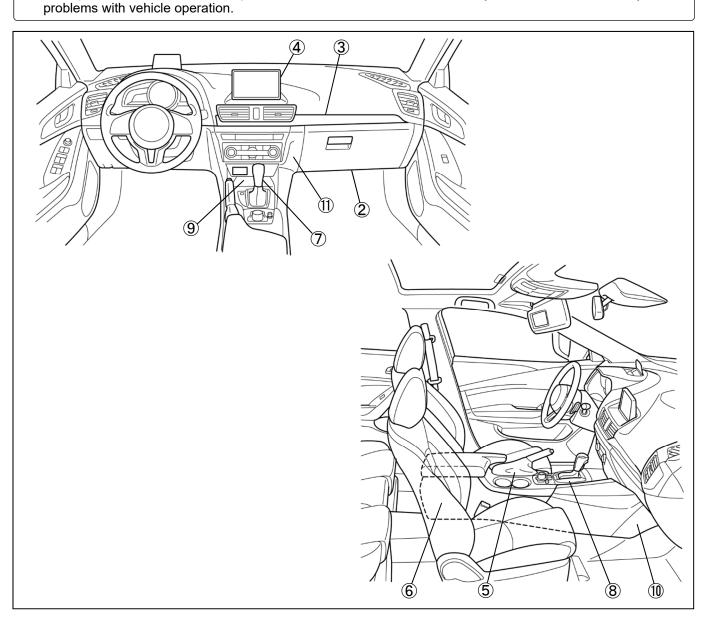
2. VEHICLE PART REMOVAL

- **1** Negative battery cable disconnection
- ② Glove compartment
- **③ Decoration panel**
- (4) Center display
- **5** Upper panel
- 6 Rear console
- ⑦ Shift lever knob (MTX) or Selector lever knob (ATX)
- **8** Shift panel
- **9** Front console box
- 0 Driver/passenger-side side wall
- ① Front console

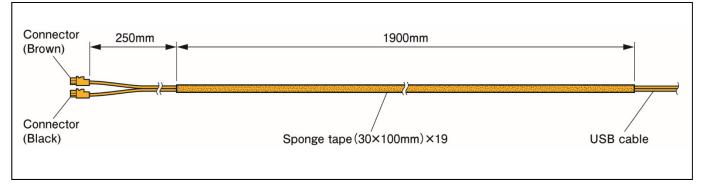
1. Wind sponge tape (100 mm x 30 mm) around the USB cable.

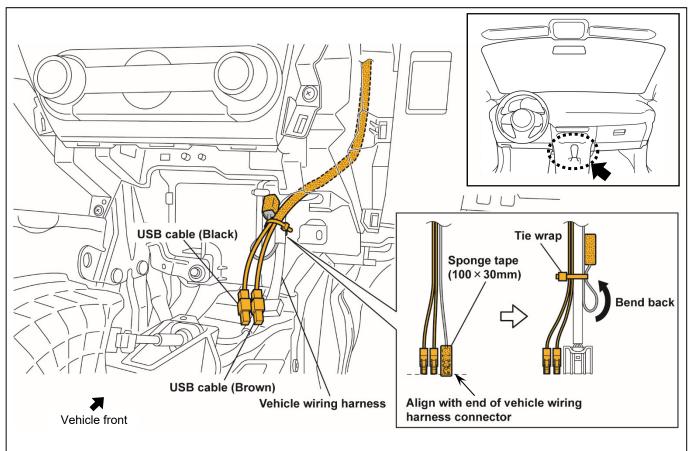
- To prevent noise, wrap the disconnected vehicle wiring harness connector with a piece of sponge tape (100 x 30 mm).
- 2. Align the ends of the vehicle wiring harness connector and the USB cable connector.
- 3. Bend back the vehicle wiring harness connector, and then use a tie wrap to secure the vehicle wiring harness together with the USB cable.

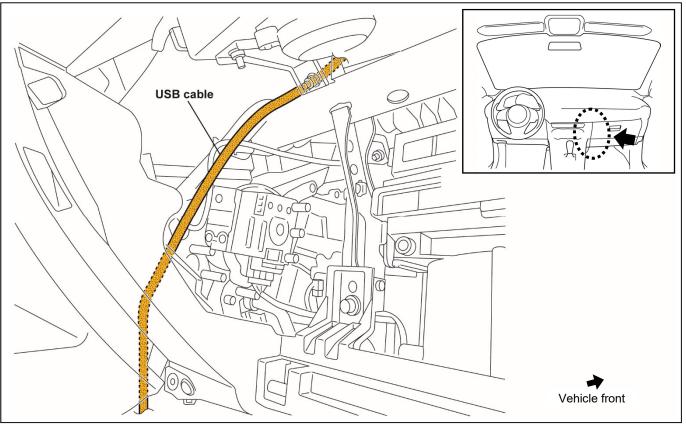
4. Route the USB cable to the underside of the center display.

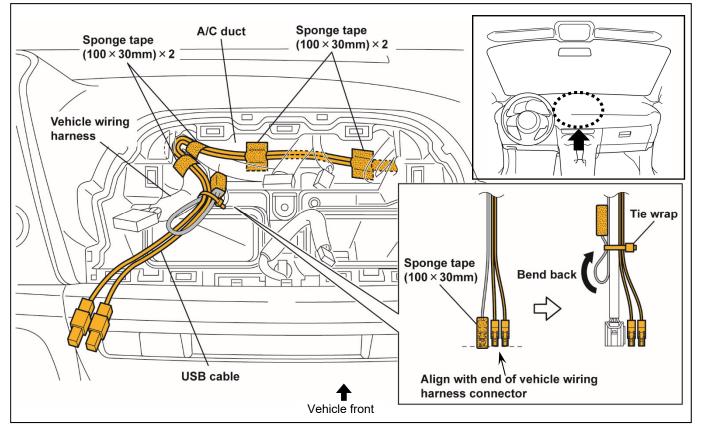
- 5. To prevent noise, wrap the disconnected vehicle wiring harness connector with a piece of sponge tape (100 x 30 mm).
- 6. Align the ends of the vehicle wiring harness connector and the USB cable connector.
- 7. Bend back the vehicle wiring harness connector, and then use a tie wrap to secure the vehicle wiring harness together with the USB cable.
- 8. Secure the USB cable to the vehicle wiring harness or A/C duct with sponge tape (100 x 30 mm).

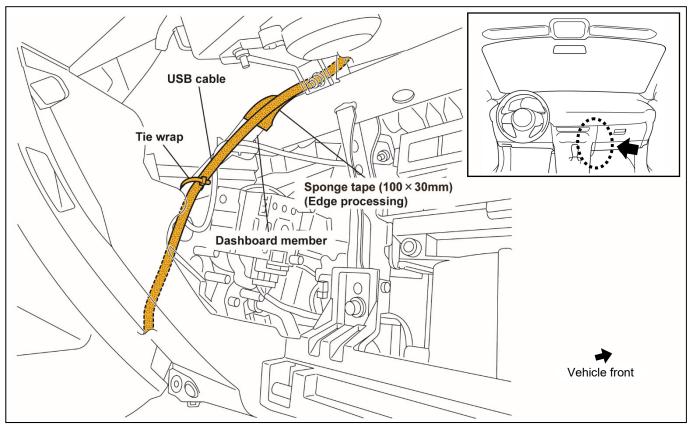
- 9. Attach sponge tape (100 x 30 mm) to the edge of the vehicle.
- 10. Secure the USB cable to the dashboard member with a tie wrap.

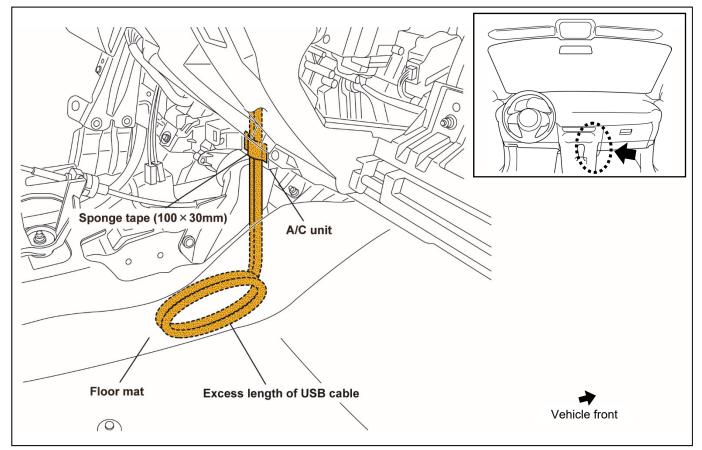
- 11. Secure the USB cable to the A/C unit with sponge tape (100 x 30 mm).
- 12. Bind the excess length of USB cable together and push it under the floor mat.

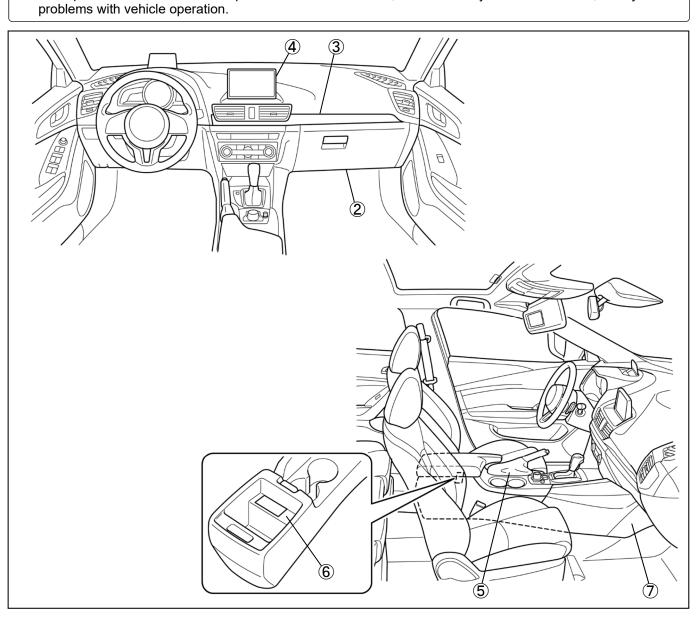
2. VEHICLE PART REMOVAL

- **1** Negative battery cable disconnection
- ② Glove compartment
- **③** Decoration panel
- (4) Center display
- **(5)** Upper panel
- 6 Console up
- $\ensuremath{\overline{\mathcal{O}}}$ Passenger-side side wall

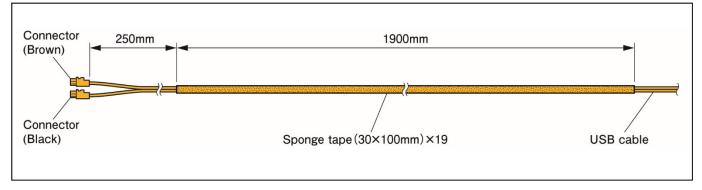
1. Wind sponge tape (100 mm x 30 mm) around the USB cable.

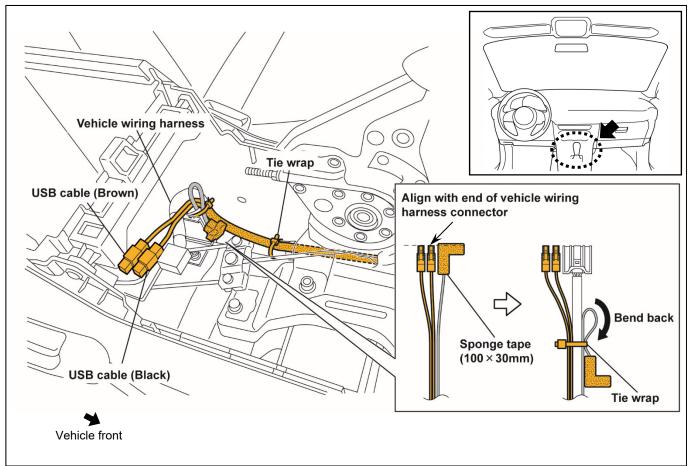
- To prevent noise, wrap the disconnected vehicle wiring harness connector with a piece of sponge tape (100 x 30 mm).
- 2. Align the ends of the vehicle wiring harness connector and the USB cable connector.
- 3. Bend back the vehicle wiring harness connector, and then use a tie wrap to secure the vehicle wiring harness together with the USB cable.

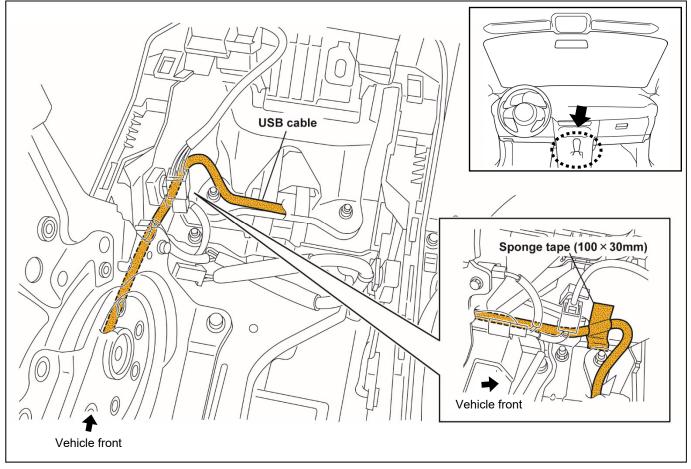
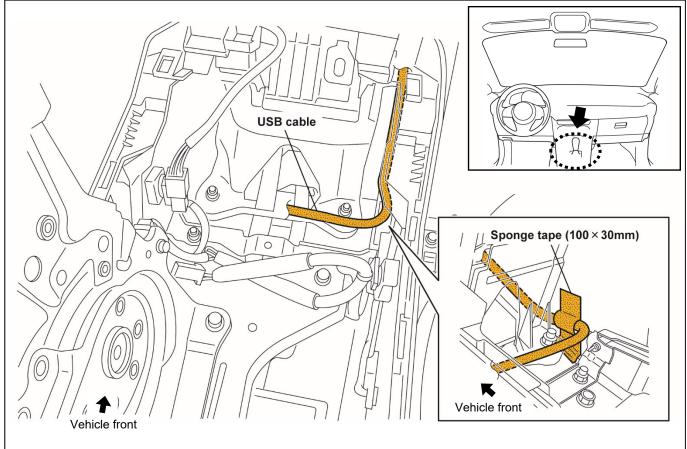
4. Secure the USB cable to the underside of the rear console with sponge tape (100 x 30 mm).

5. Secure the USB cable to the underside of the rear console with sponge tape (100 x 30 mm).

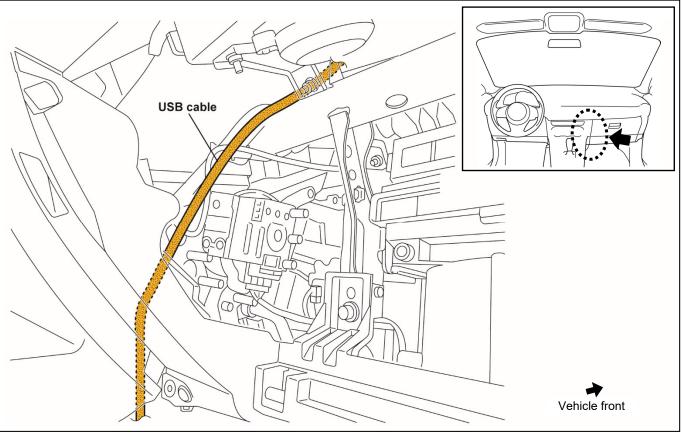
6. Route the USB cable to the underside of the center display.

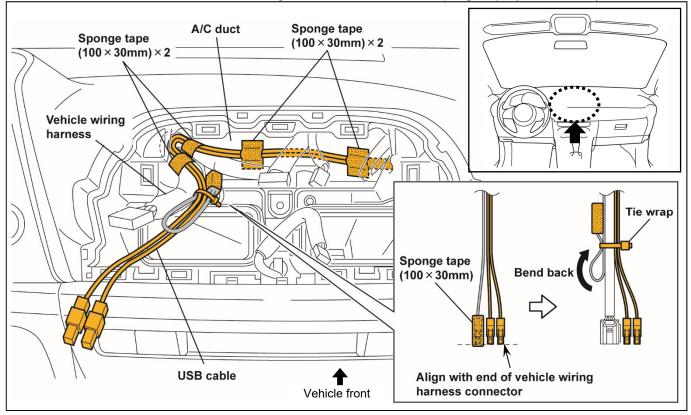
- To prevent noise, wrap the disconnected vehicle wiring harness connector with a piece of sponge tape (100 x 30 mm).
- 8. Align the ends of the vehicle wiring harness connector and the USB cable connector.
- 9. Bend back the vehicle wiring harness connector, and then use a tie wrap to secure the vehicle wiring harness together with the USB cable.
- 10. Secure the USB cable to the vehicle wiring harness or A/C duct with sponge tape (100 x 30 mm).

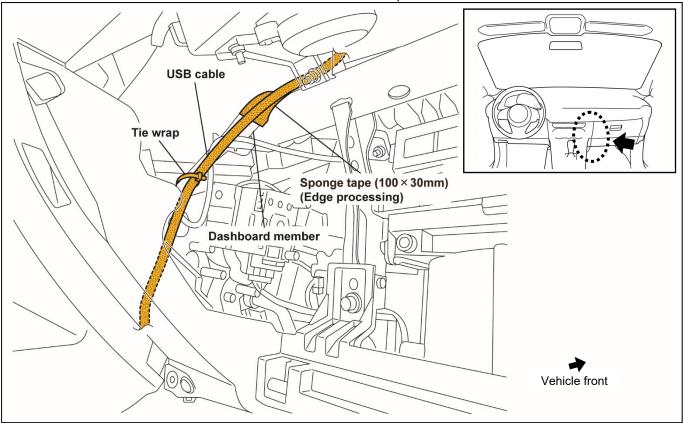
- 11. Attach sponge tape (100 x 30 mm) to the edge of the vehicle.
- 12. Secure the USB cable to the dashboard member with a tie wrap.

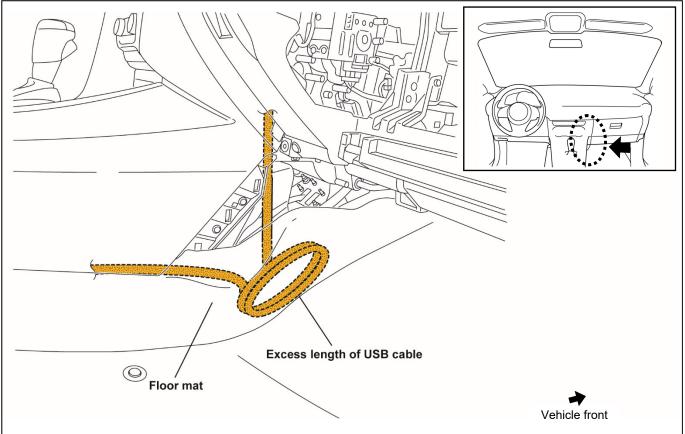
13. Bind the excess length of USB cable together and push it under the floor mat.

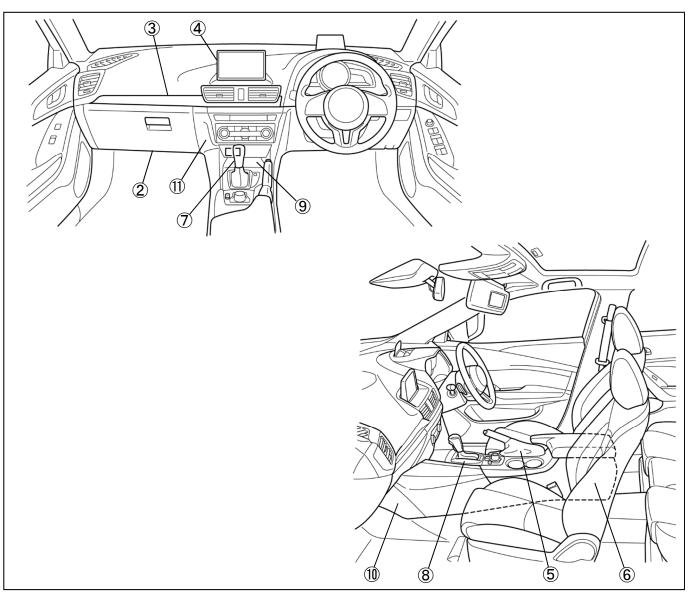
2. VEHICLE PART REMOVAL

- **1** Negative battery cable disconnection
- ② Glove compartment
- **③** Decoration panel
- **④** Center display
- **(5)** Upper panel
- 6 Rear console
- ⑦ Shift lever knob (MTX) or Selector lever knob (ATX)
- **8** Shift panel
- **9** Front console box
- 0 Driver/passenger-side side wall
- ① Front console

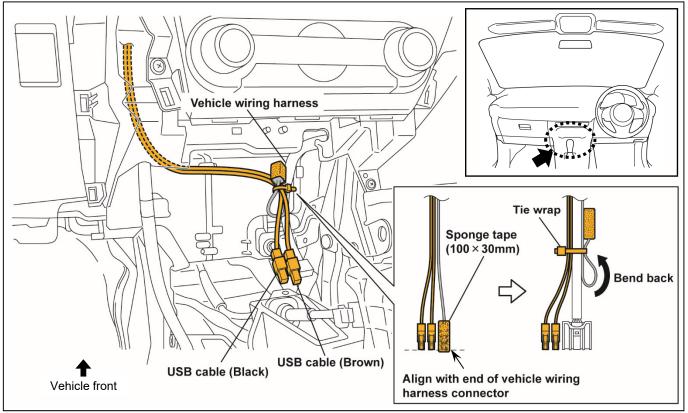
- 1. To prevent noise, wrap the disconnected vehicle wiring harness connector with a piece of sponge tape (100 x 30 mm).
- 2. Align the ends of the vehicle wiring harness connector and the USB cable connector.
- 3. Bend back the vehicle wiring harness connector, and then use a tie wrap to secure the vehicle wiring harness together with the USB cable.

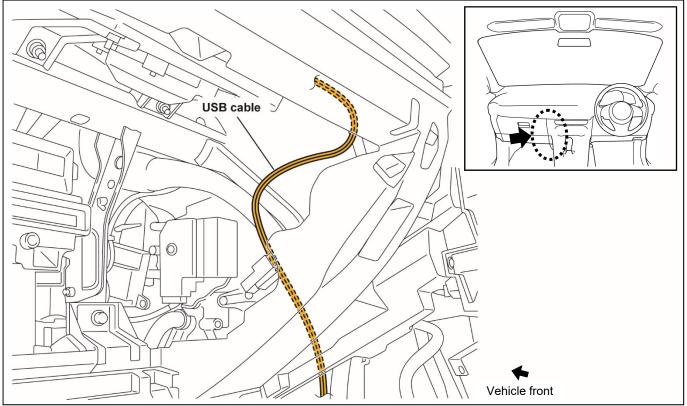
4. Route the USB cable to the underside of the center display.

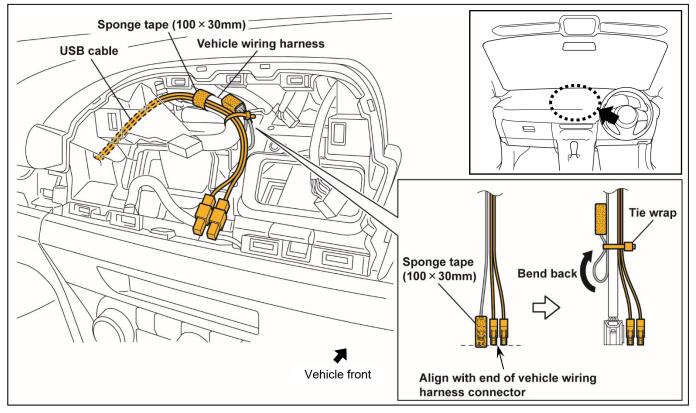
- To prevent noise, wrap the disconnected vehicle wiring harness connector with a piece of sponge tape (100 x 30 mm).
- 6. Align the ends of the vehicle wiring harness connector and the USB cable connector.
- 7. Bend back the vehicle wiring harness connector, and then use a tie wrap to secure the vehicle wiring harness together with the USB cable.
- 8. Secure the USB cable to the vehicle wiring harness with a sponge tape (100 x 30 mm).

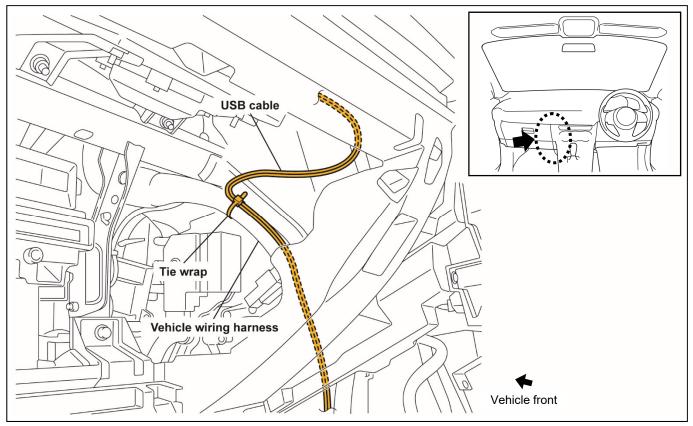
9. Secure the USB cable to the vehicle wiring harness with a tie wrap.

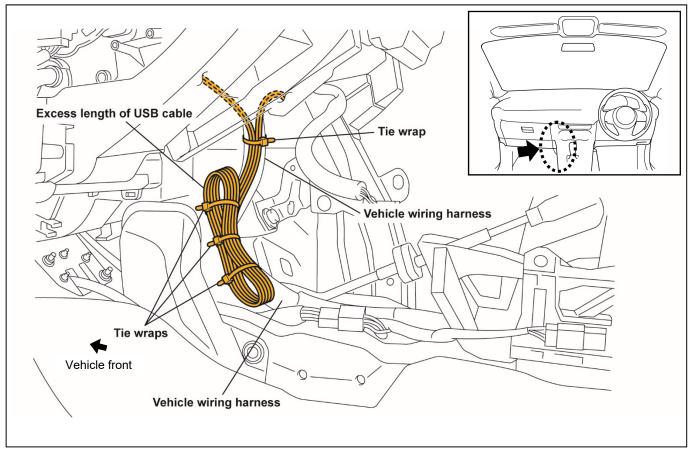
- 10. Secure the USB cable to the vehicle wiring harness with a tie wrap.
- 11. Bind the excess length of USB cable together and secure it with tie wraps.
- 12. Secure the excess length of USB cable to the vehicle wiring harness with a tie wrap.

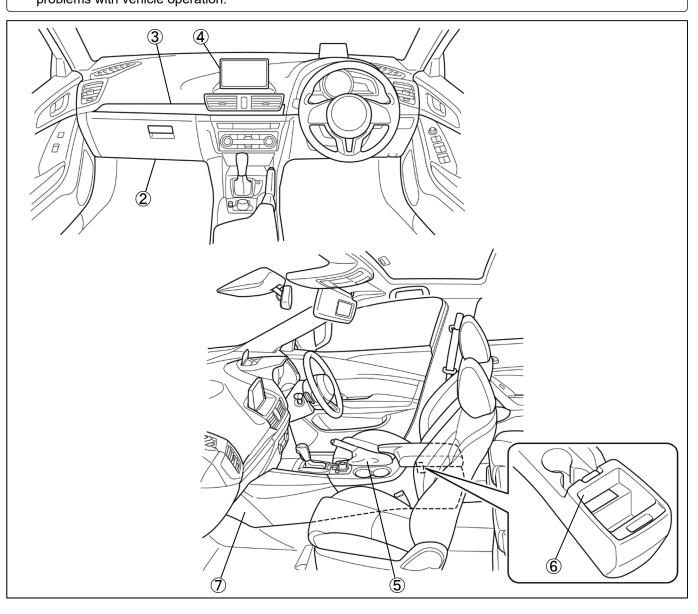
2. VEHICLE PART REMOVAL

- **1** Negative battery cable disconnection
- ② Glove compartment
- **③ Decoration panel**
- (4) Center display
- **(5)** Upper panel
- 6 Console up
- \bigcirc Passenger-side side wall

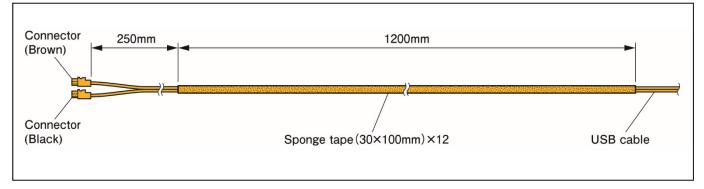
1. Wind sponge tape (100 mm x 30 mm) around the USB cable.

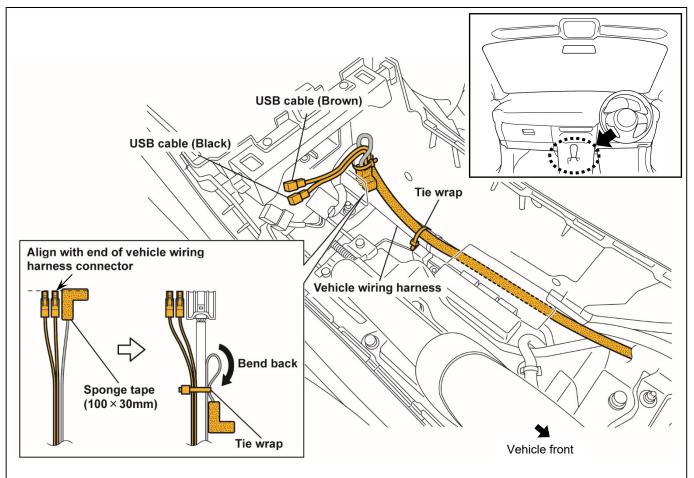
- To prevent noise, wrap the disconnected vehicle wiring harness connector with a piece of sponge tape (100 x 30 mm).
- 2. Align the ends of the vehicle wiring harness connector and the USB cable connector.
- 3. Bend back the vehicle wiring harness connector, and then use a tie wrap to secure the vehicle wiring harness together with the USB cable.
- 4. Secure the USB cable to the vehicle wiring harness with a tie wrap.

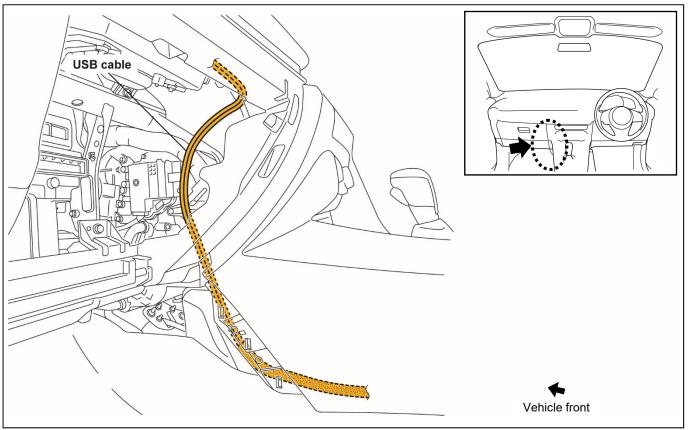
5. Route the USB cable to the underside of the center display.

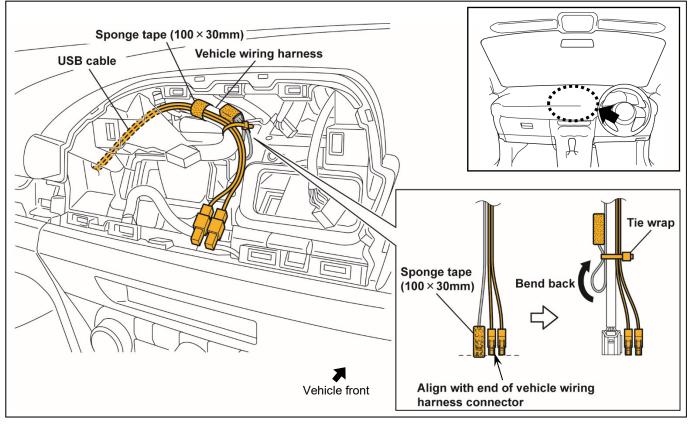
- To prevent noise, wrap the disconnected vehicle wiring harness connector with a piece of sponge tape (100 x 30 mm).
- 7. Align the ends of the vehicle wiring harness connector and the USB cable connector.
- 8. Bend back the vehicle wiring harness connector, and then use a tie wrap to secure the vehicle wiring harness together with the USB cable.
- 9. Secure the USB cable to the vehicle wiring harness with a sponge tape (100 x 30 mm).

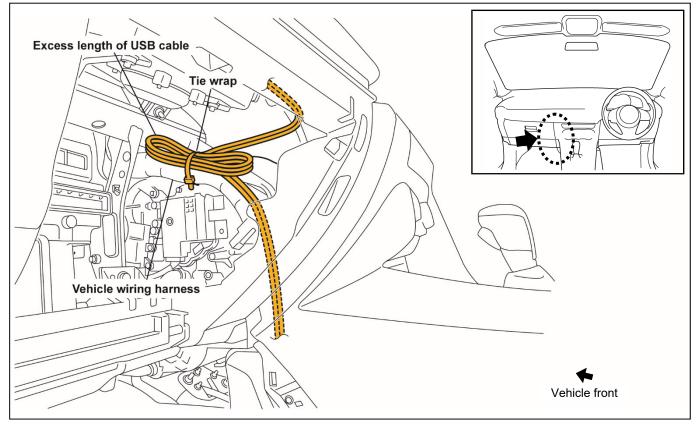
10. Bind the excess length of USB cable together and secure it to the vehicle wiring harness with a tie wrap.
