**Macrolux**[®]

CORRUGATED POLYCARBONATE SHEET PRODUCT

10 YEAR NON PRORATED WARRANTY

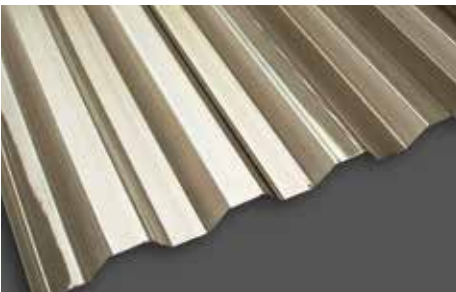
Greca 76-18

CHARACTERISTICS	ROMA (SINE WAVE)	GRECA	OMEGA
Nominal Width	50" & 26"	50" & 26"	50" & 26"
Nominal Thickness (mm)	0.8	0.8	0.8
Corrugation Pitch (mm)	76	76	76
Corrugation Height	18	18	18
Weight: lbs/sf	0.22	0.23	0.23
Light Transmission ASTM-D1003 (%)			
Clear		90	
Bronze		48	
Opal		60	
HD Soft White	PAR Ligh 90% with 100% Light Diffusion

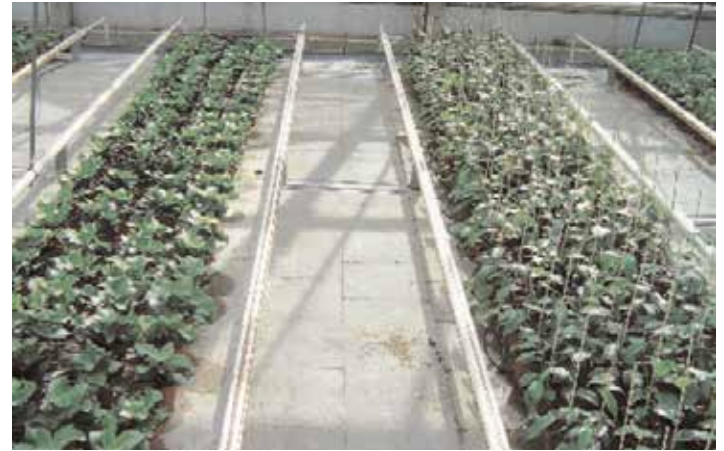
Shadows with clear covering

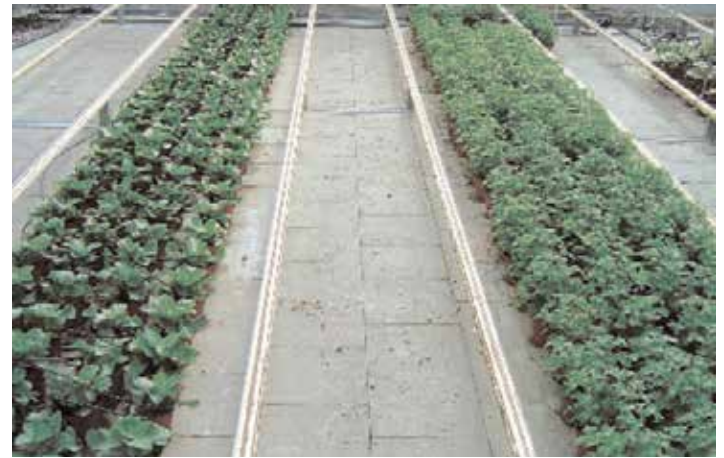
No shadows with HD Soft White
